# Terwer Creek Riparian Restoration Project

Klamath River Basin Fisheries Task Force  
Project # 2004-HR-04/2005-HR-02  
FY 2004 Agreement #113334J005  
FY 2005 Agreement #813335J003

January 23, 2007

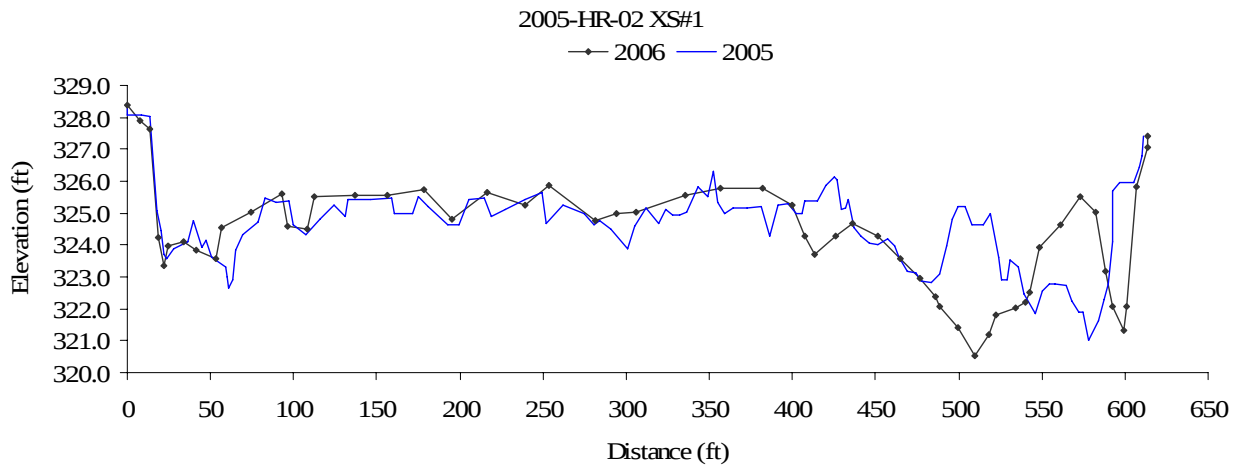
Stream channel cross sections through the 2005-HR-02 project reach reveal that the main thalweg has shifted 30-50 feet away from the west (right) bank following the bioengineering work (Figures 16-17). In addition, the cross sections reveal that deposition has occurred across the large floodplain on the east (left) side of the channel. This has resulted in a rise in bed elevation across this floodplain and a corresponding decrease in the number and flow frequency of braided secondary channels across this surface (Figures 16-17).

Figure 16. Stream channel cross-sectional profile before and after installation of willow baffles, 2005-HR-02 XS#1, Lower Terwer Creek, California, 2005-2006.

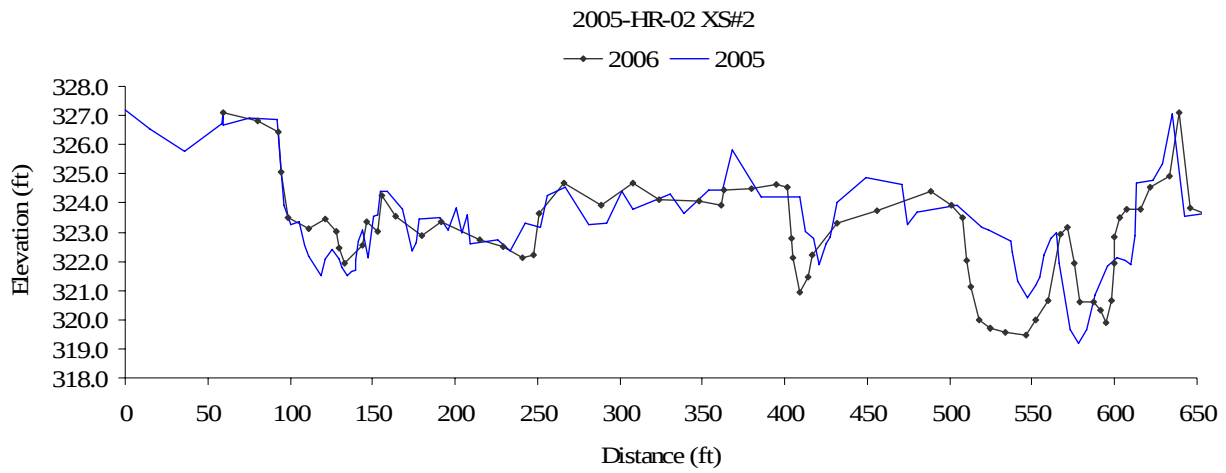
Figure 17. Stream channel cross-sectional profile before and after installation of willow baffles, 2005-HR-02 XS#2, Lower Terwer Creek, California, 2005-2006.

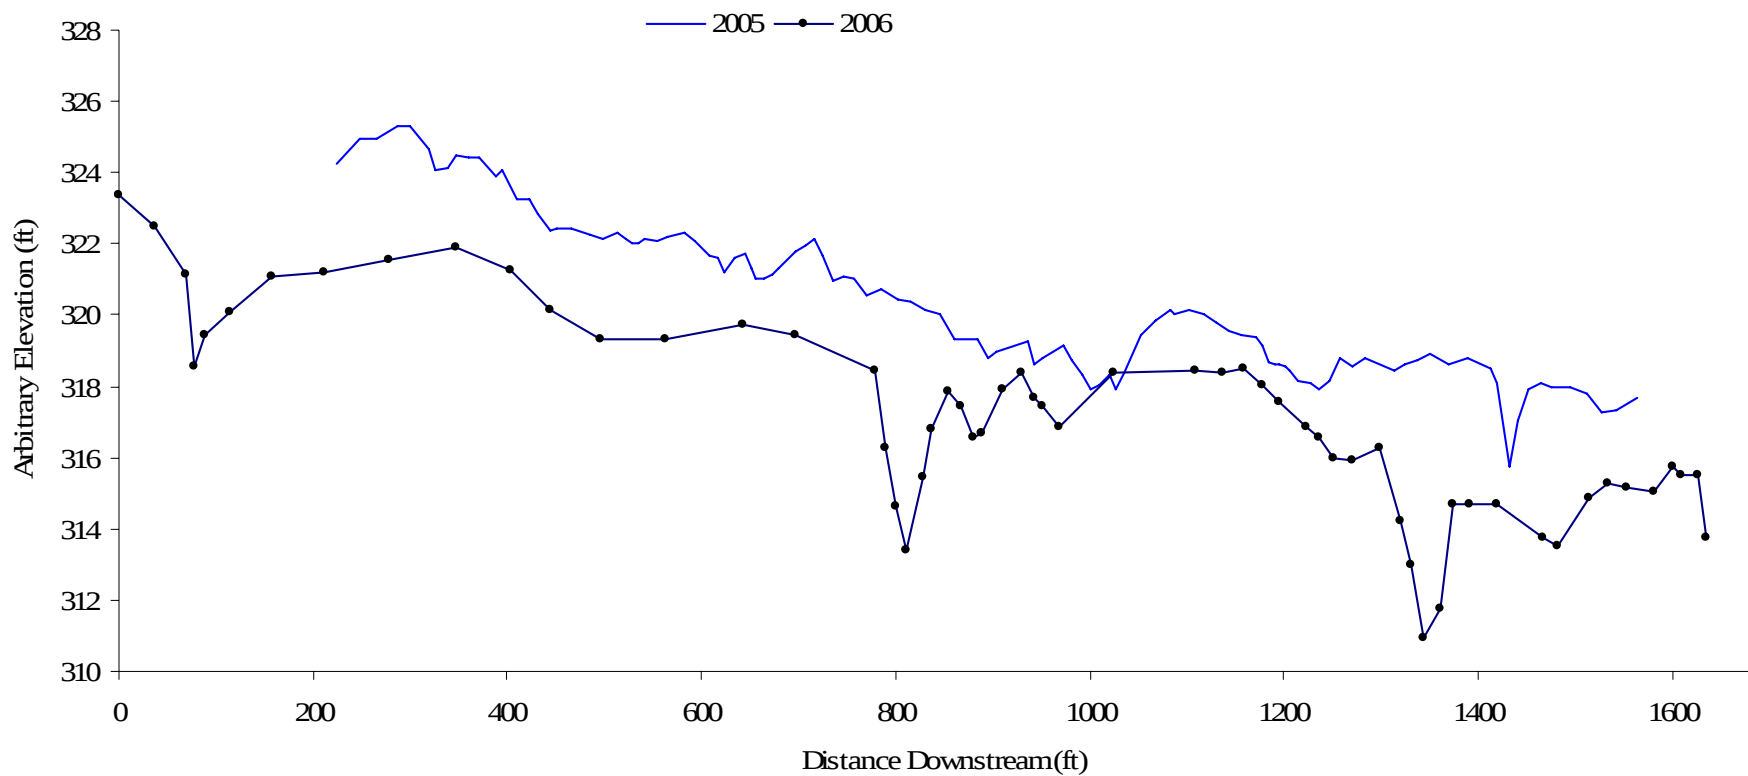
Thalweg longitudinal profiles surveyed through this reach before and after bioengineering implementation reveals a 4-5 foot lowering of the thalweg bed elevation throughout the project reach (Figure 19). In addition, the longitudinal profiles reveal a noticeable increase in pool depth and overall habitat diversity throughout the project reach.

Figure 19. Stream channel longitudinal profile before and after installation of willow baffles at 2005-HR-02 XS#1 project site, Lower Terwer Creek, California, 2005-2006.

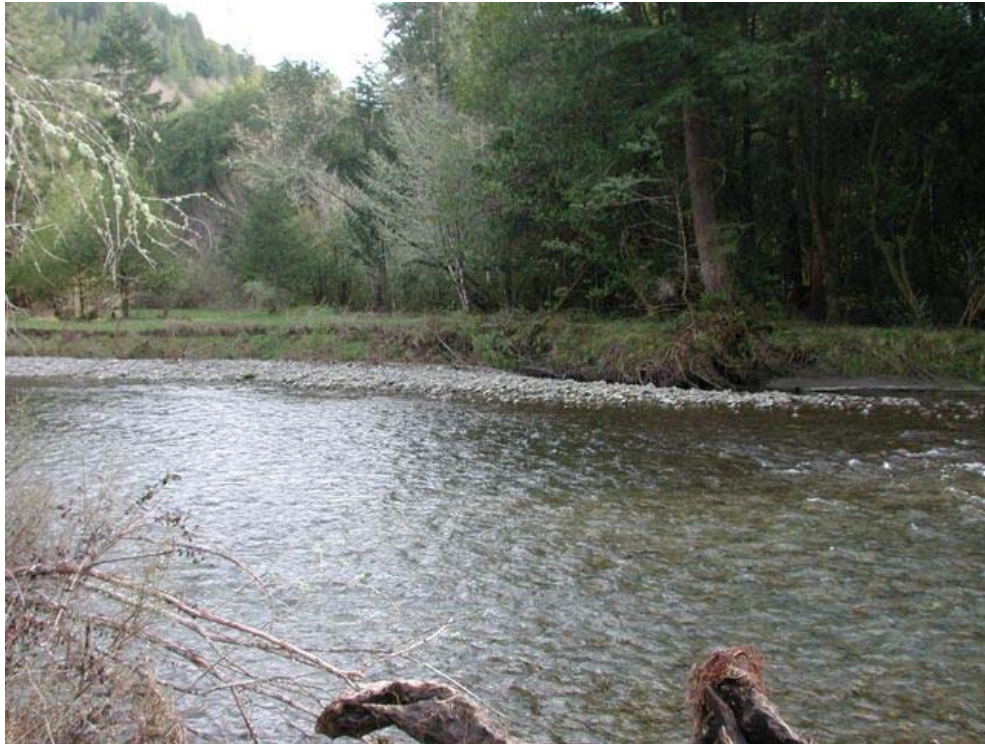
Figure 22. Eroding streambank on east side of creek, Lower Terwer Creek, Lower Klamath River, California, 2004.

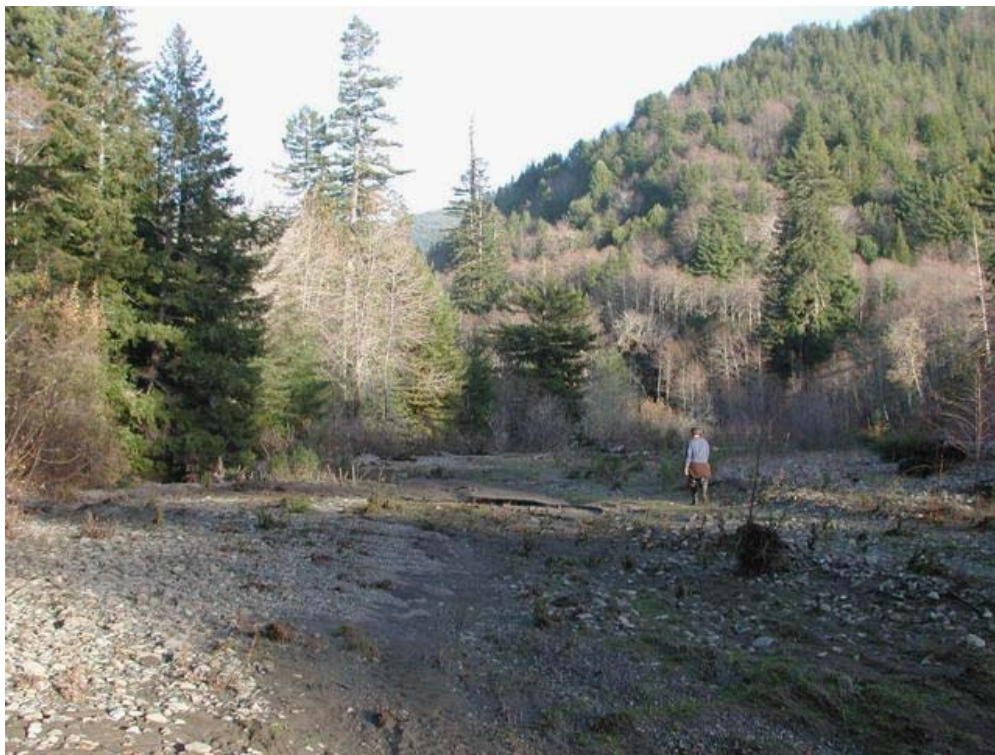
Figure 23. Middle of willow baffle/mattress project site before construction, Lower Terwer Creek, Lower Klamath River, California, 2004.

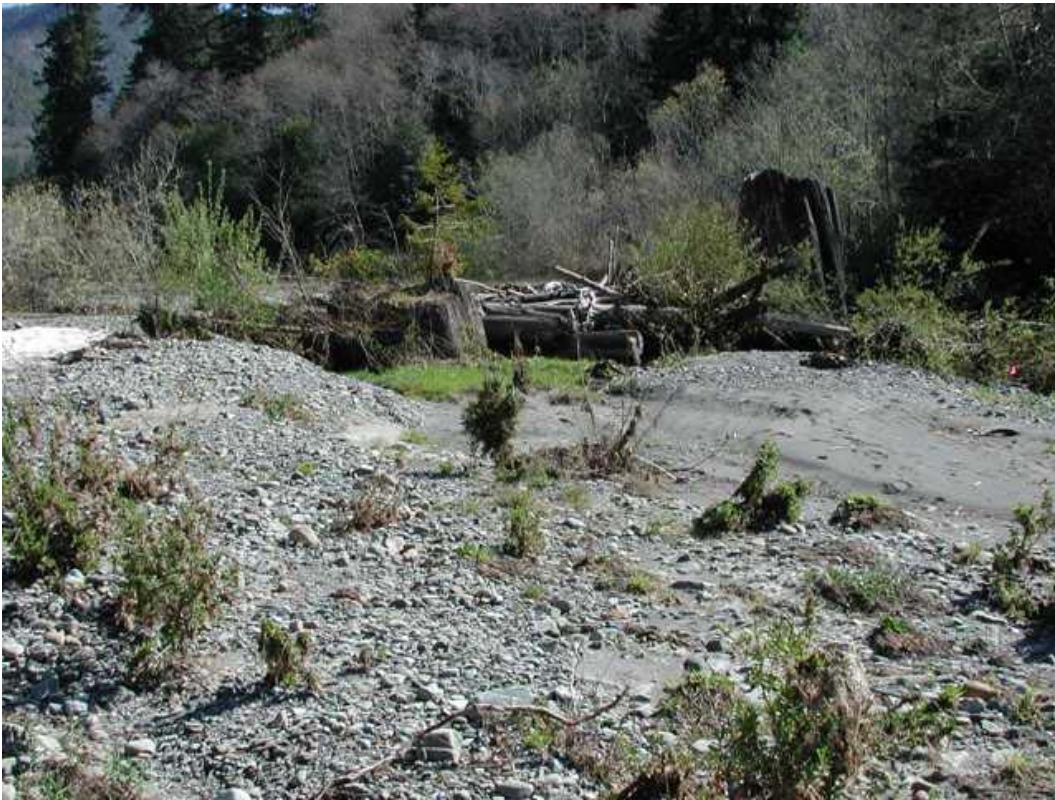
Figure 26. Upper end of willow baffle/mattress project site before construction, Lower Terwer Creek, Lower Klamath River, California, 2004.

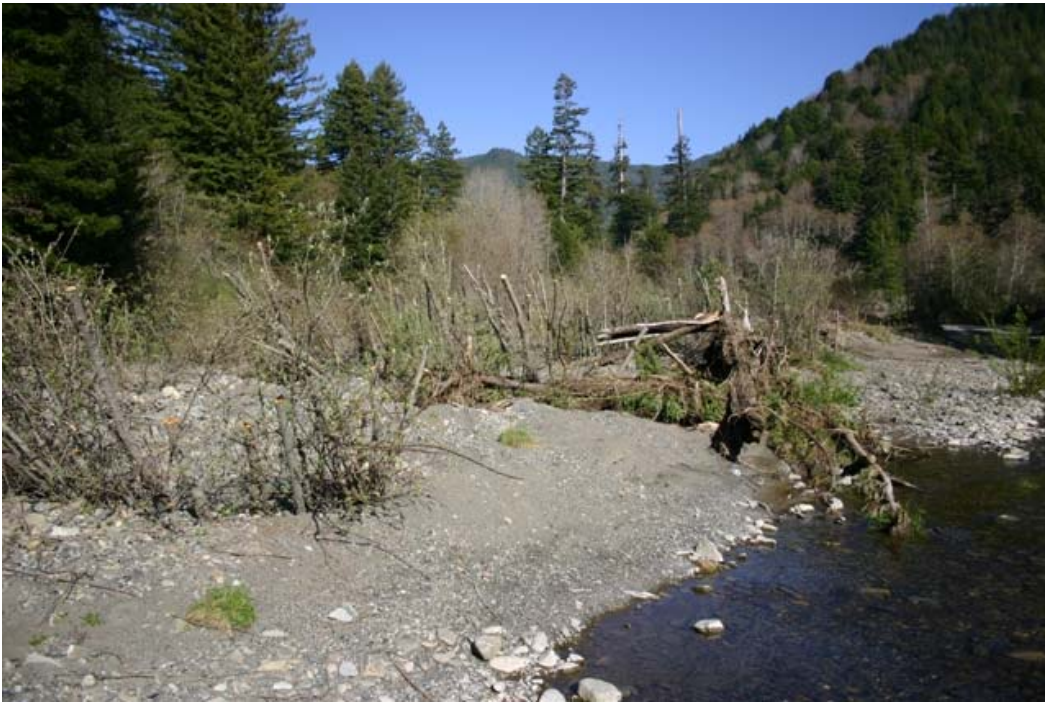
Figure 29. Willow baffles at lower end of site following high flow event, Lower Terwer Creek, Lower Klamath River, California, 2005.

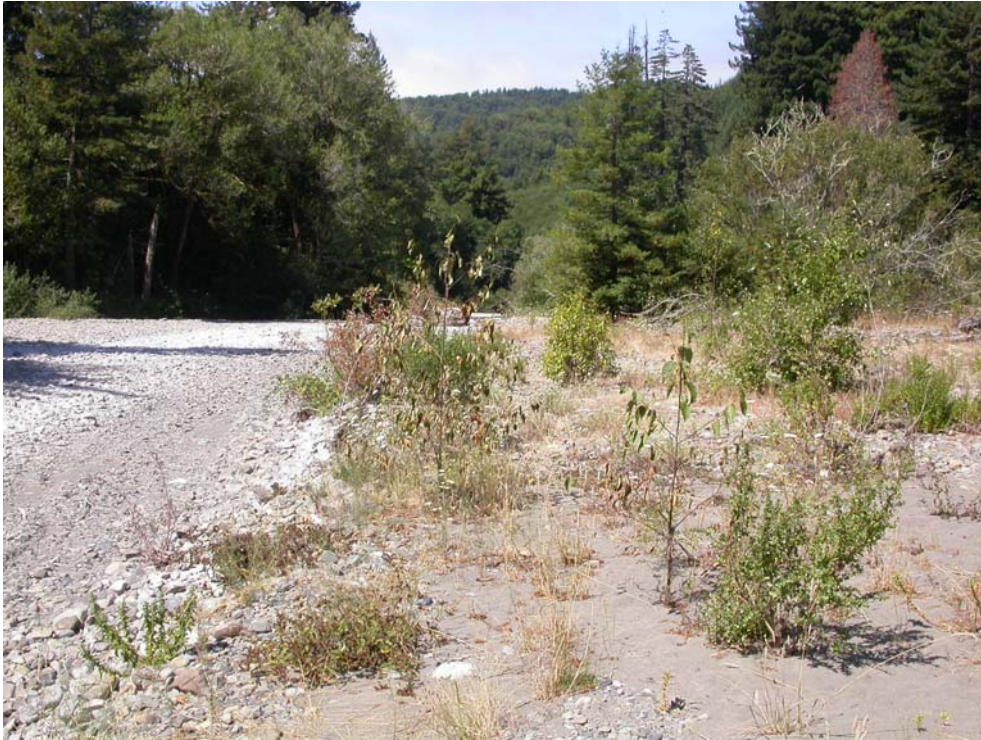
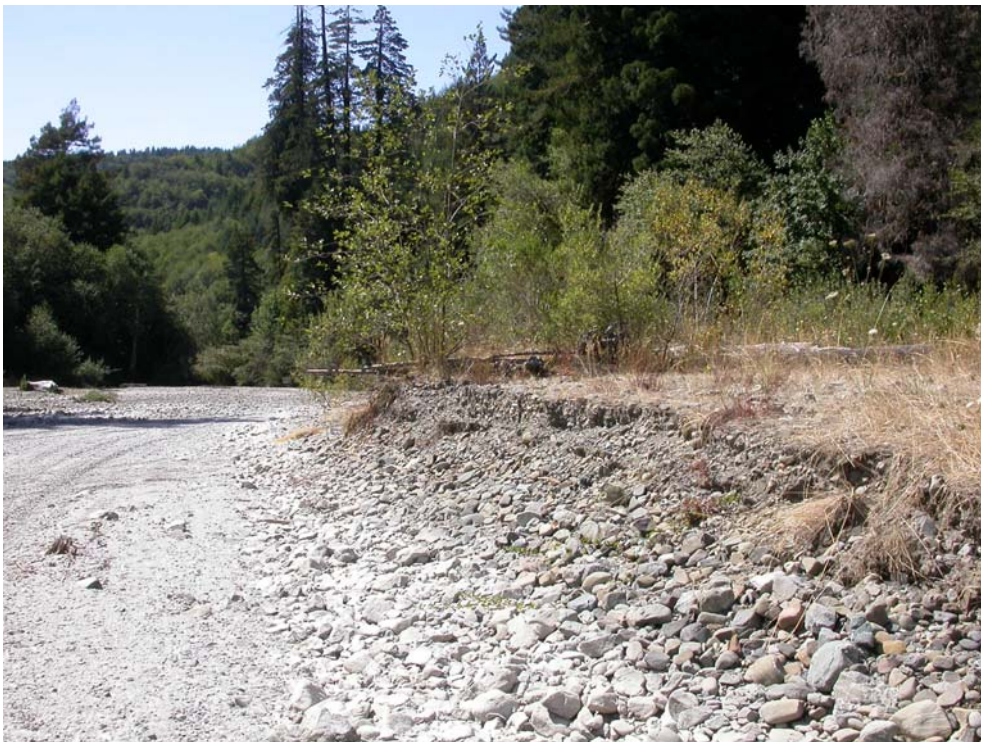
Figure 35. Photographs taken from a permanent photographic monitoring point in Terwer Creek, Lower Klamath River. The upper photograph was taken in summer 2004 and the lower photograph was taken in summer 2005. Note the newly eroded stream bank in the 2005 photograph.

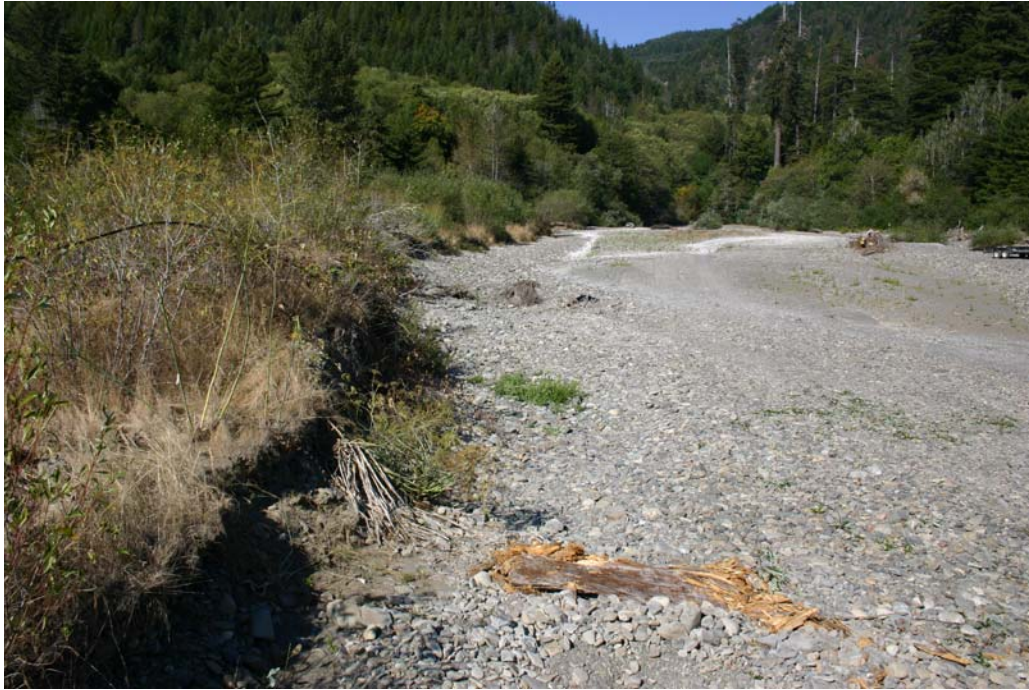
Figure 36. Lower end of willow baffle/mattress project site before construction, Lower Terwer Creek, Lower Klamath River, California, 2005.

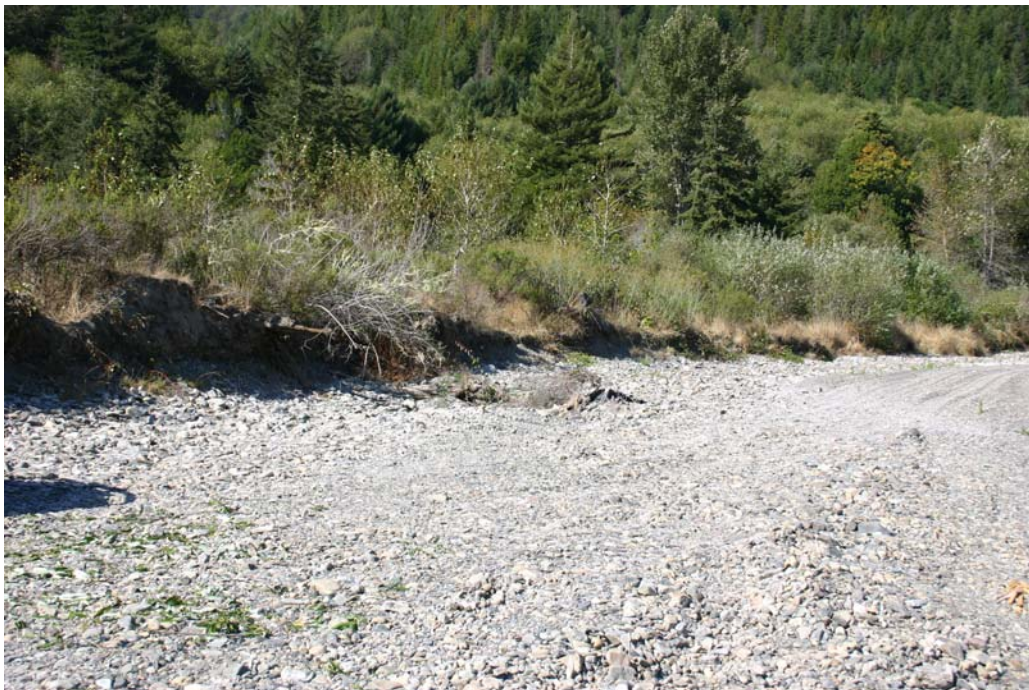
Figure 37. Upper end of willow baffle/mattress project site before construction, Lower Terwer Creek, Lower Klamath River, California, 2005.

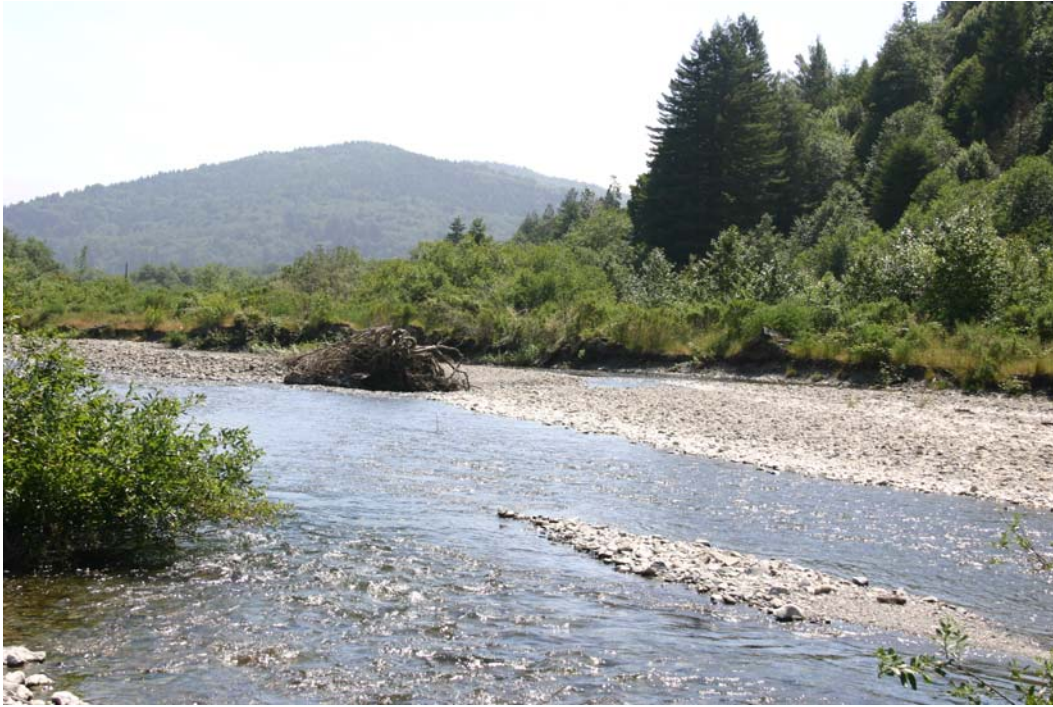
Figure 38. Upper end of willow baffle/mattress project site before construction, Lower Terwer Creek, Lower Klamath River, California, 2005.

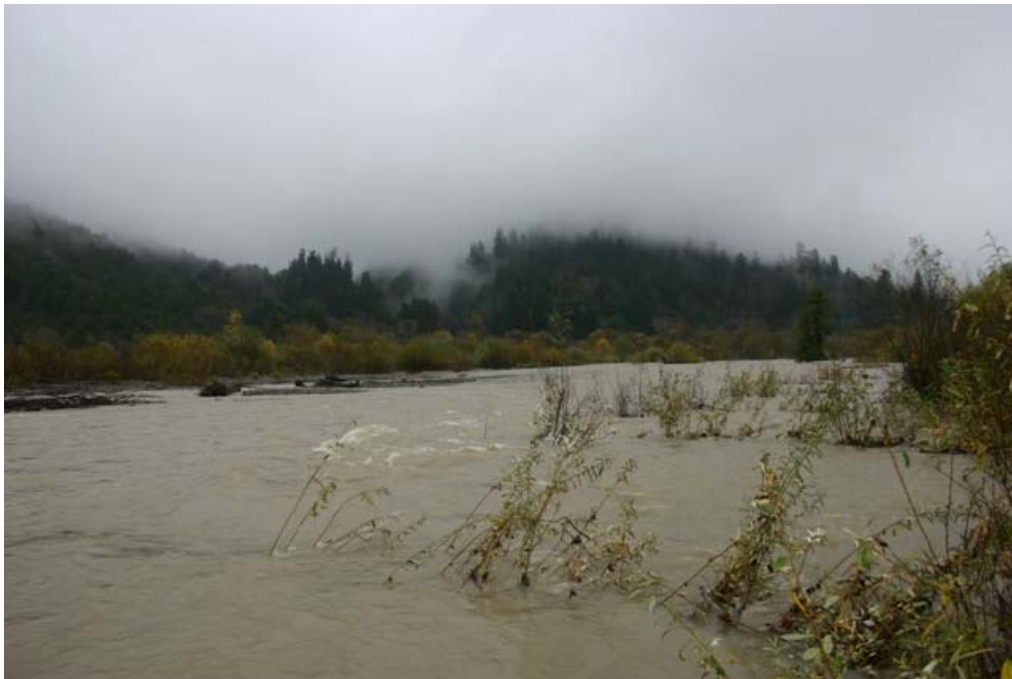
Figure 51. Willow baffles during >bankfull discharge flow event on 13-Dec-2006, Lower Terwer Creek, Lower Klamath River, 2006.
