## **Terwer Creek**

## **Terwer Creek Restoration Background**

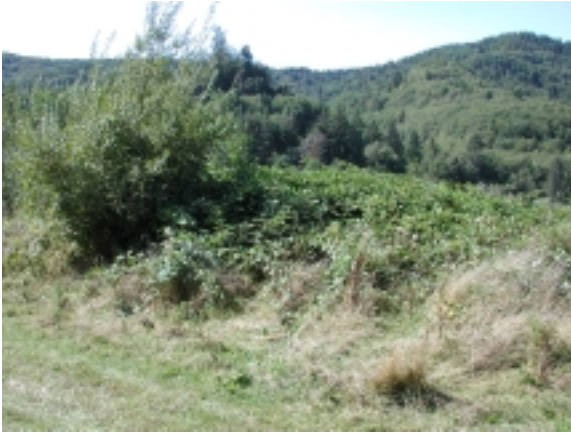
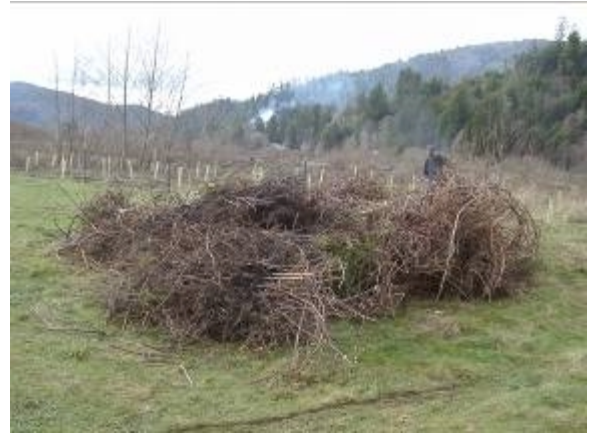
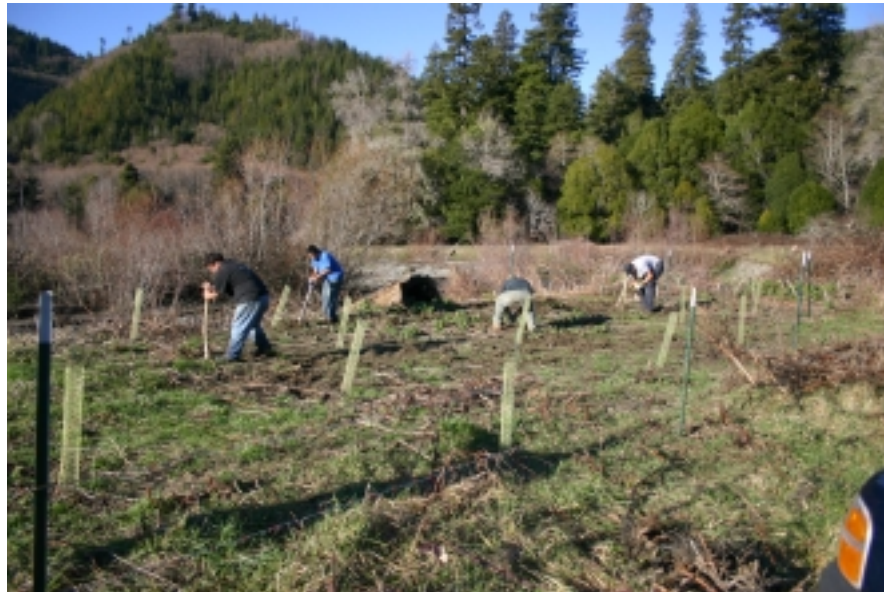
Figure 38. Photographs of a himalayan blackberry stand (top left photograph 2004); and Yurok Tribal Fisheries Program staff preparing to burn recently pulled blackberries (top right photograph 2004) and then removing blackberry crowns and planting native trees in lower Terwer Creek, Lower Klamath River Sub-basin, California (bottom photograph 2005).

YTFP initiated riparian enhancement in lower Terwer Creek during 2003 to address riparian dysfunction and channel instability in the reach located directly upstream of several small-scale livestock operations (Figure 37) (Gale and Beesley 2006). This area is locally known as Arrow Mills after the timber mill that formerly operated at the site. Specific tasks associated with phase 1 included: 1) removing invasive vegetation from the project area to promote existing and planted riparian vegetation (Figure 38); 2) stabilizing highly erodible

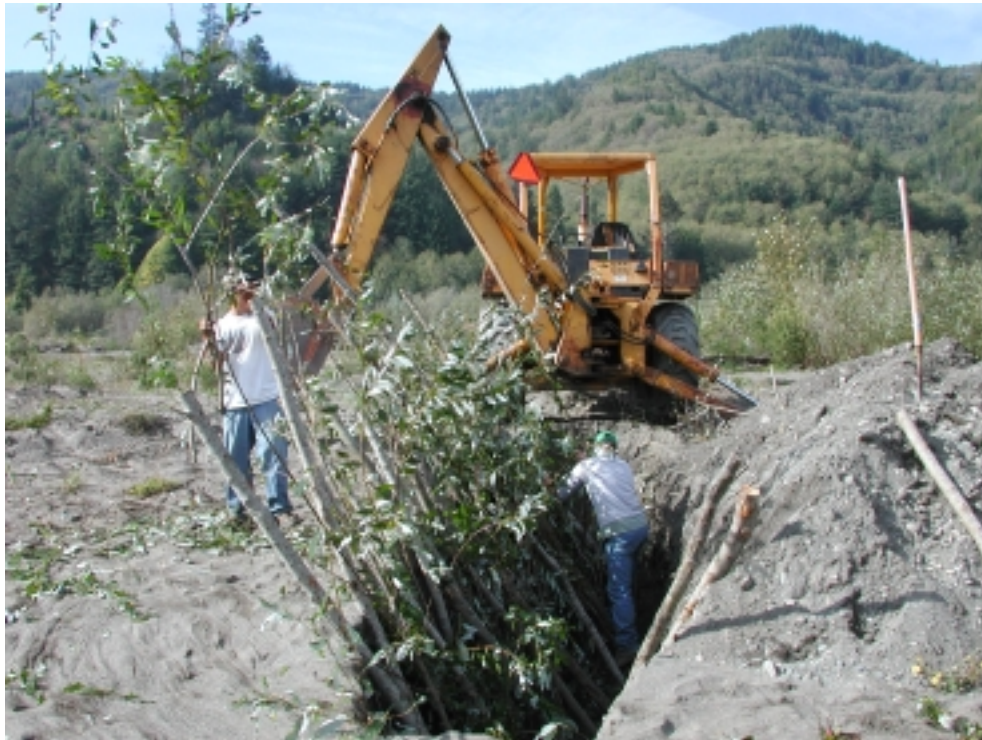
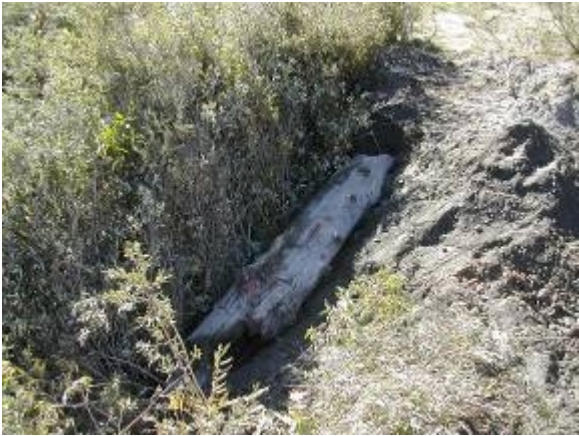
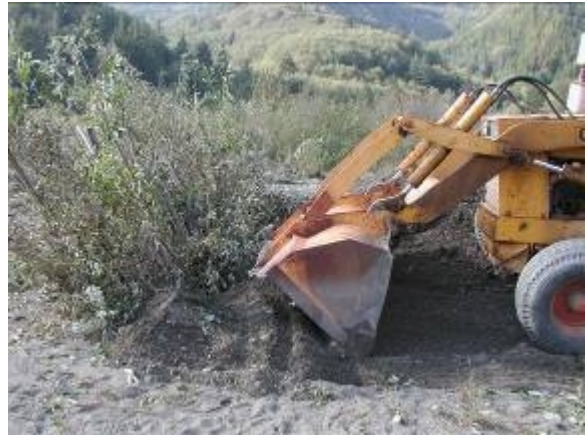
Figure 39. Construction of a willow siltation baffles in lower Terwer Creek, Lower Klamath River Sub-basin, California (2004) (Note the large wood placed at the base of the baffle).

banks using willow revetment techniques (i.e. siltation baffles and sprigs) (Figure 39) and large wood structures (Figure 40); and 3) planting floodprone surfaces and terraces with native willow, maple, cottonwood, and conifers (Figure 41).

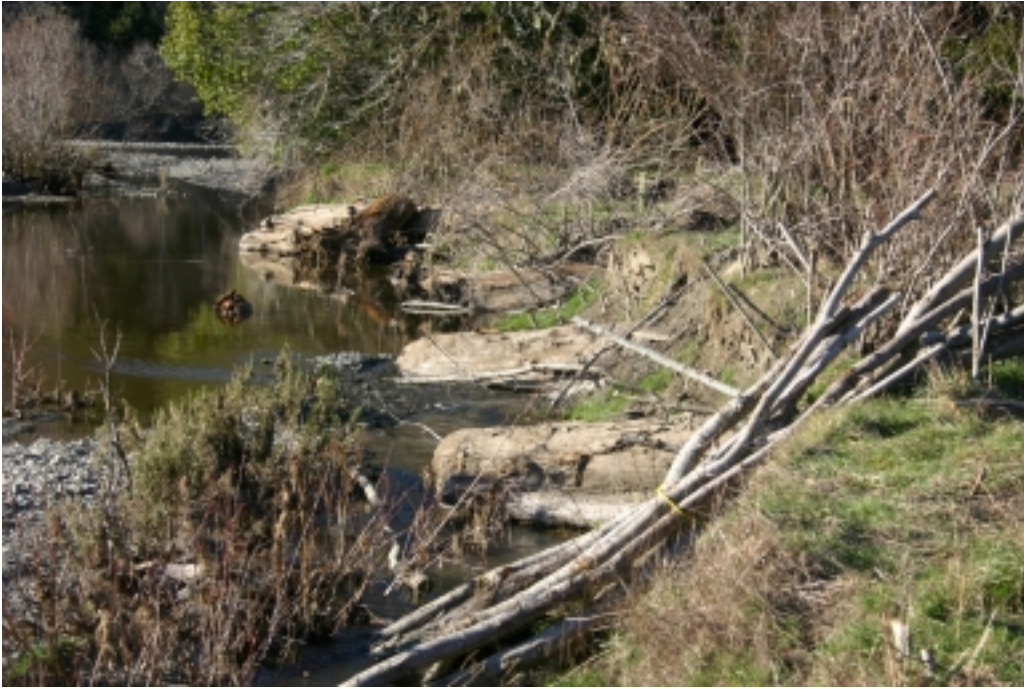
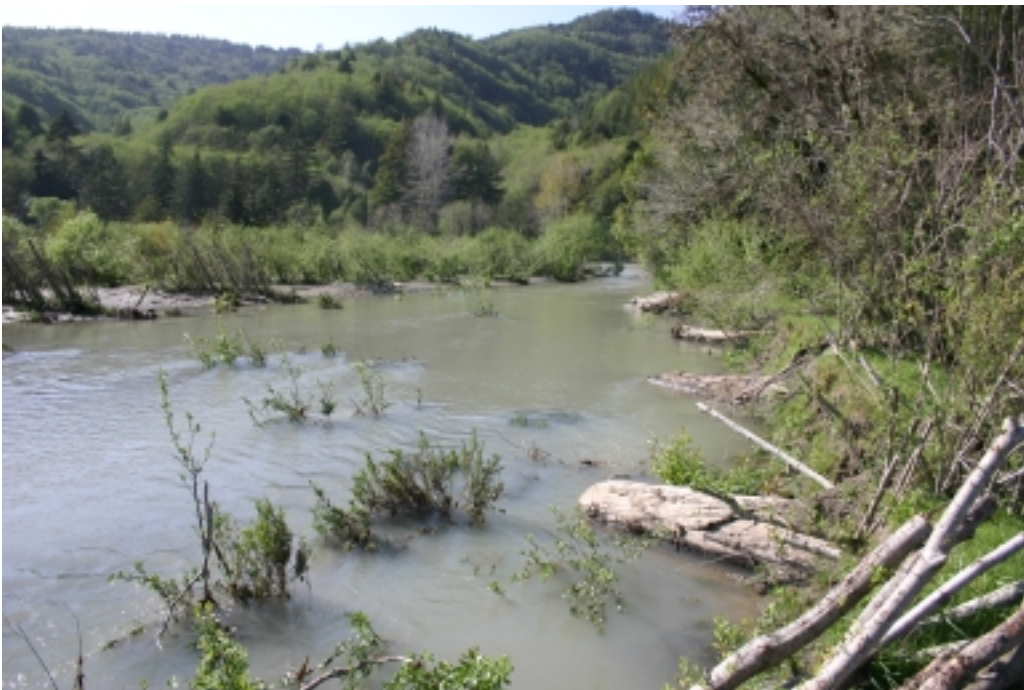
Figure 40. Large wood and willow structures following construction (top photograph 2005) and during a moderate flow event (bottom photograph 2005), lower Terwer Creek, Lower Klamath River Sub-basin, California.

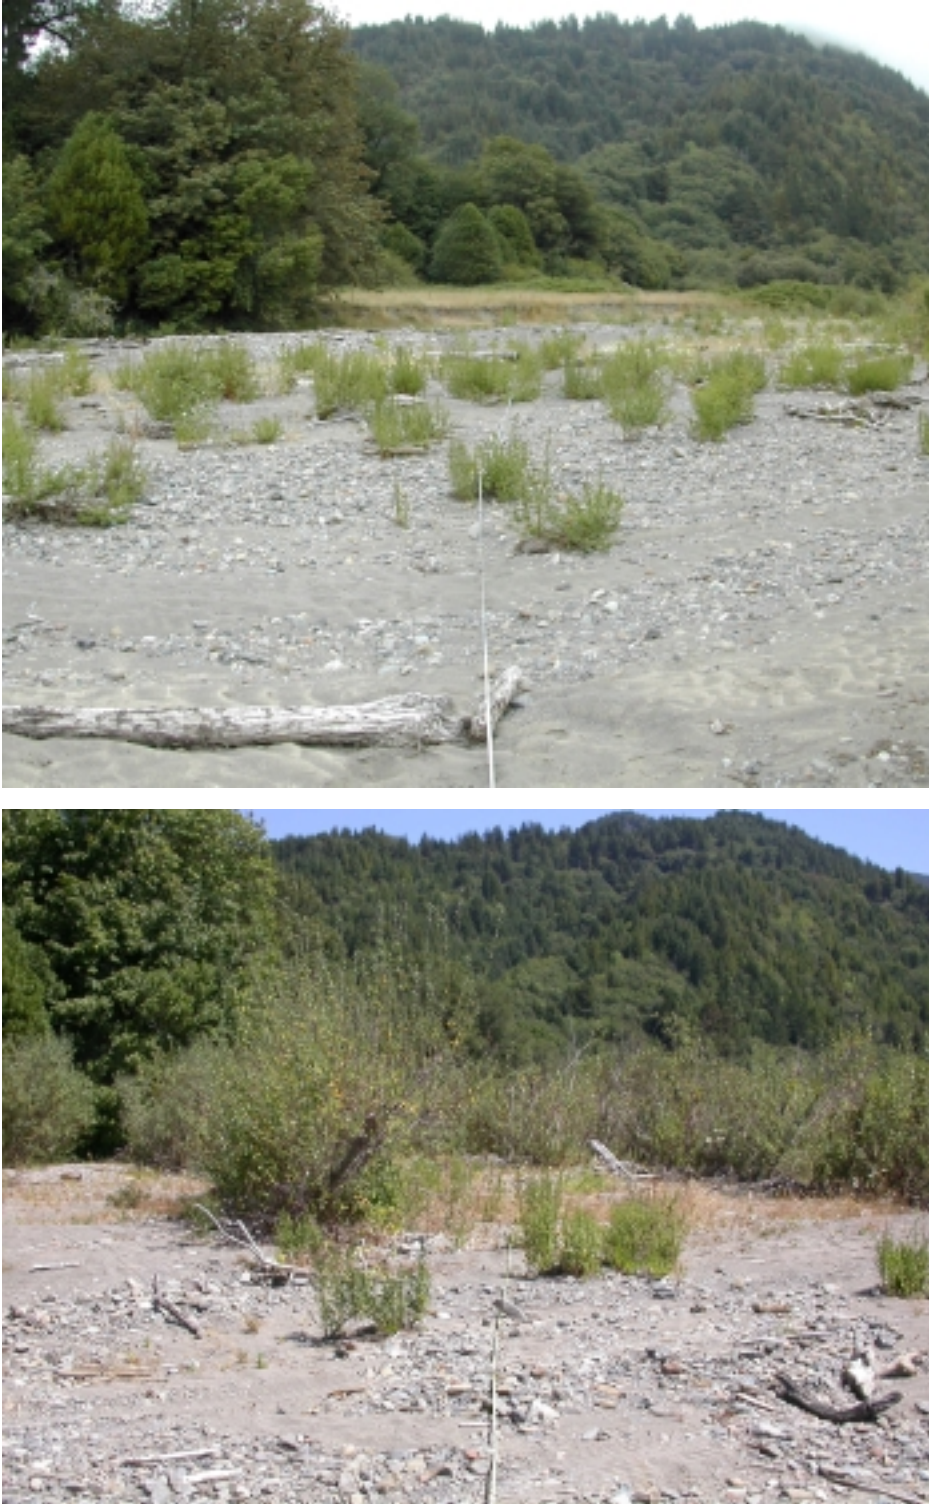
Figure 42. Photographs taken from a permanent photographic monitoring point in Terwer Creek, Lower Klamath River Sub-basin, California. The top photograph depicts pre-project conditions (2004), while the bottom photograph depicts newly constructed willow siltation baffles on the floodplain (2005).

Crews constructed a total of 32 willow siltation baffles on a floodprone surface located on the east side of Terwer Creek (Figure 42). The baffles were constructed perpendicular to the dominant flow path and were 20-25 feet in length. Baffles were comprised of live willow posts and brush and the bases were buried up to 5-6 feet with parent soil and gravels. The aerial portion of the willows varied in height from 5-15 feet. Five large wood-boulder structures were constructed along the bank of a high flow channel located at the site (Figure 40). Live willow was incorporated in these structures to enhance riparian conditions and promote long-term channel stability (Figure 40). A primary task of this first phase was reducing invasive vegetation including Canadian thistle, bull thistle, pampas grass, and Himalayan blackberry. Crews then planted the area with ~1,000 live willow sprigs, 120 big-

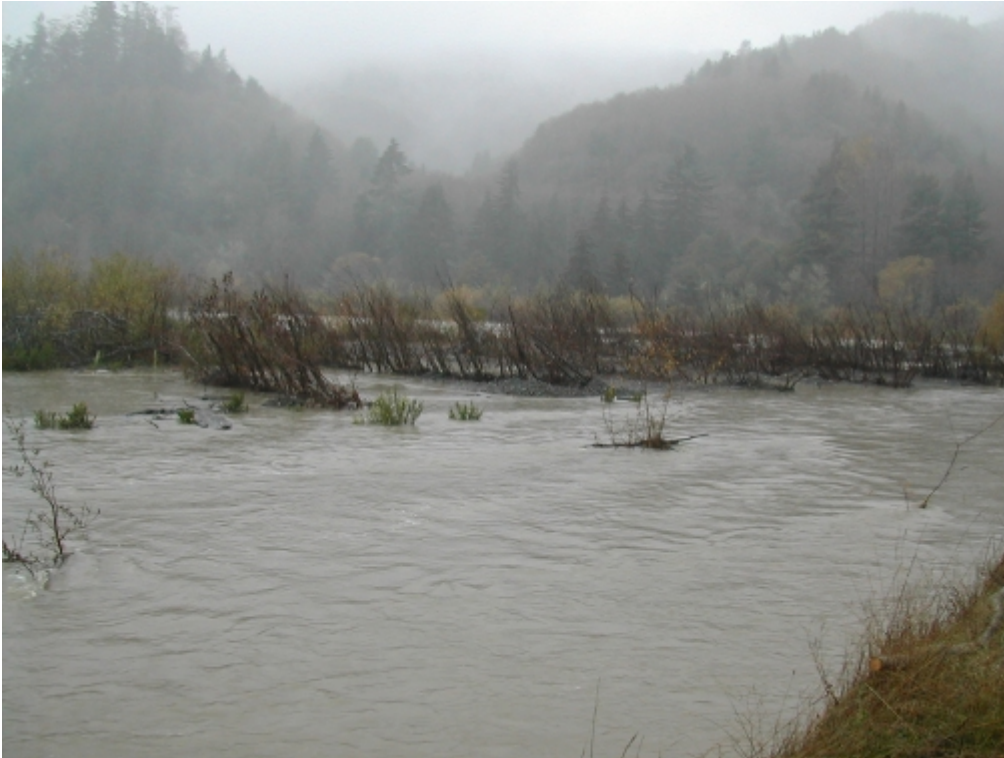
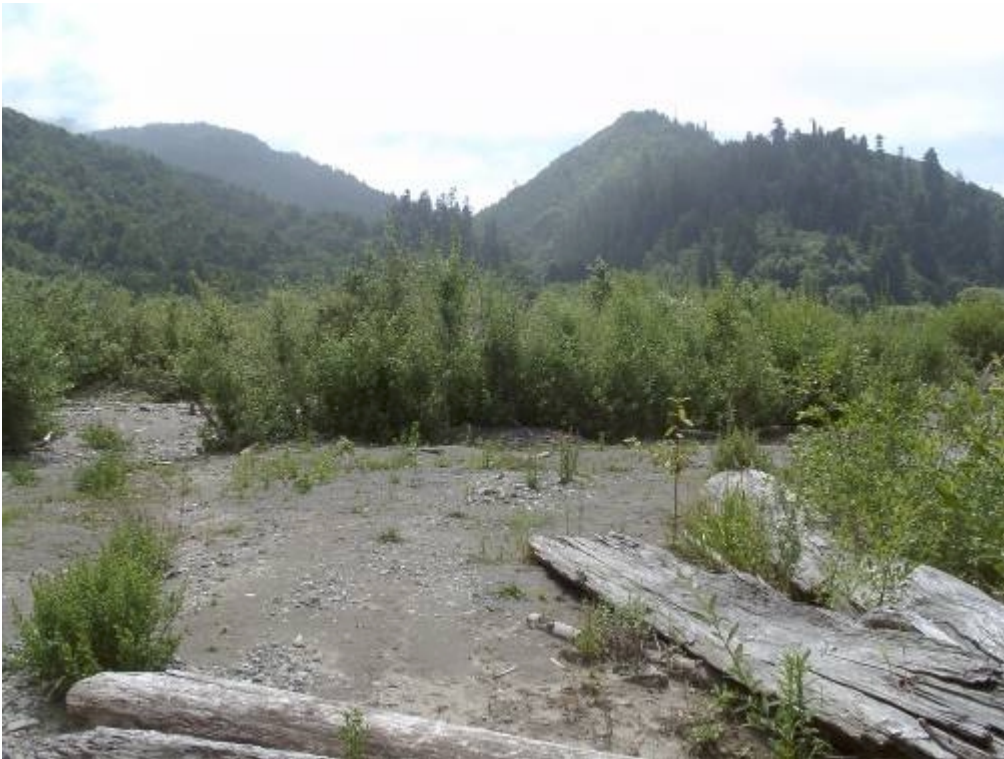
Figure 43. Willow siltation baffles during a high flow event (top photograph 2004) and during summer (bottom photograph 2005), lower Terwer Creek, Lower Klamath River Sub-basin, California.

Other priority objectives for YTFP included providing quality employment opportunities for Yurok Tribe members and staff through hands-on experience planning, implementing, and monitoring watershed restoration in the LKRSB. Long-term topographic, vegetation, and photographic monitoring protocols were established and implemented in the project area to assess channel and riparian response to restoration. The project area was inundated in early December 2004 by a high flow event (Figure 43). Post-flow evaluations revealed the baffles and structures withstood the event and were effective at accumulating fine grain materials by reducing local stream velocities (Figure 43).

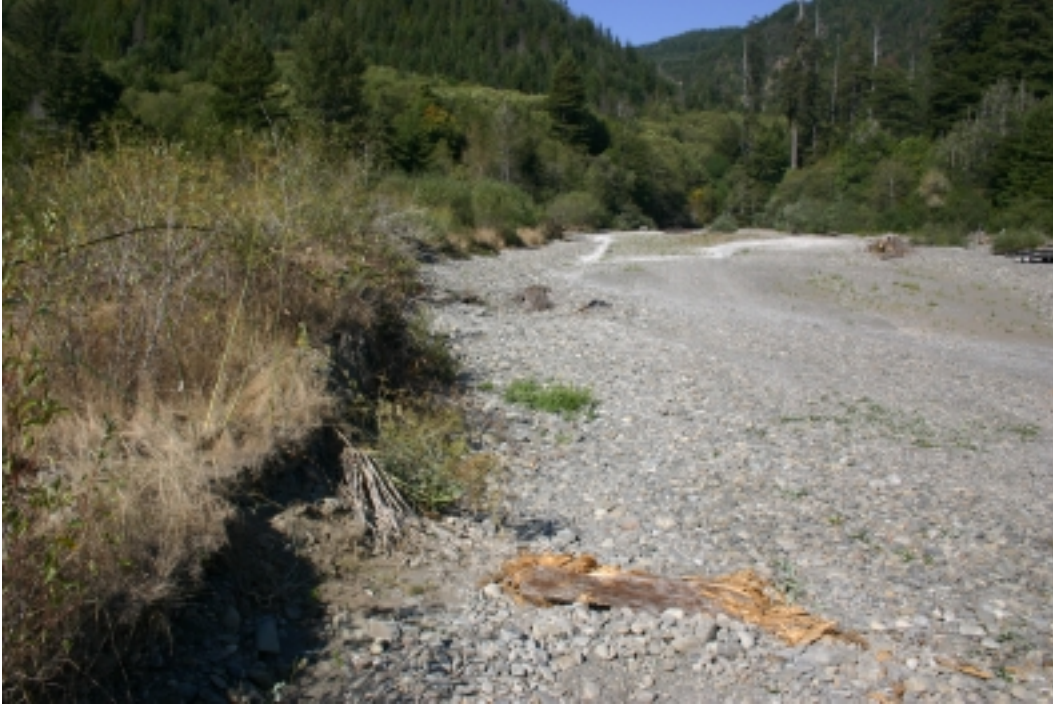
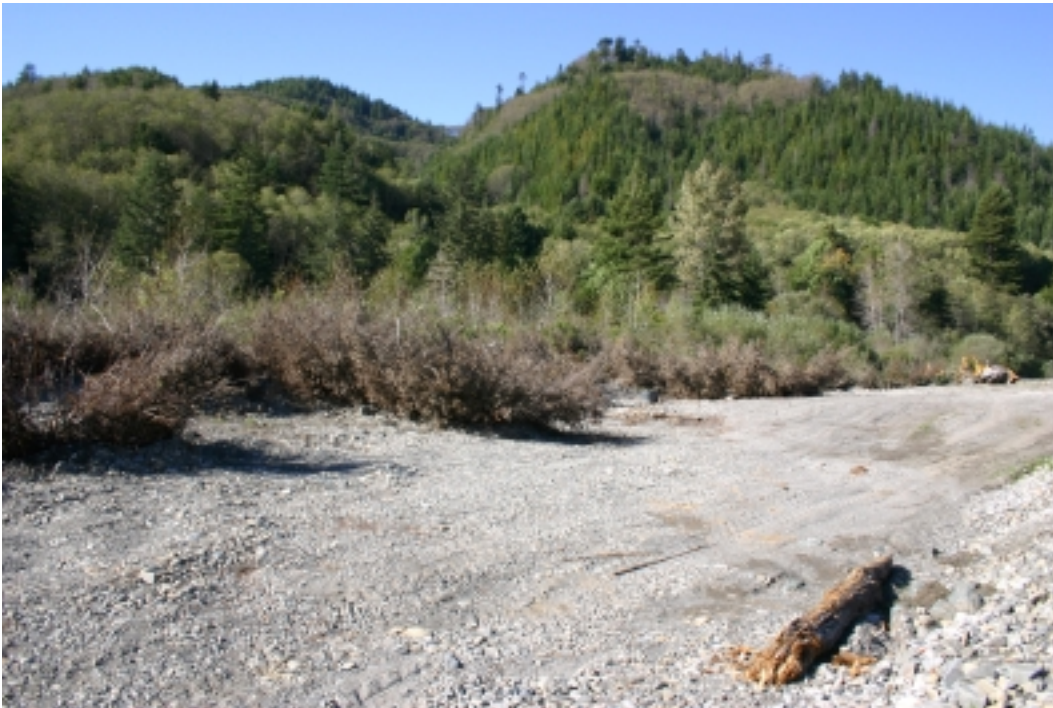
Figure 45. Photographs of an eroding bank in lower Terwer Creek (top photograph 2005) and newly constructed willow siltation baffles and mattresses at the same location (bottom photograph 2005), Lower Klamath River Sub-basin, California.

YTFP constructed 14 willow siltation baffles along the bank using a combination of heavy equipment and hand-crews (Figure 45). The baffles were comprised of willow brush and the bases were lined with ¼ ton quarry rock in an effort to reduce localized scour (Figure 46). Fifteen willow mattresses were constructed parallel with the channel along the bank between the baffles. Mattress bases were lined with small and large wood to improve growing conditions (Figure 47). YTFP crews also constructed a series of large wood-boulder structures upstream of Mr. Farley's well to deflect stream flows away from his property and reduce near-bank shear stress (Figure ). Live willow was incorporated in all of the structures and willow mattresses were constructed between the structures to promote long-term bank stability (Figure 48). Crews also constructed 41 willow brush and post baffles on the adjacent floodprone surface; and planted 500 willow sprigs, 30 big-leaf maple, 65 black cottonwood, 41 red alder, and 350 bareroot Douglas fir trees. The deciduous trees were started from seed (maples and alders) or cuttings (cottonwood) and grown out for over a year at the YTFP native tree nursery. These measures were implemented to immediately enhance existing riparian habitats; reduce stream velocities on floodprone surfaces; and promote conditions that maintain complex, native riparian forests and large wood recruitment to Terwer Creek.

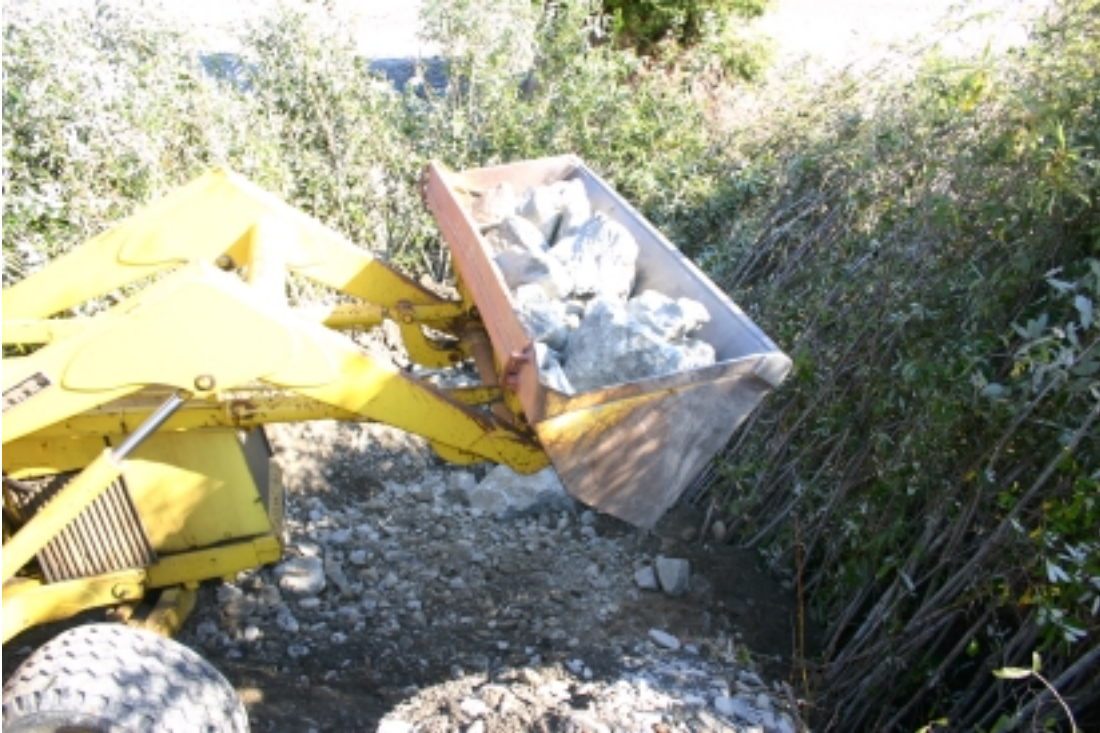
Figure 46. Placement of ¼ ton quarry rock at the base of a willow siltation baffle constructed in lower Terwer Creek, Lower Klamath River Sub-basin, California (2005).

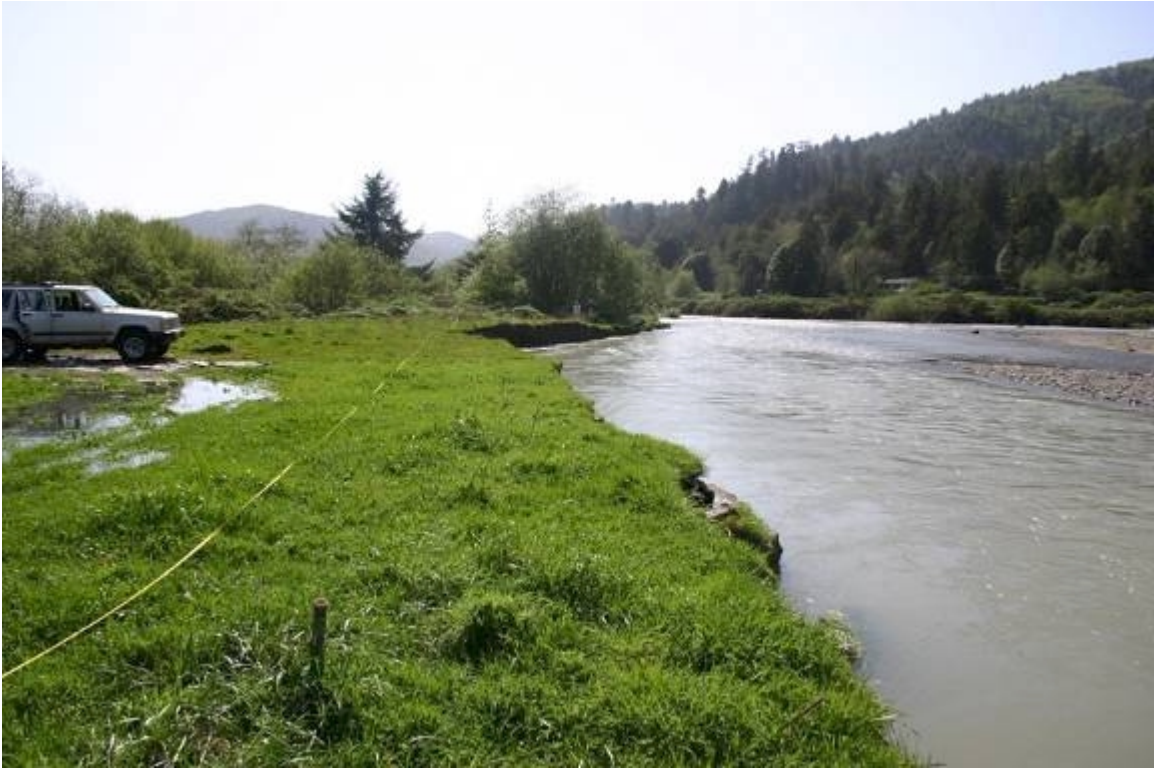
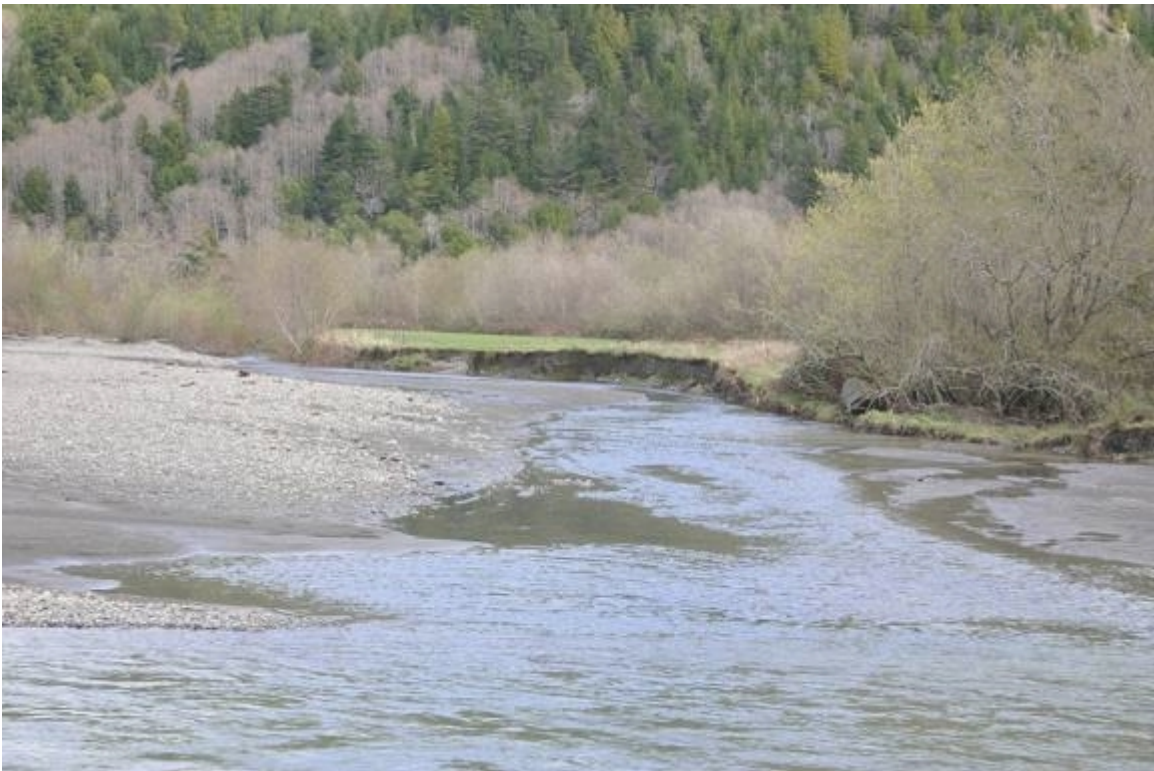
Figure 51. Photographs of an eroding bank in lower Terwer Creek, Lower Klamath River Sub-basin, California (2006).

Crews constructed six willow siltation baffles and 12 willow mattresses along the east bank of Terwer Creek (Figures 51 – 52). As on the west bank, the baffle bases were lined with ¼ ton quarry rock and the mattress bases were lined with wood. All baffles and mattresses were watered during project implementation to ensure survival. Four large wood-boulder structures with live willow incorporated were constructed along at this location (Figure 53). Invasive pampas grass plants and sprouts, and Himalayan blackberry patches were removed from the project site prior to any riparian planting. A total of 59 big-leaf maple, 210 black cottonwood, and 51 red alder, 186 Douglas fir, three coastal redwood, and 37 bareroot western red cedar trees were planted in the project area. The deciduous trees were started from seed (maples and alders) or cuttings (cottonwood) and grown out for over a year at the YTFP native tree nursery. The fir and redwood trees were bareroot trees that YTFP grew out in 5-gallon containers for 1-2 years in our nursery before planting. In addition, 79 live willow sprigs were planted in the vicinity of the large wood-boulder structures.

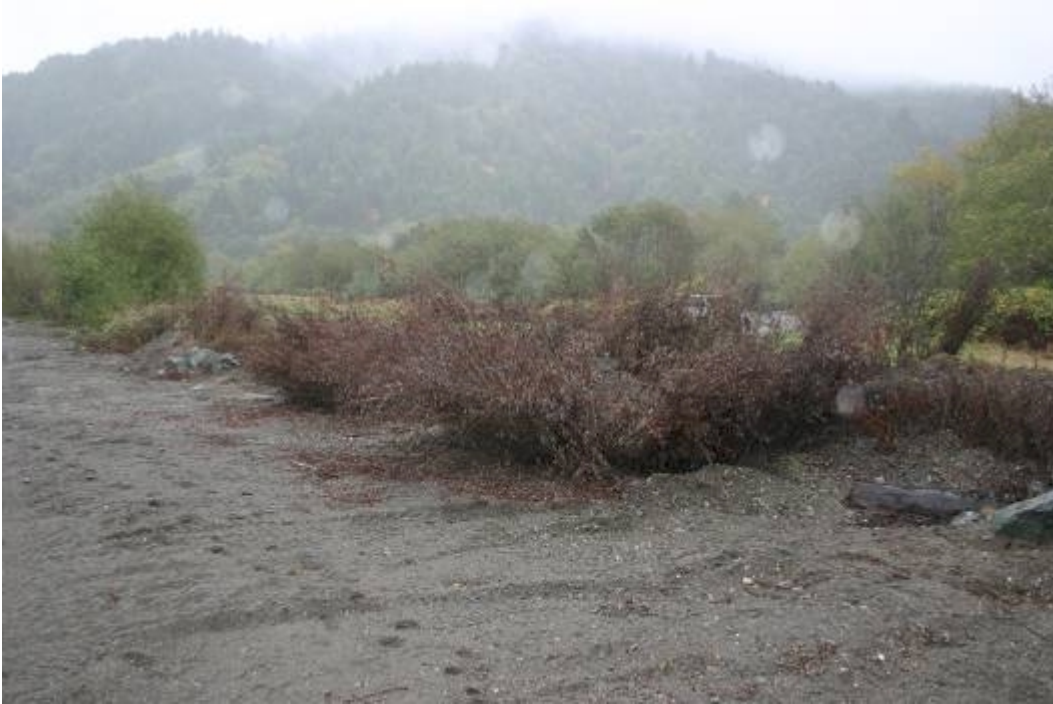
Figure 52. Newly constructed willow siltation baffles and mattresses along the east bank of lower Terwer Creek Lower Klamath River Sub-basin, California (2006).

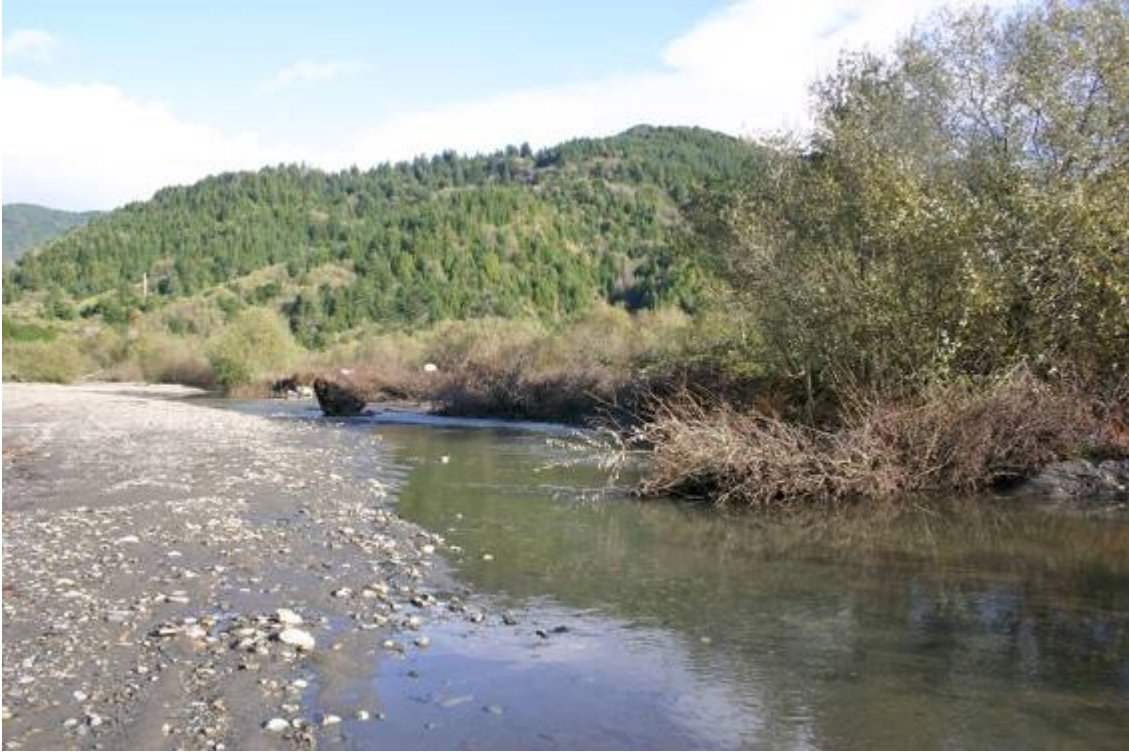
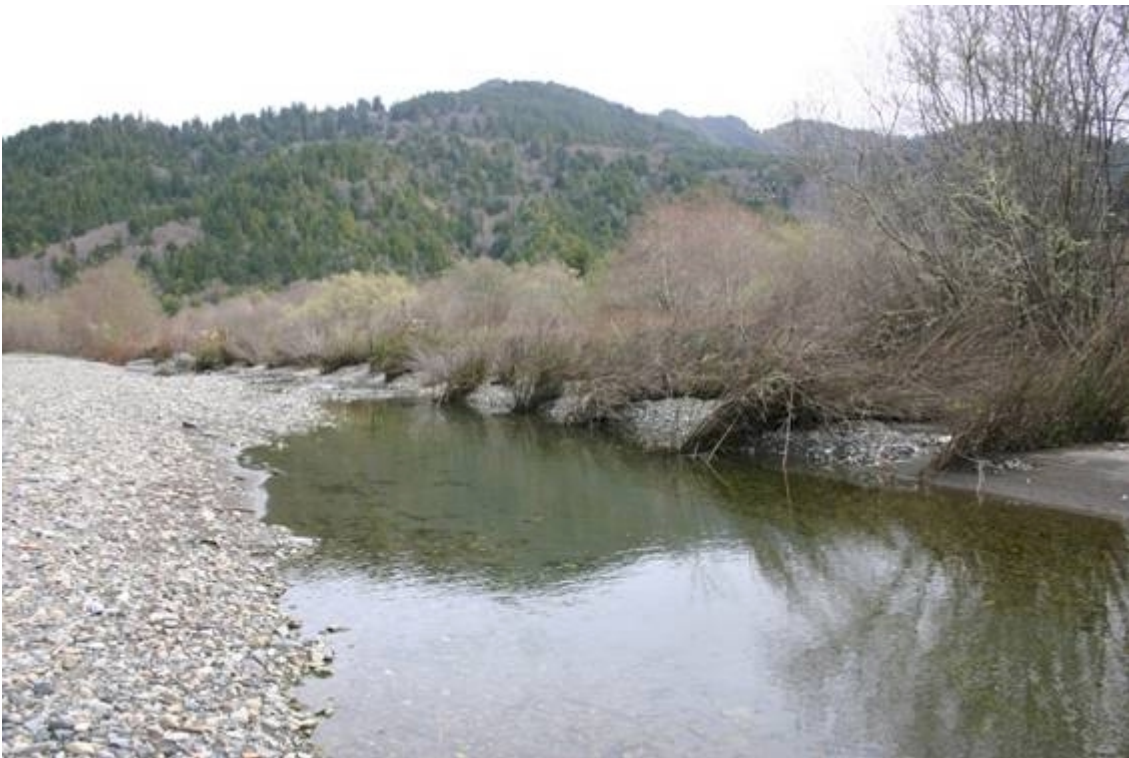
Figure 56. Willow siltation baffles constructed along the east bank of Terwer Creek, Lower Klamath River Sub-basin, California (top photograph 2006 and bottom photograph 2008).

Twenty-three willow siltation baffles with ¼ ton quarry rock were constructed along the west bank of Terwer Creek just downstream of the large wood-boulder structures that were placed in Phase I (Figure 56). Crews also planted 12 willow mattresses between these baffles to increase flow resistance to reduce near-bank shear stress along the entire eroding bank. Crews also constructed 12 willow siltation baffles and four willow mattresses along the east bank of Terwer Creek ~ 1,500 feet downstream of the Arrow Mills Site (Figures 57 – 58). These baffles were comprised of willow brush and the bases were lined with ¼ ton quarry rock in an effort to reduce localized scour. Mattress bases were lined with small and large wood to improve growing conditions. Sixteen willow terrace baffles (no quarry rock) were constructed directly behind the siltation baffles to increase storage of fine grain materials on this floodplain to promote root growth and increased shear resistance of bank materials.

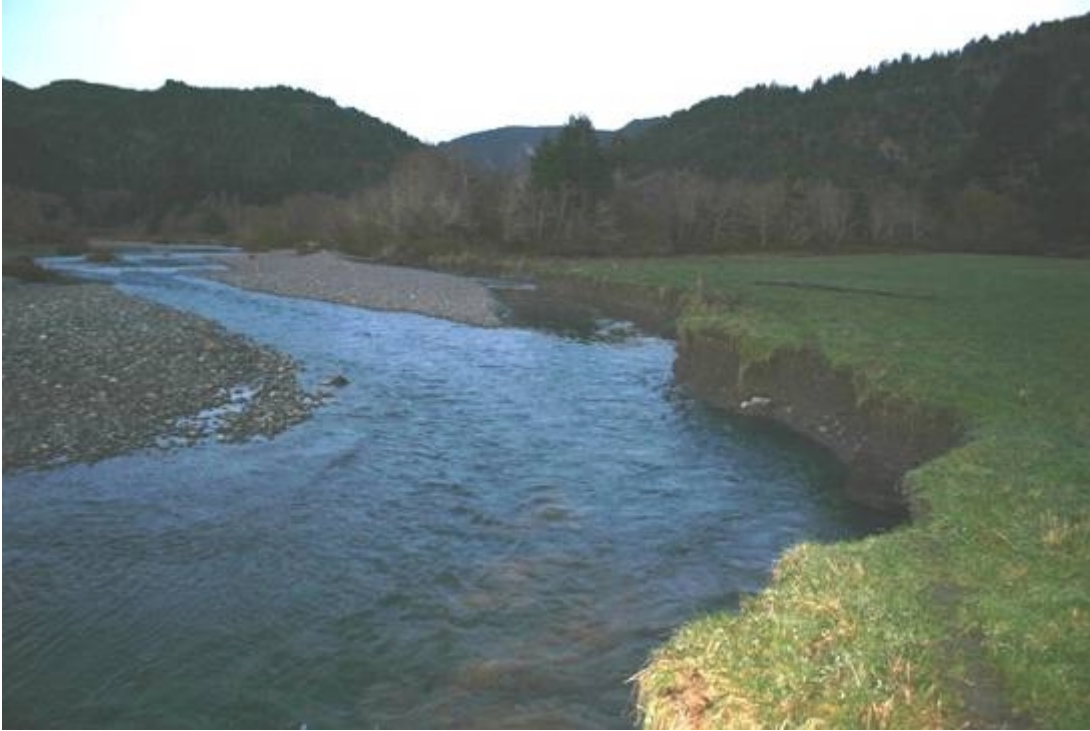
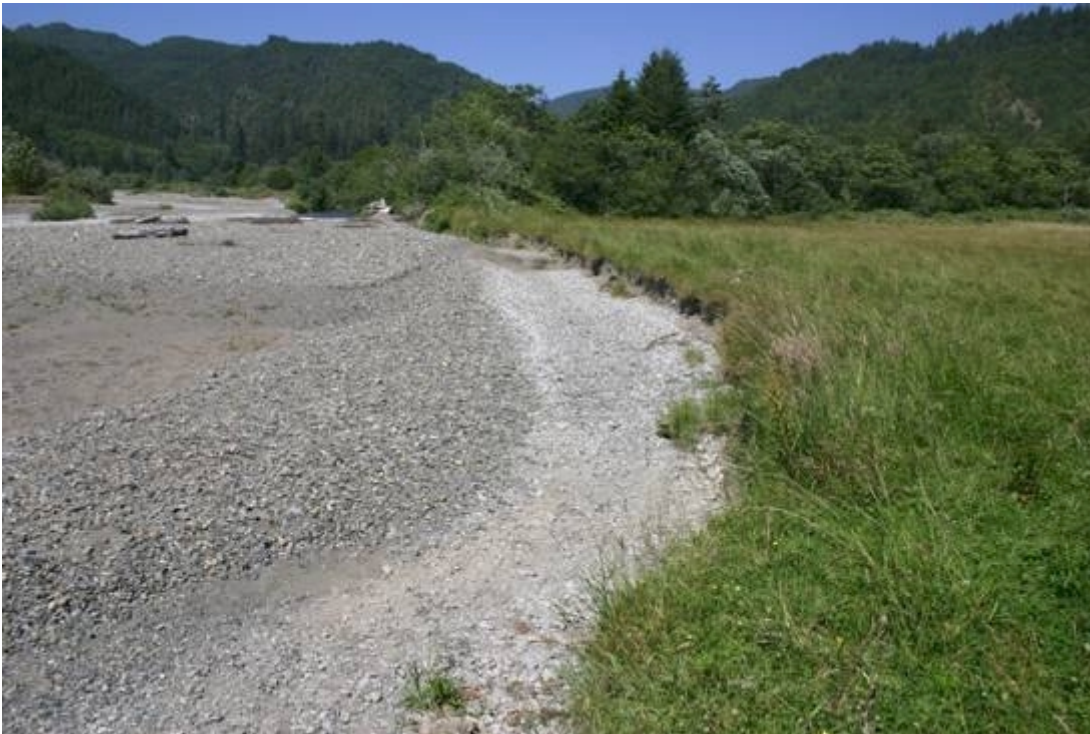
Figure 57. Photographs of an eroding bank in lower Terwer Creek, Lower Klamath River Sub-basin, California (top photograph 2005, bottom photograph 2006).

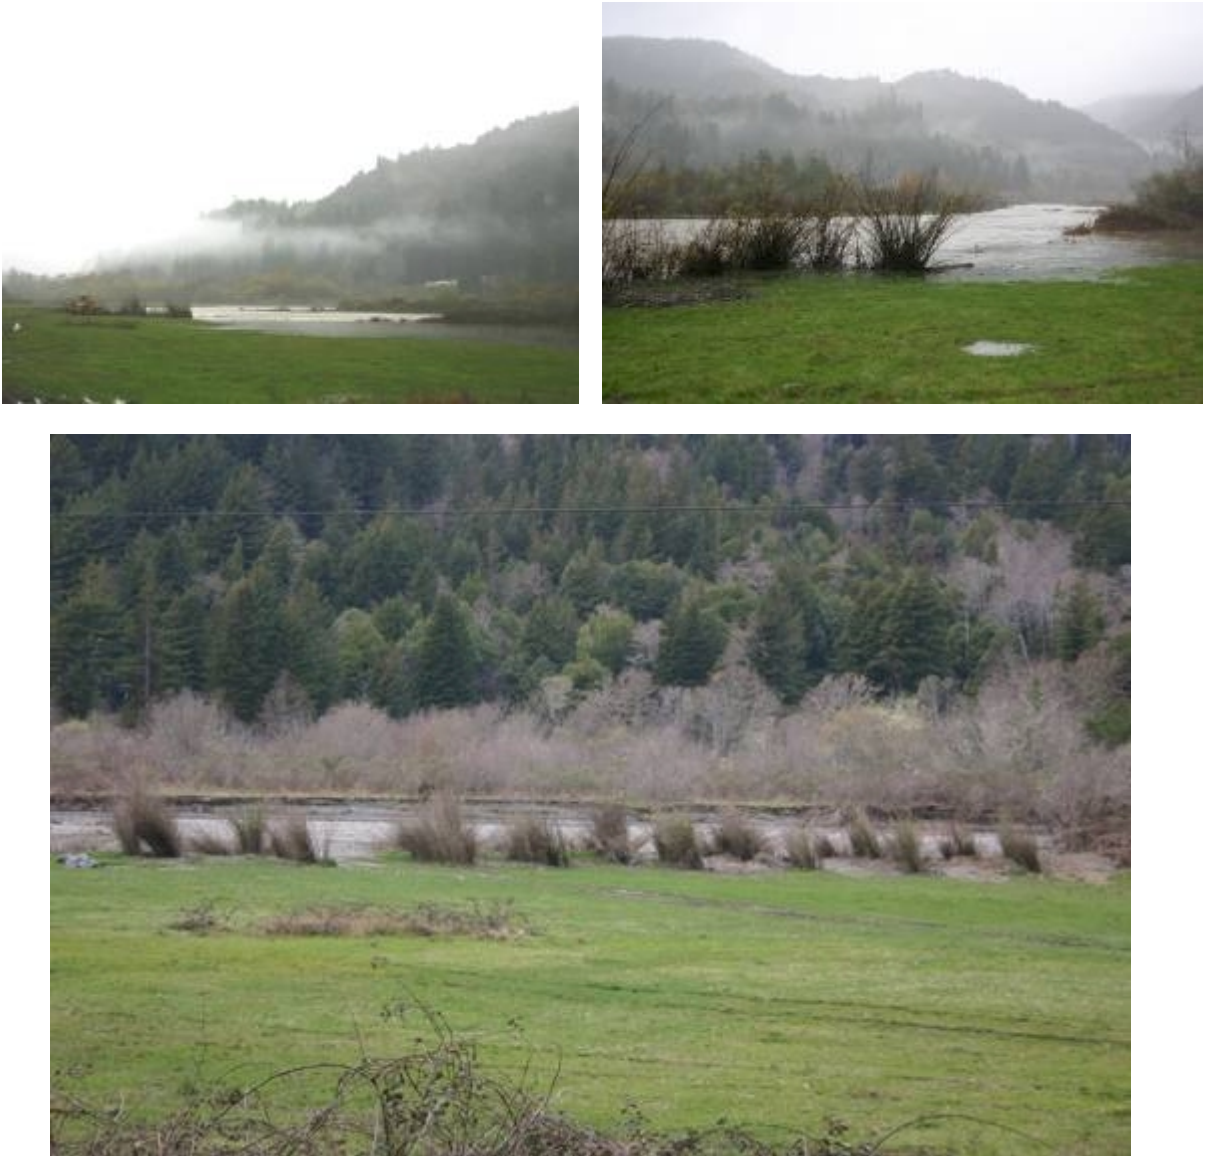
Figure 58. Recently constructed willow siltation baffles during a high flow event in 2006 (top photograph), and then with additional willow terrace baffles in 2008 (bottom photograph), lower Terwer Creek, Lower Klamath River Sub-basin, California.

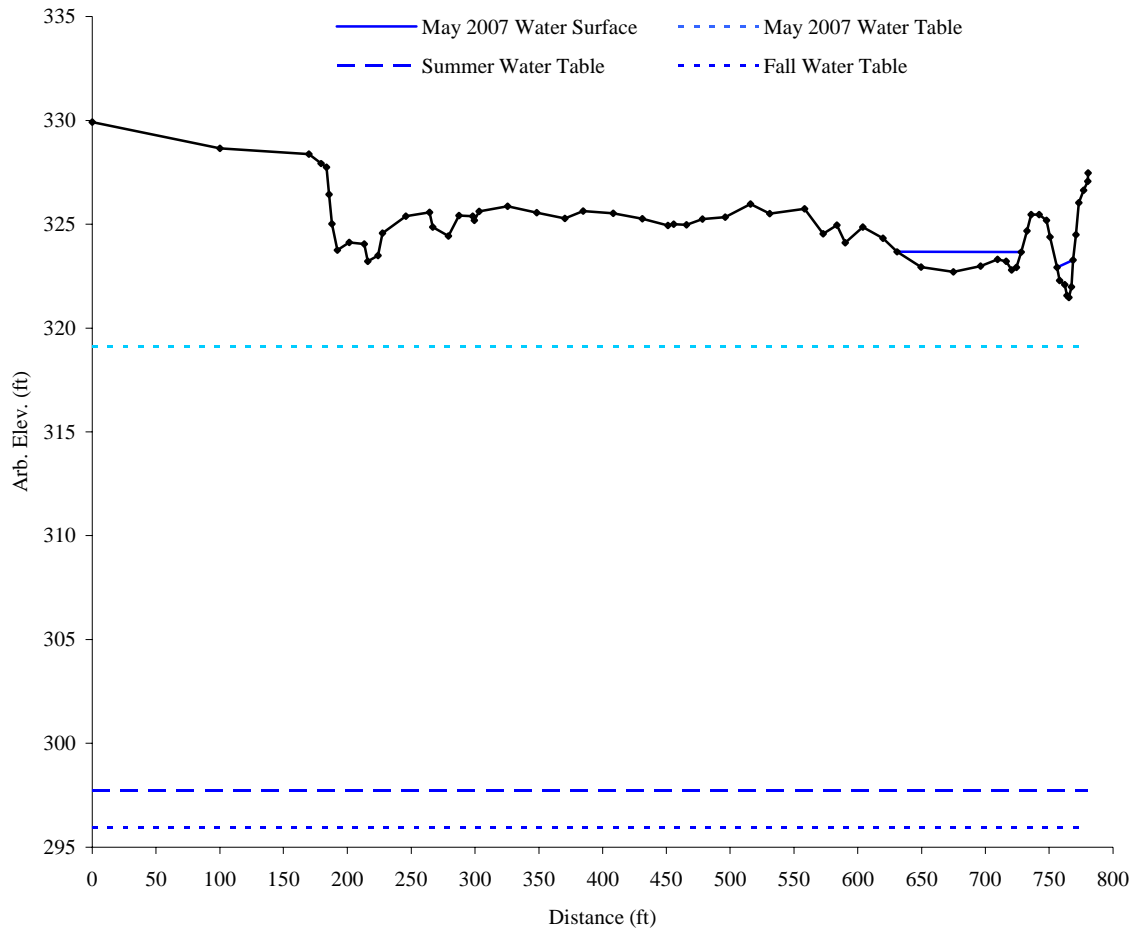
Groundwater monitoring and topographic survey data collected at the Arrow Mills site indicated that the water table during late summer – fall was 25 – 30 feet below the active channel and floodplain surfaces (Figure 64). The summer water table was closer to channel and floodplain surfaces at monitoring stations located ~ 4,000 feet downstream of the Arrow Mills site (Figure 65). Water tables located near the mouth of Terwer Creek appeared to be

Figure 64. Cross section plot depicting elevations of channel and floodprone surfaces relative to base flow and water table elevations in the vicinity of Arrow Mills, Terwer Creek, Lower Klamath River Sub-basin, California (2007).
