# Instream Restoration of Lower West Fork McGarvey Creek

Prepared by:

Daniel B. Gale  
Yurok Tribal Fisheries Program  
P.O. Box 339  
Klamath, CA 95548

March 28, 2008

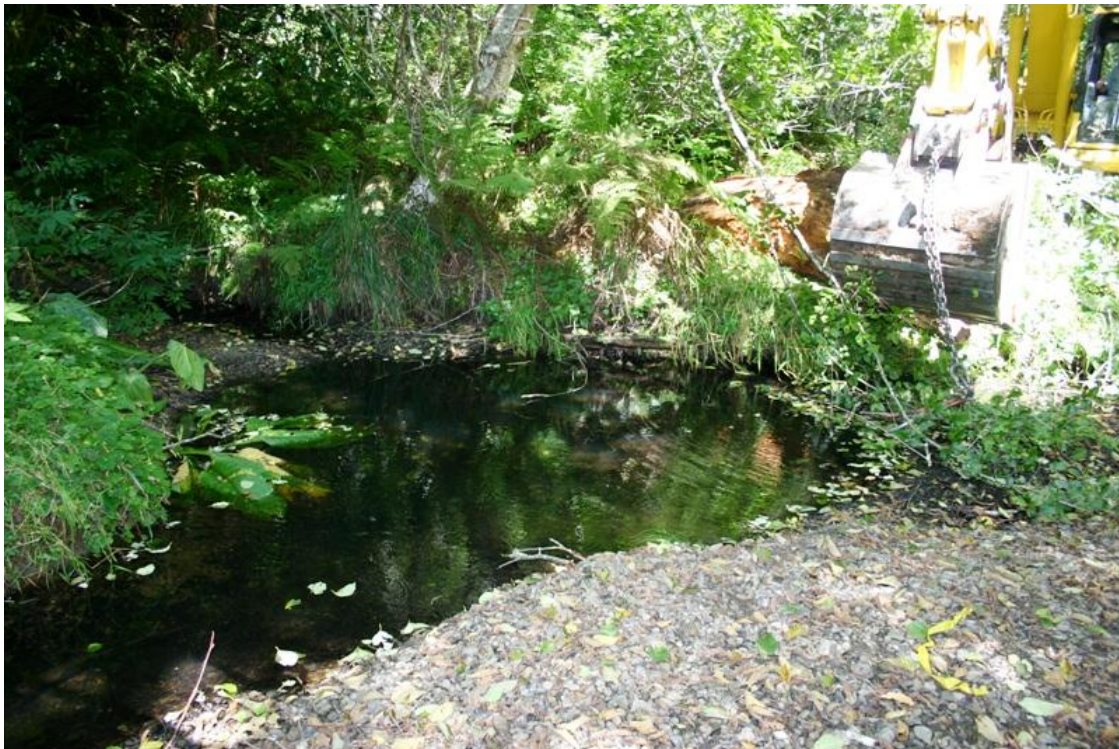
Figure 26. Shallow pool at top end of project reach prior to installation of LWD piece #1, West Fork McGarvey Creek, Lower Klamath River, California, 2007.

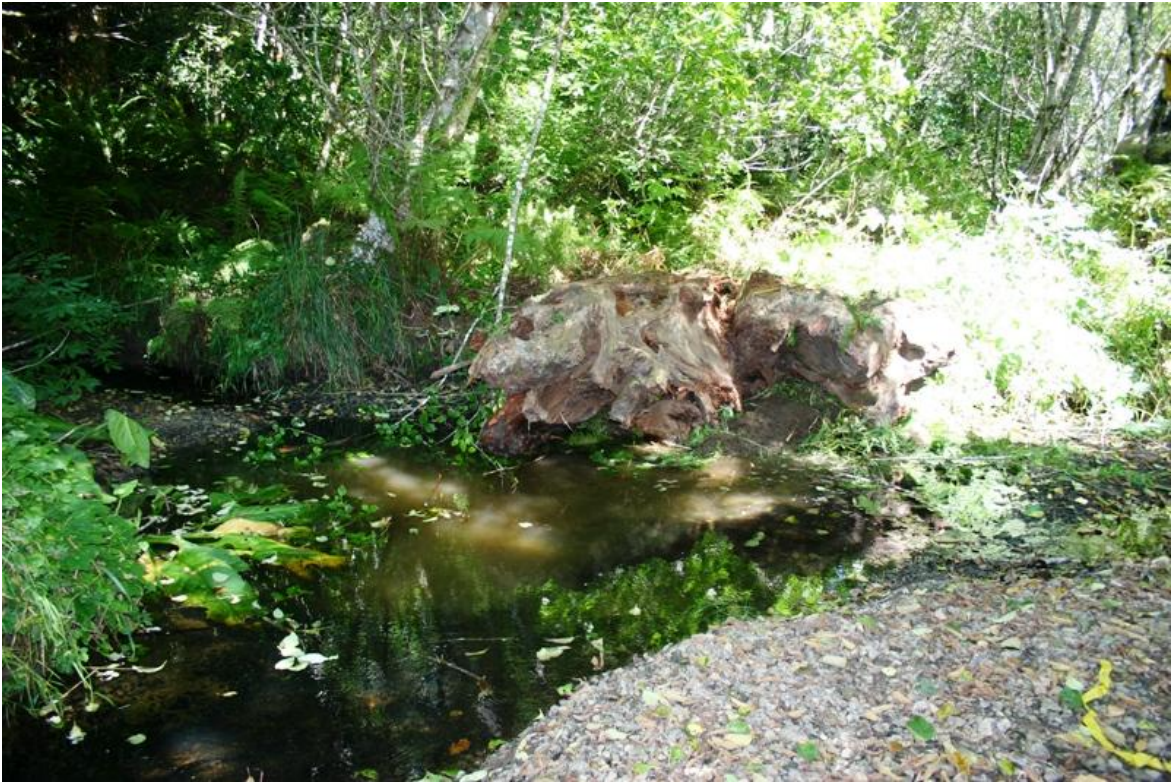
Figure 27. Shallow pool at top end of project reach following installation of LWD piece #1, West Fork McGarvey Creek, Lower Klamath River, California, 2007.

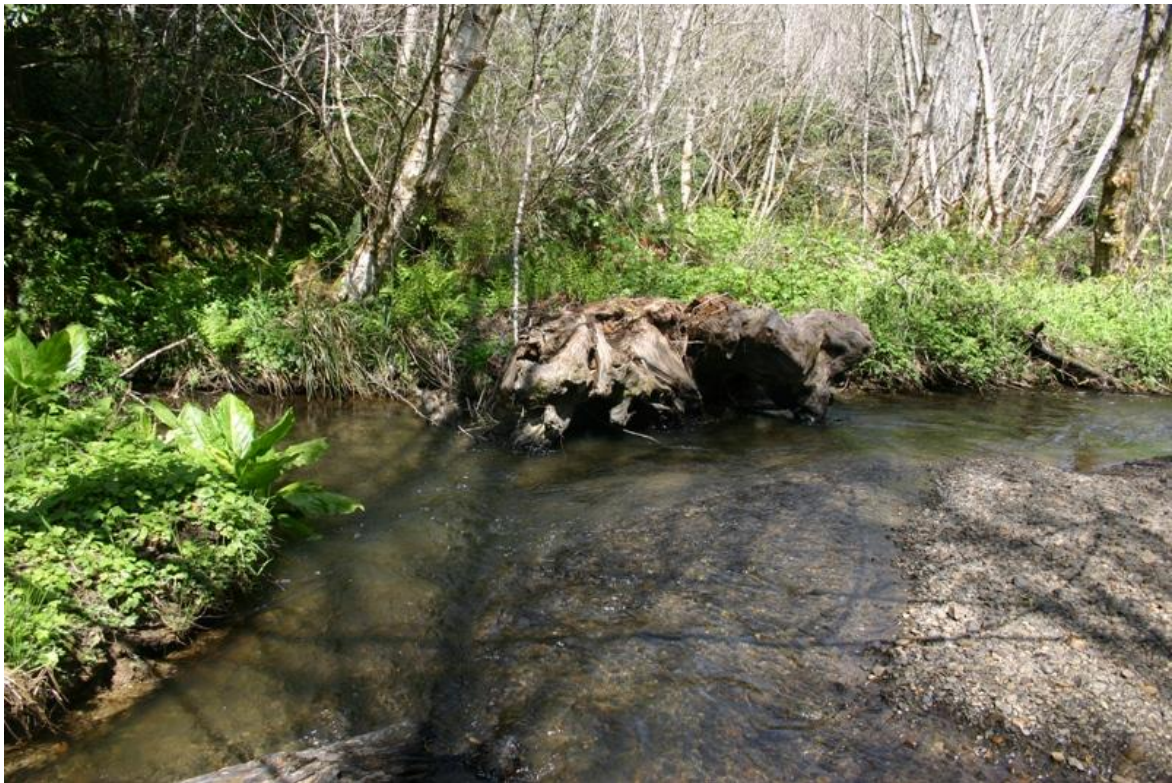
Figure 28. LWD piece #1 following first winter, West Fork McGarvey Creek, Lower Klamath River, California, 2008.

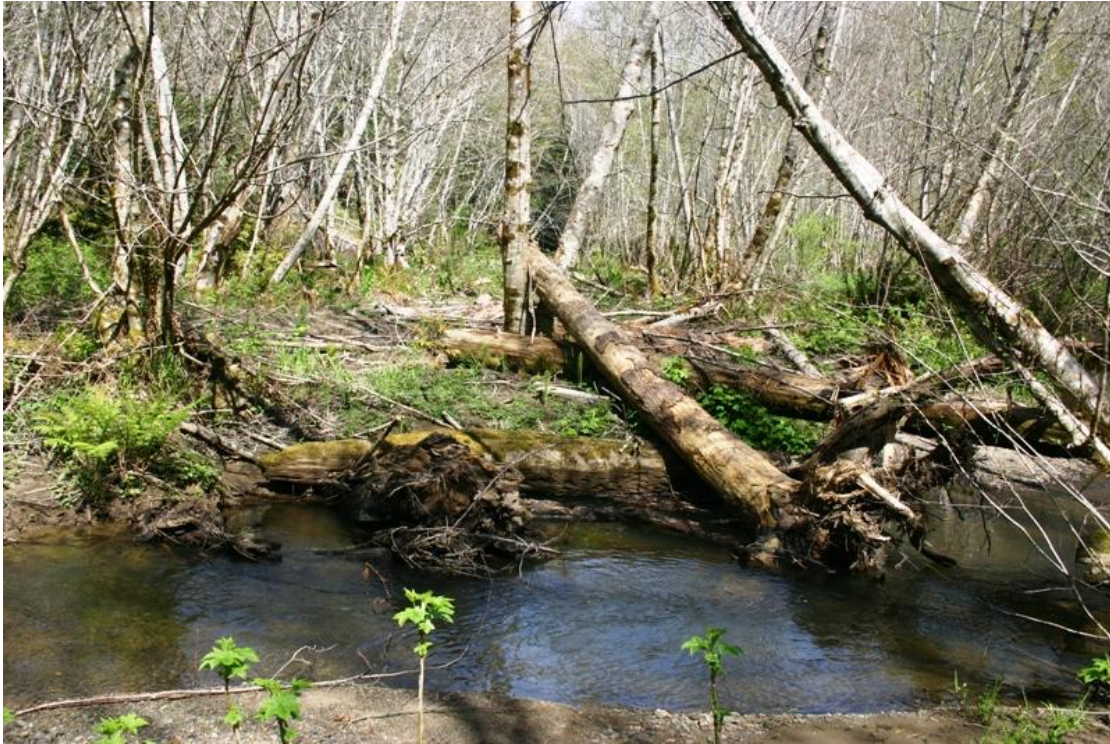
Figure 31. LWD pieces #2-4 following first winter, West Fork McGarvey Creek, Lower Klamath River, California, 2008.

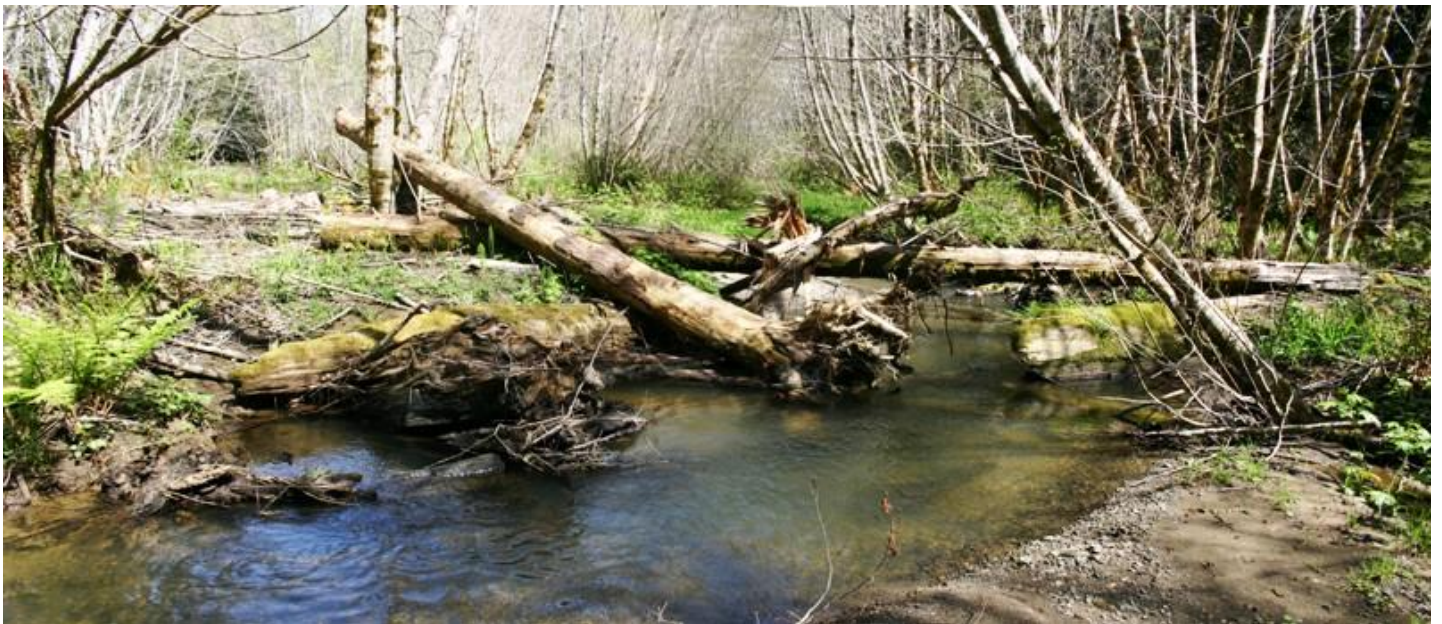
Figure 32. LWD pieces #2-4 following first winter, West Fork McGarvey Creek, Lower Klamath River, California, 2008

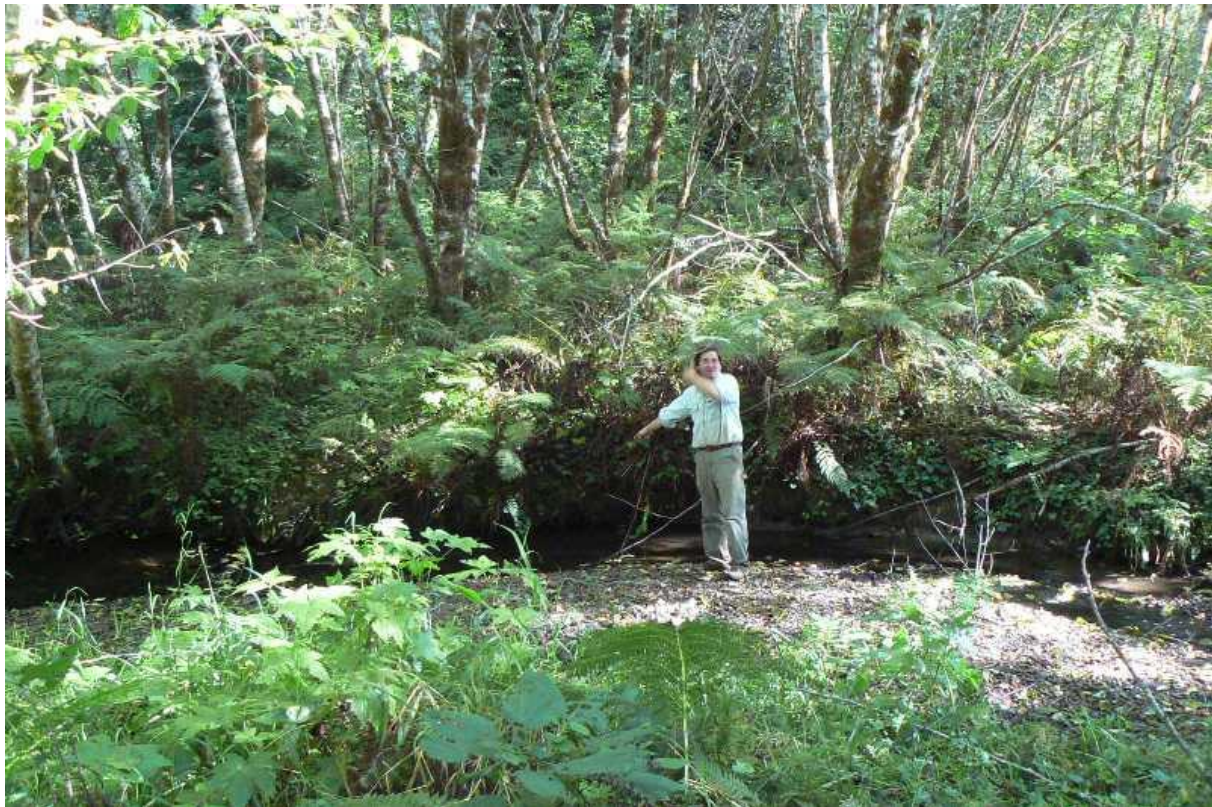
Figure 33. Shallow pool near top of project reach prior to installation of LWD pieces #5-10, West Fork McGarvey Creek, Lower Klamath River, California, 2007.

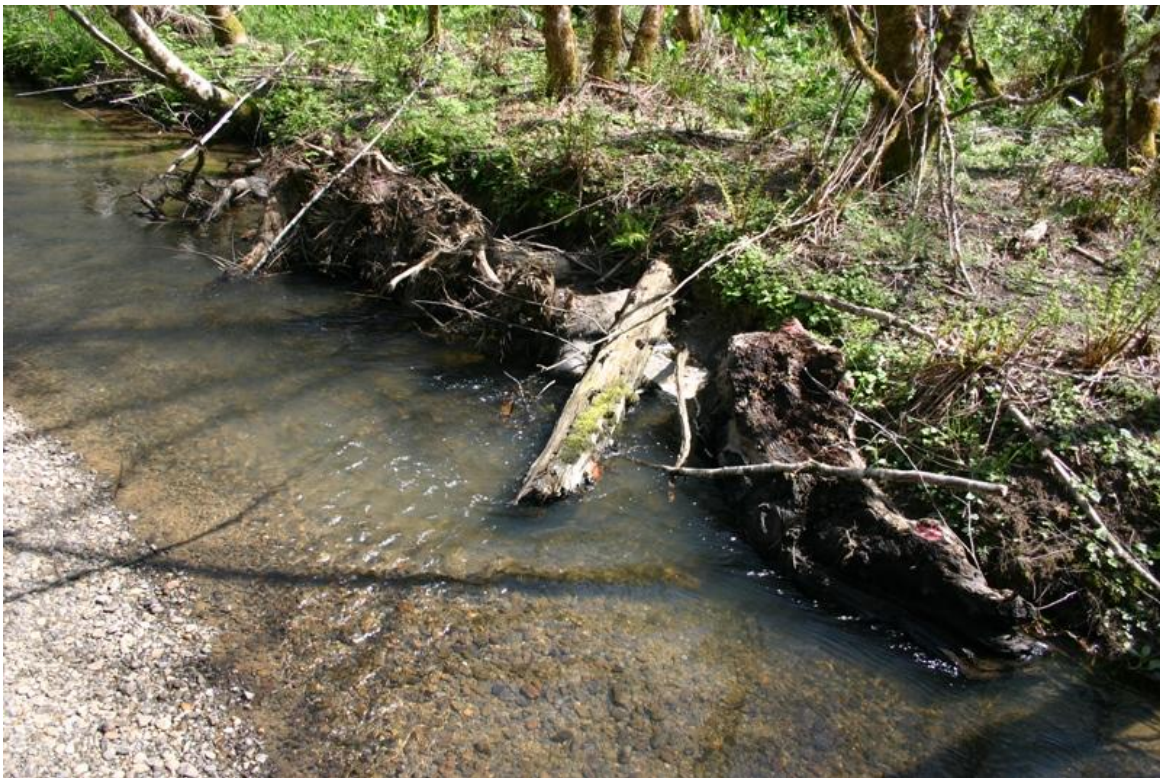
Figure 36. LWD pieces #5-10 following first winter, West Fork McGarvey Creek, Lower Klamath River, California, 2008.

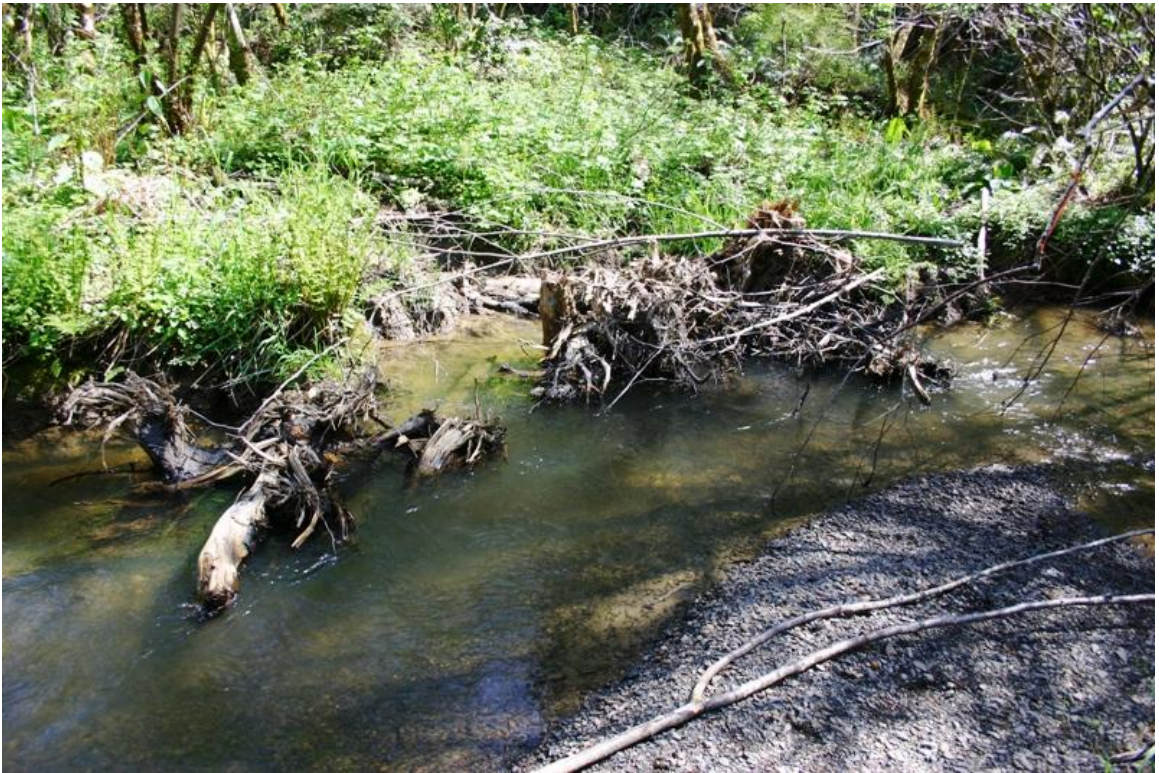
Figure 38. LWD pieces #11-15 following first winter, West Fork McGarvey Creek, Lower Klamath River, California, 2008.

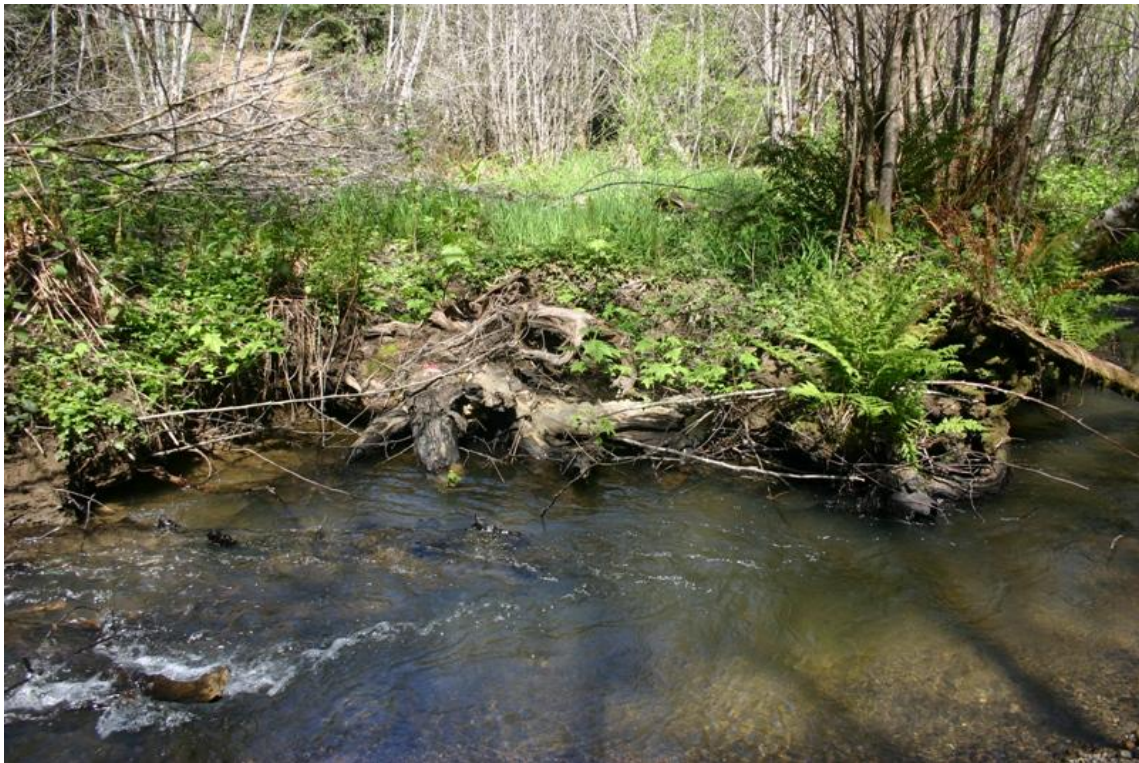
Figure 39. LWD piece #16 following first winter, West Fork McGarvey Creek, Lower Klamath River, California, 2008.

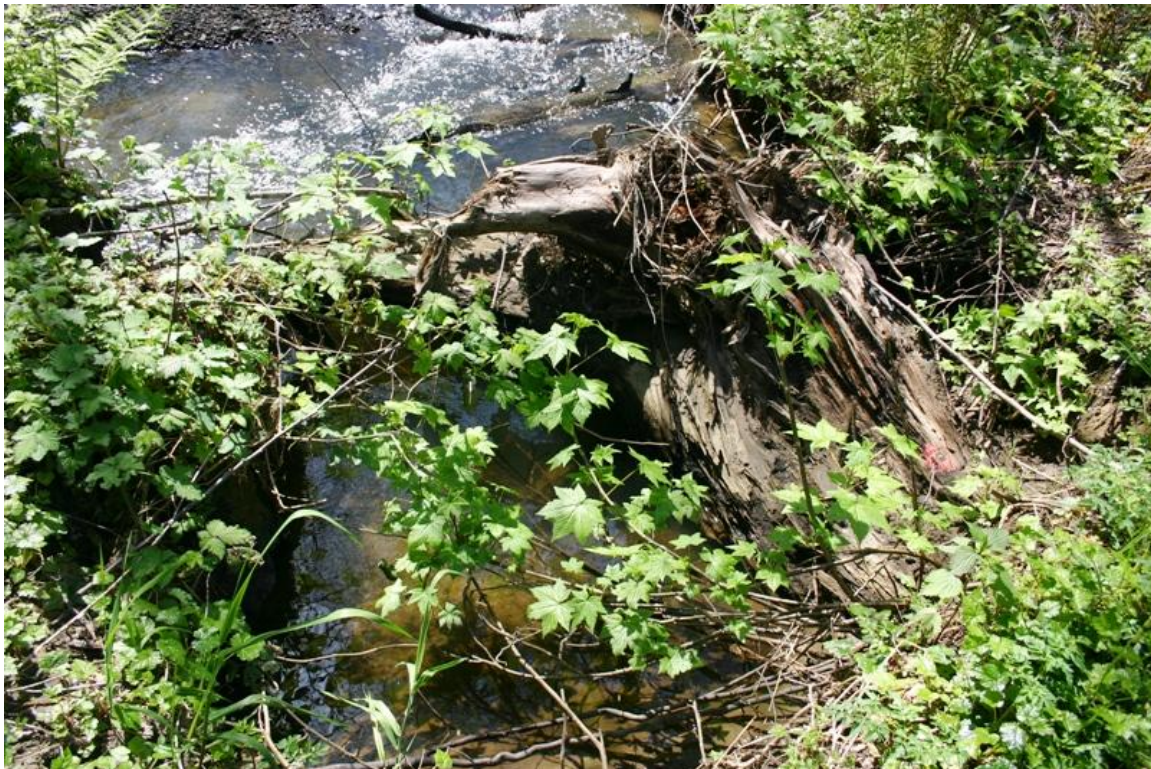
Figure 40. LWD piece #16 following first winter, West Fork McGarvey Creek, Lower Klamath River, California, 2008.

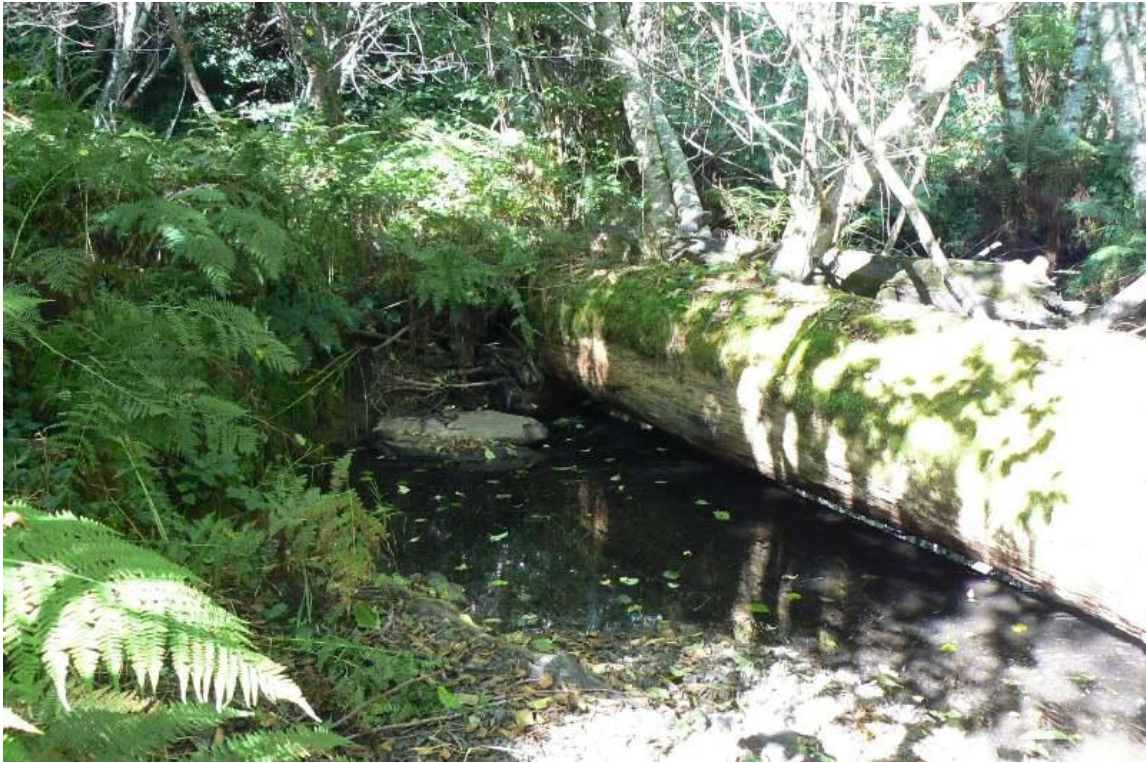
Figure 41. Backwater pool above natural full-spanning log prior to placing rootwad (LWD piece #17), West Fork McGarvey Creek, Lower Klamath River, California, 2007.

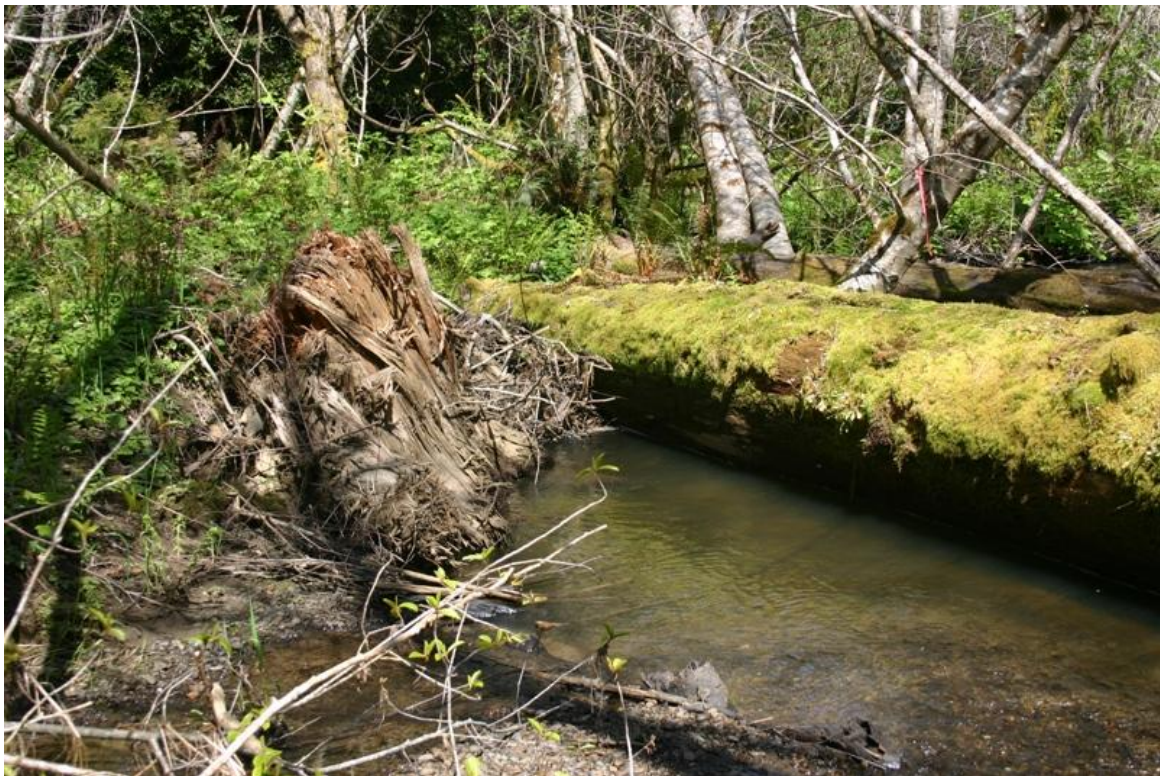
Figure 44. LWD piece #17 following first winter, West Fork McGarvey Creek, Lower Klamath River, California, 2008.

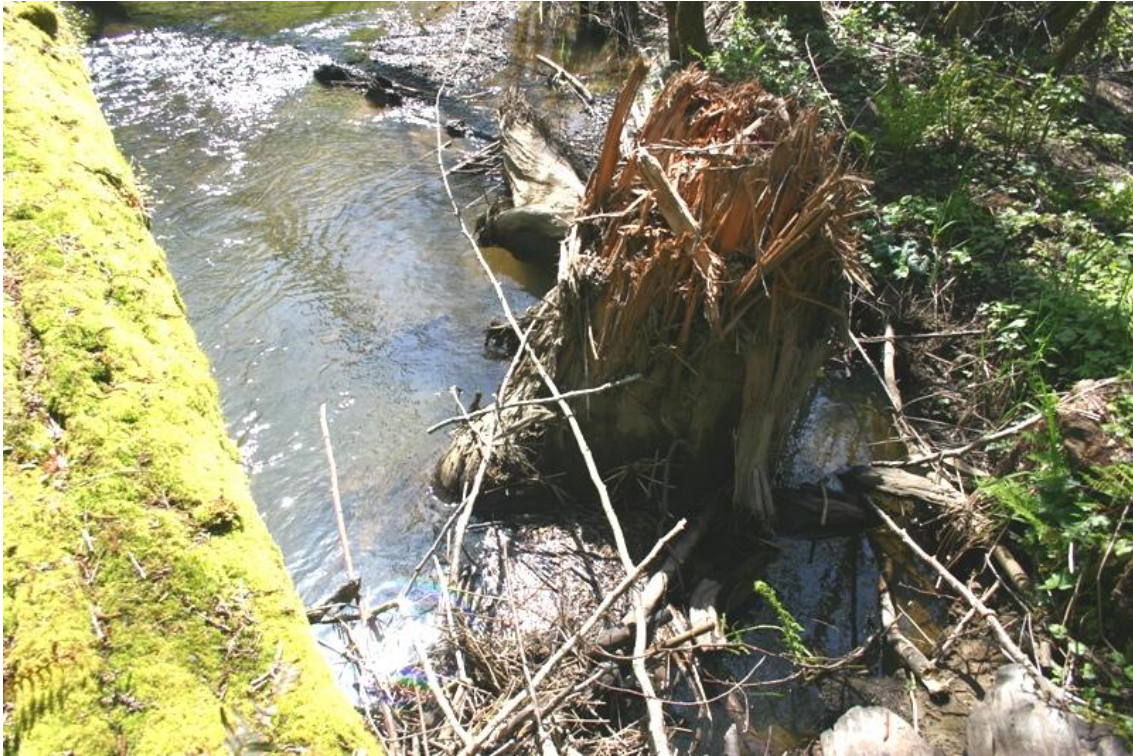
Figure 45. LWD piece #17 following first winter, West Fork McGarvey Creek, Lower Klamath River, California, 2008.

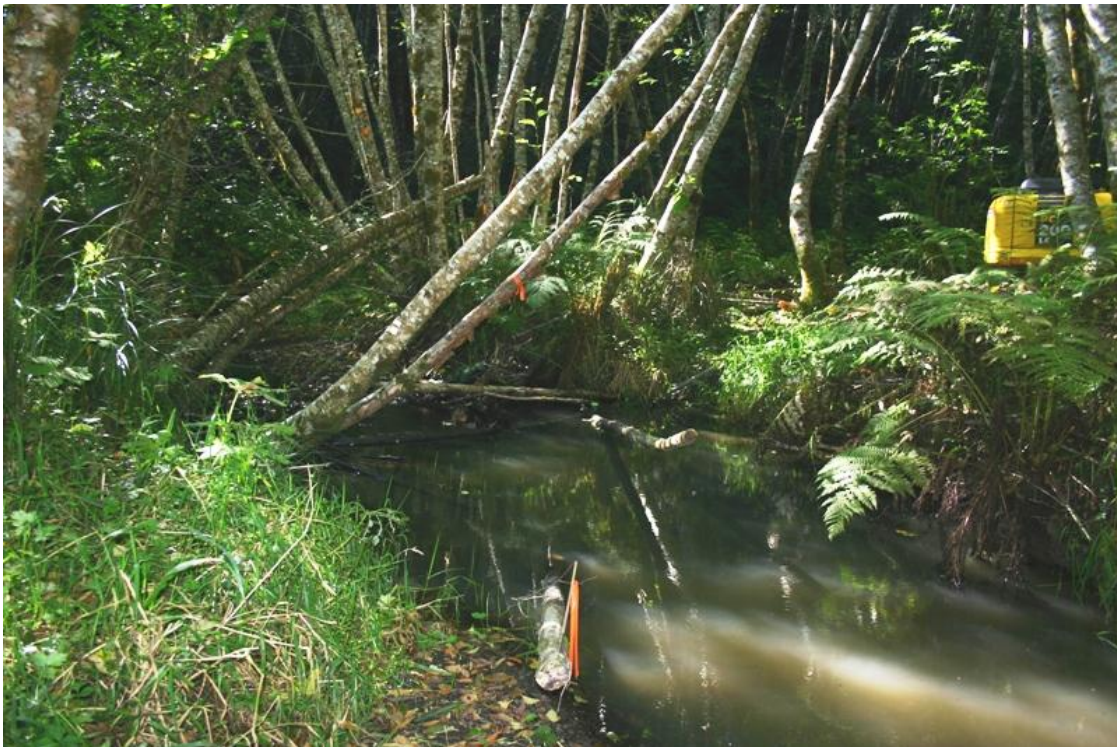
Figure 46. Shallow pool prior to installation of LWD pieces #18-21, West Fork McGarvey Creek, Lower Klamath River, California, 2007.

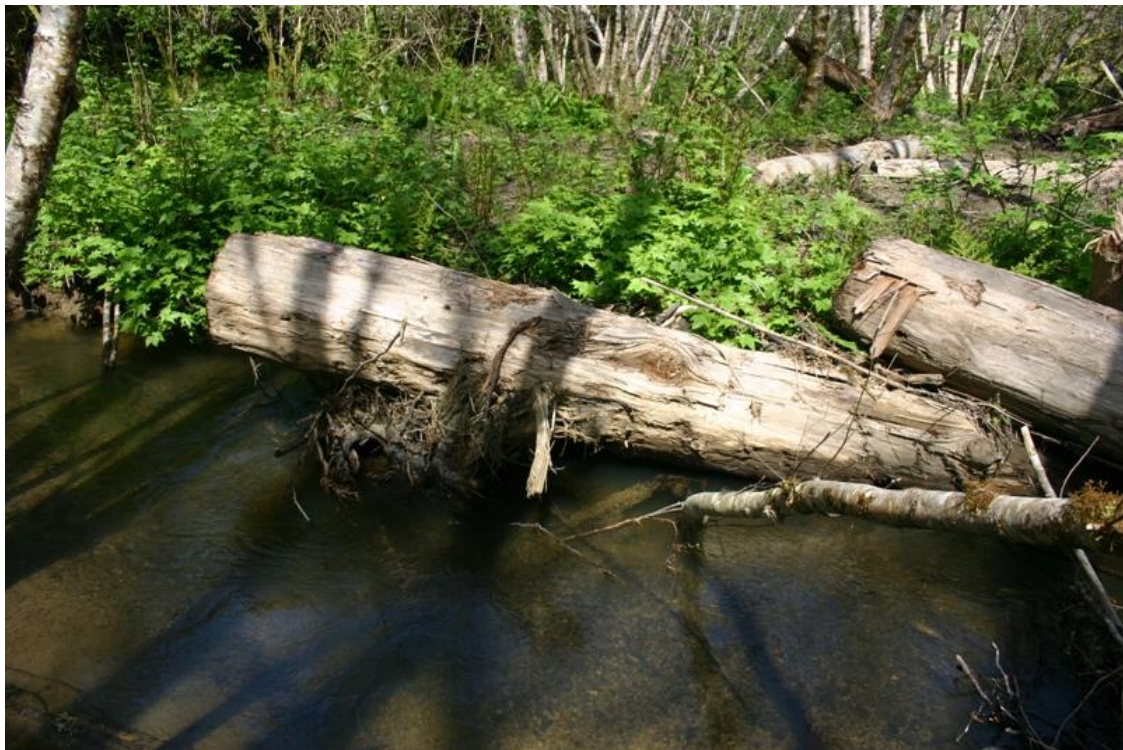
Figure 50. LWD pieces #18-21 following first winter, West Fork McGarvey Creek, Lower Klamath River, California, 2008.

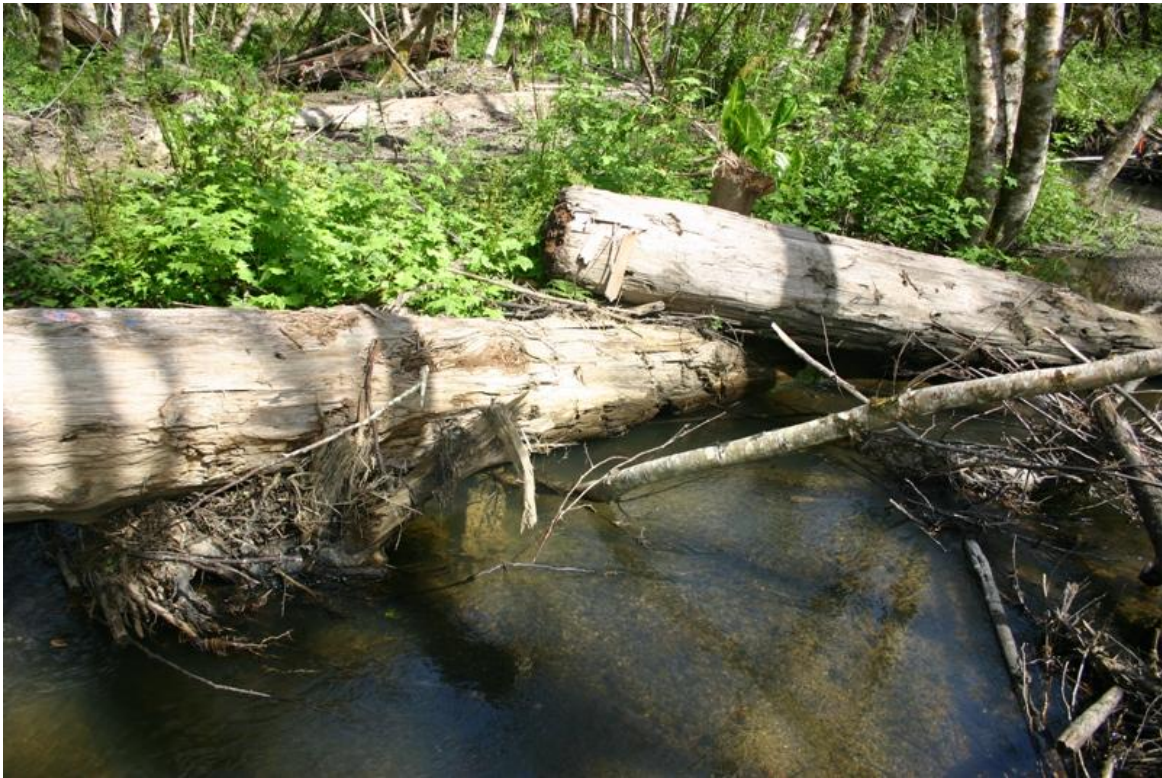
Figure 51. LWD pieces #18-21 following first winter, West Fork McGarvey Creek, Lower Klamath River, California, 2008.

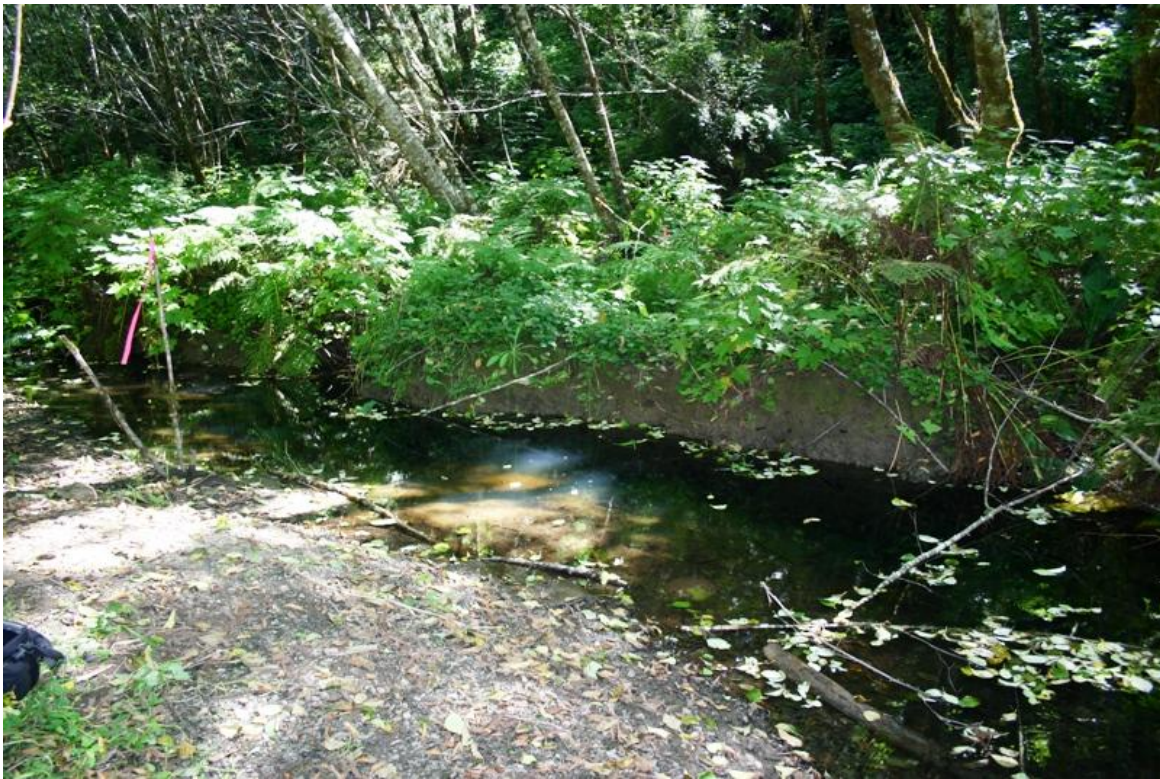
Figure 52. Shallow pool prior to installation of LWD pieces #22-26, West Fork McGarvey Creek, Lower Klamath River, California, 2007.

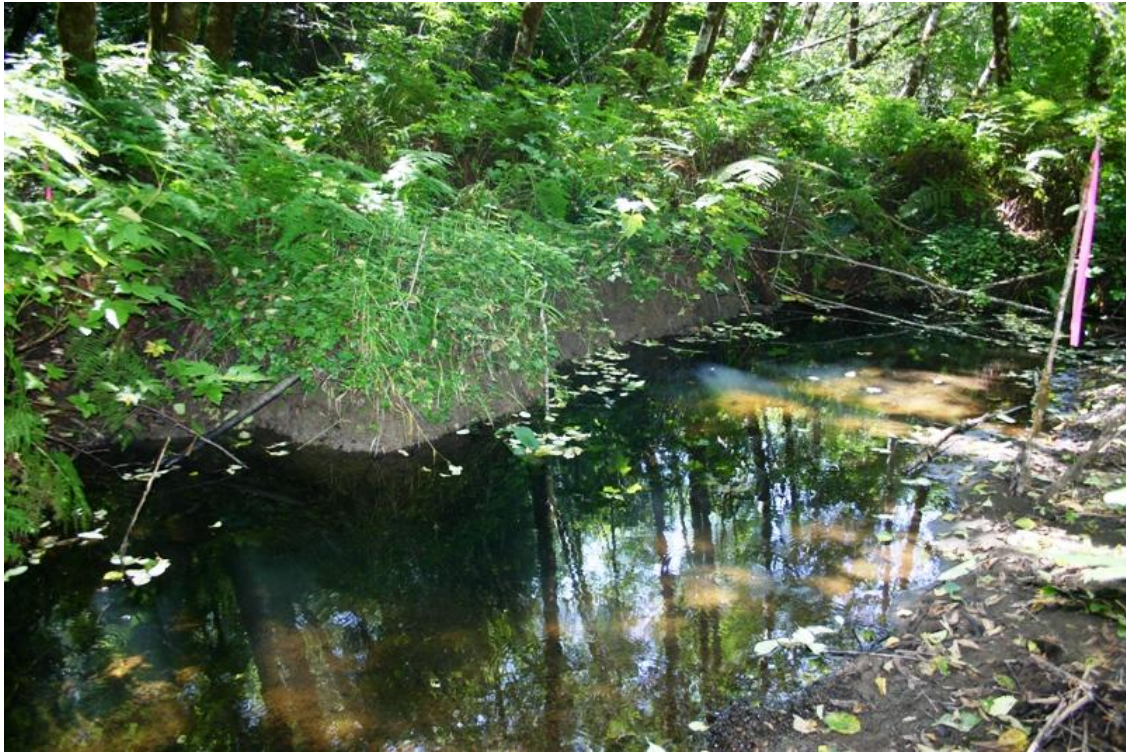
Figure 53. Shallow pool prior to installation of LWD pieces #22-26, West Fork McGarvey Creek, Lower Klamath River, California, 2007.

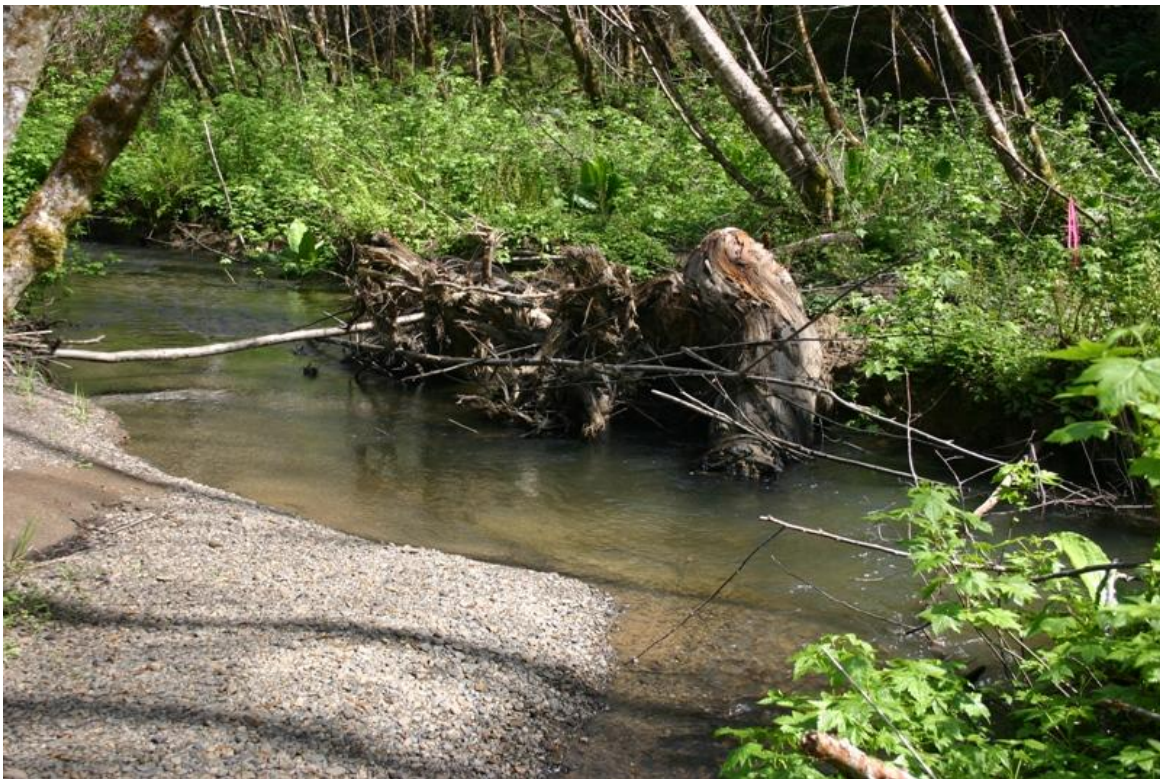
Figure 56. LWD pieces #22-26 following first winter, West Fork McGarvey Creek, Lower Klamath River, California, 2008.

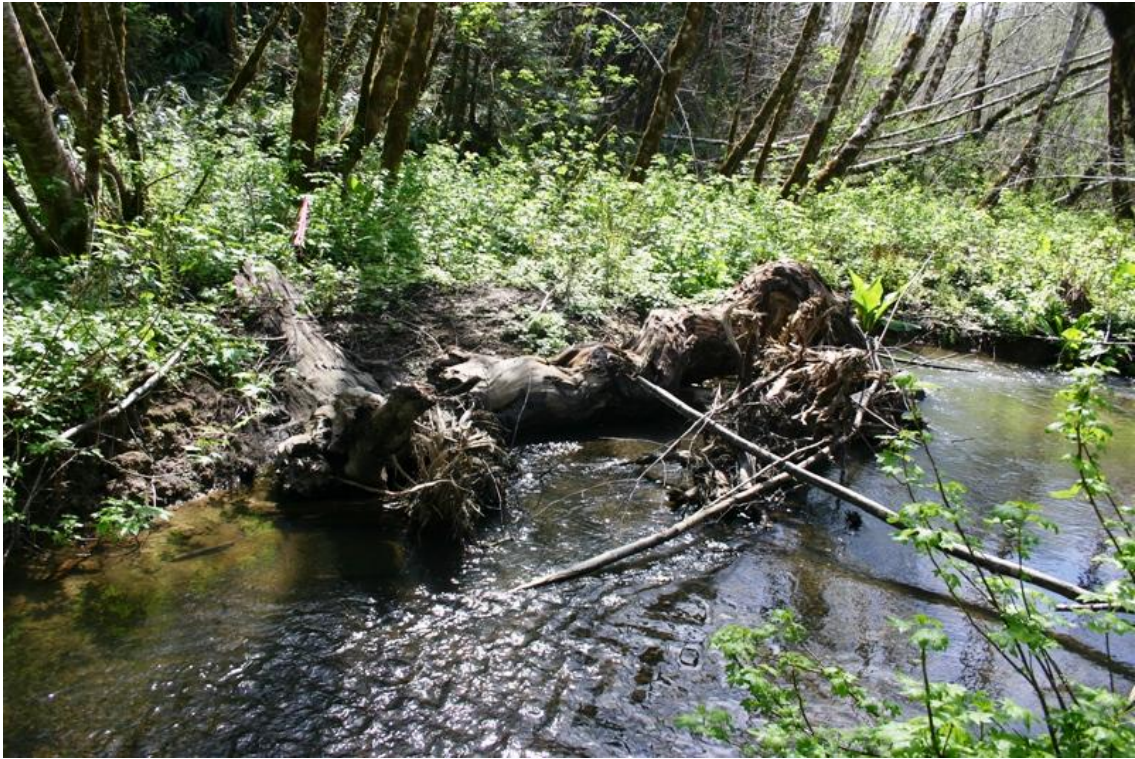
Figure 57. LWD pieces #22-26 following first winter, West Fork McGarvey Creek, Lower Klamath River, California, 2008.

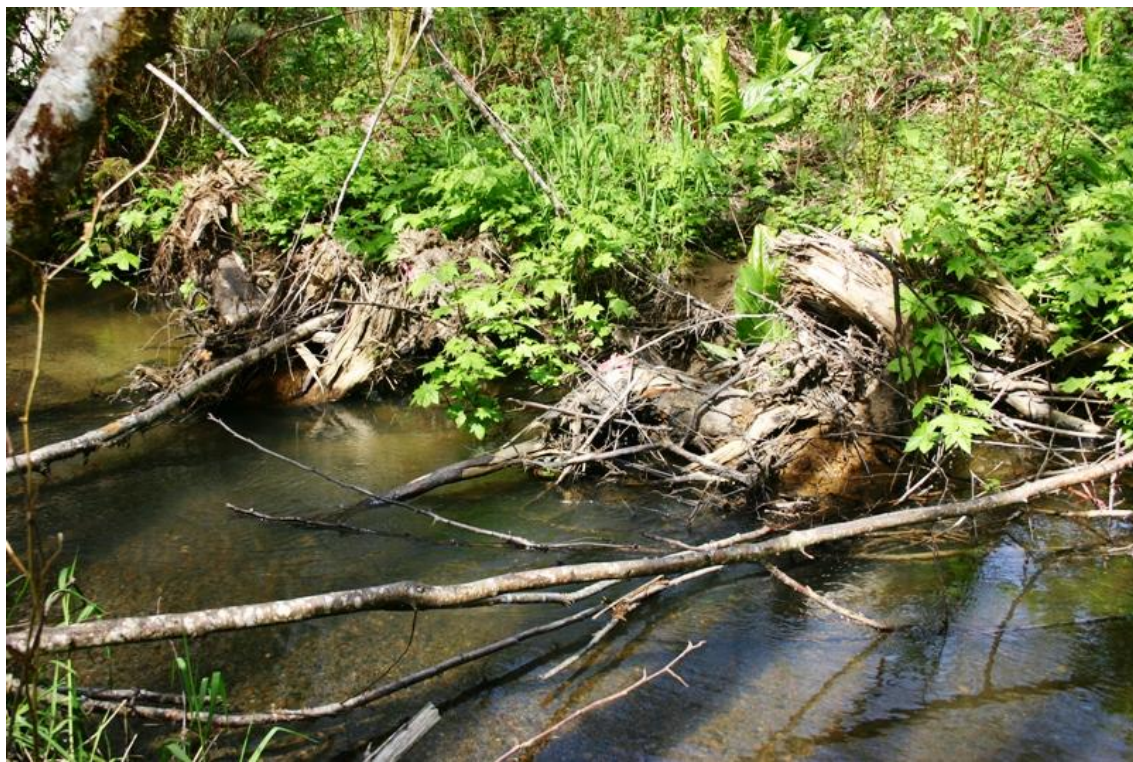
Figure 60. LWD pieces #27-30 following first winter, West Fork McGarvey Creek, Lower Klamath River, California, 2008.

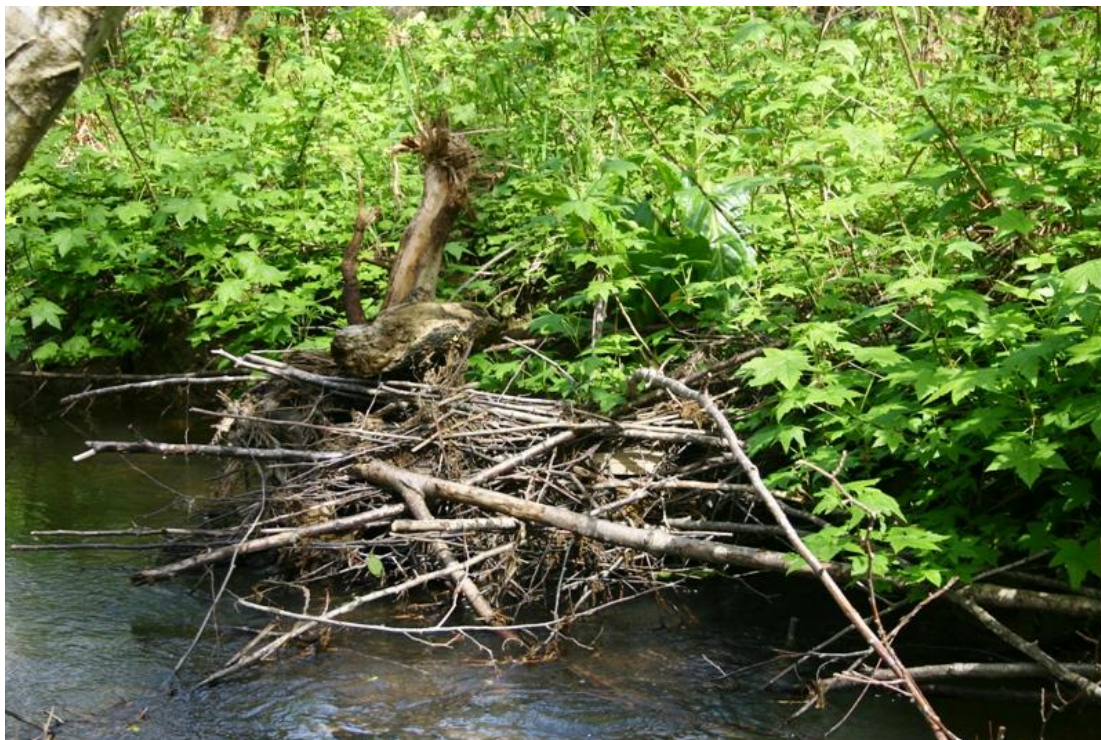
Figure 61. LWD pieces #27-30 following first winter, West Fork McGarvey Creek, Lower Klamath River, California, 2008.

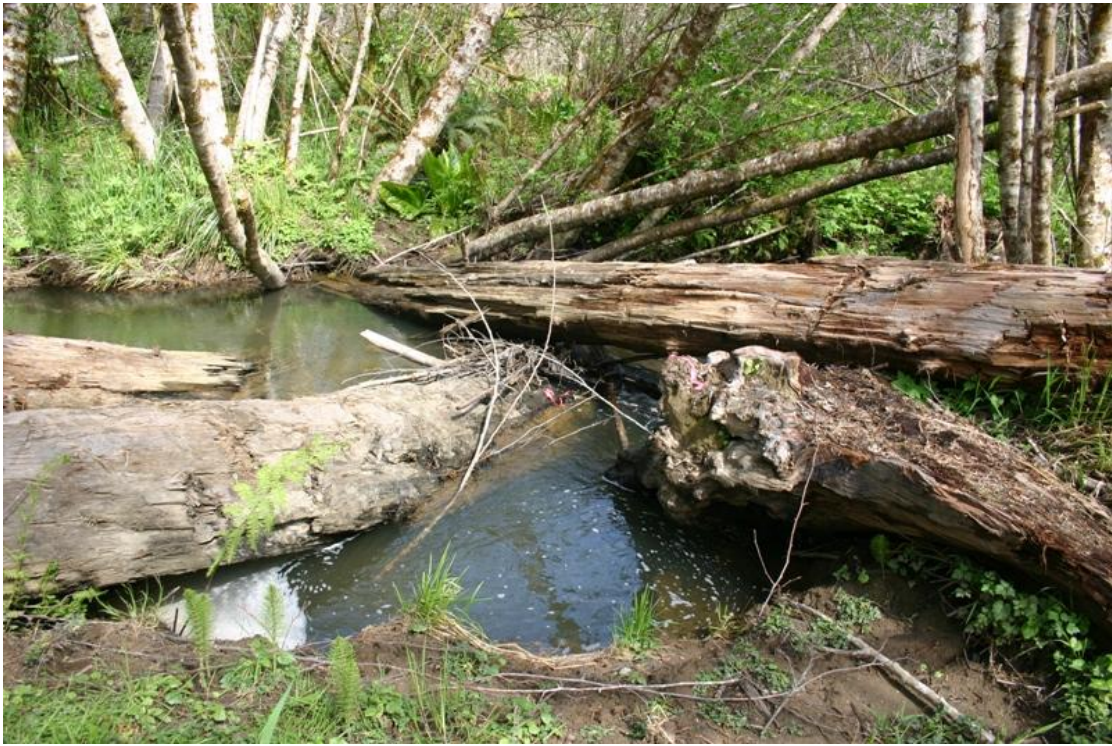
Figure 65. LWD pieces #31-34 following first winter, West Fork McGarvey Creek, Lower Klamath River, California, 2008.

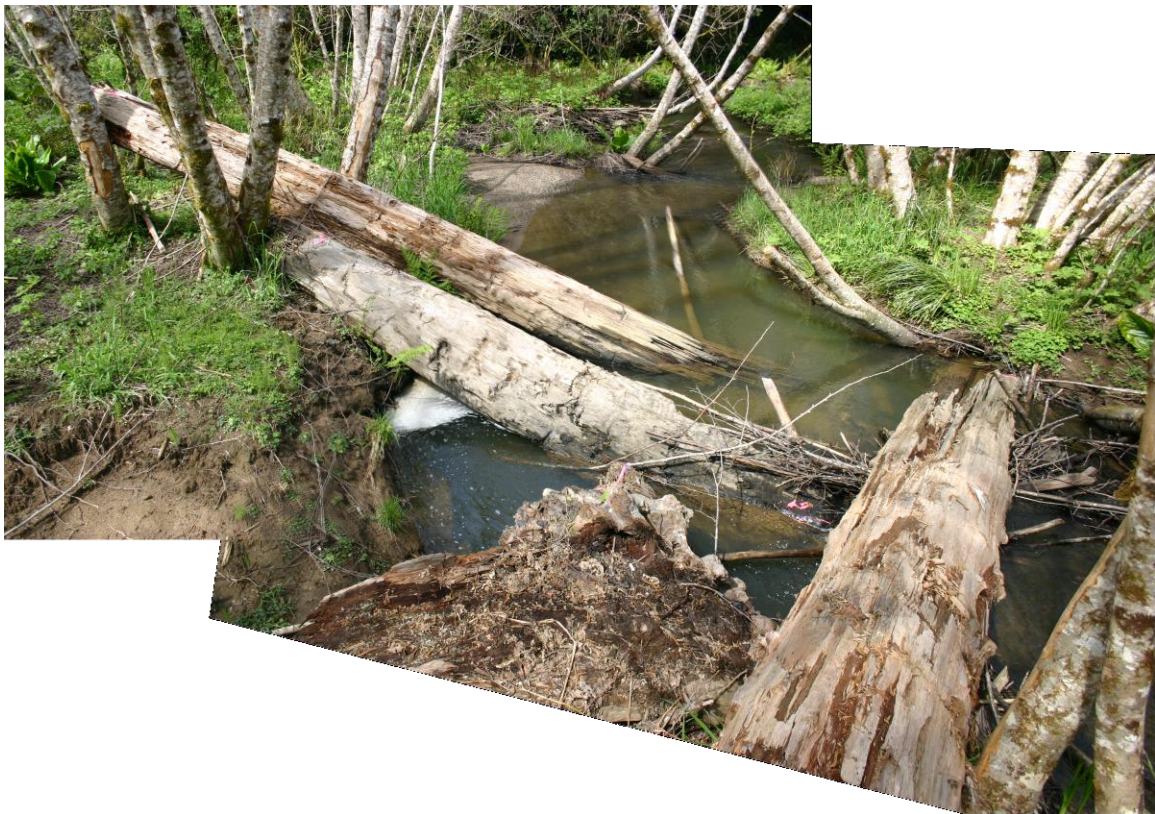
Figure 66. LWD pieces #31-34 following first winter, West Fork McGarvey Creek, Lower Klamath River, California, 2008.
