# **STREAM & FLOODPLAIN ENHANCEMENT OF HUNTER CREEK LOWER KLAMATH RIVER**

**Yurok Tribal Fisheries Program**

**March 2013**

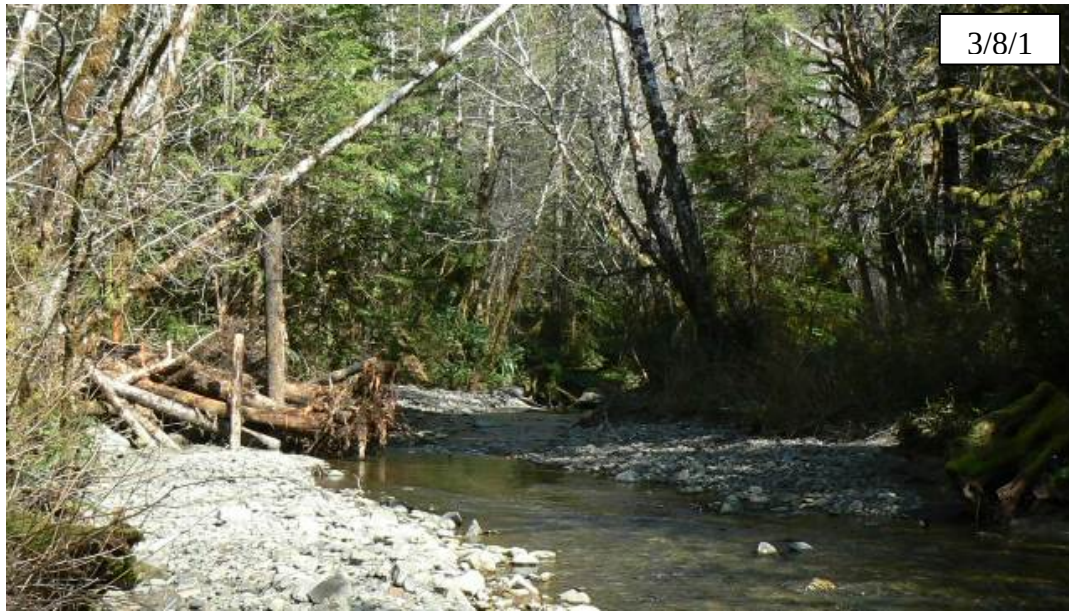
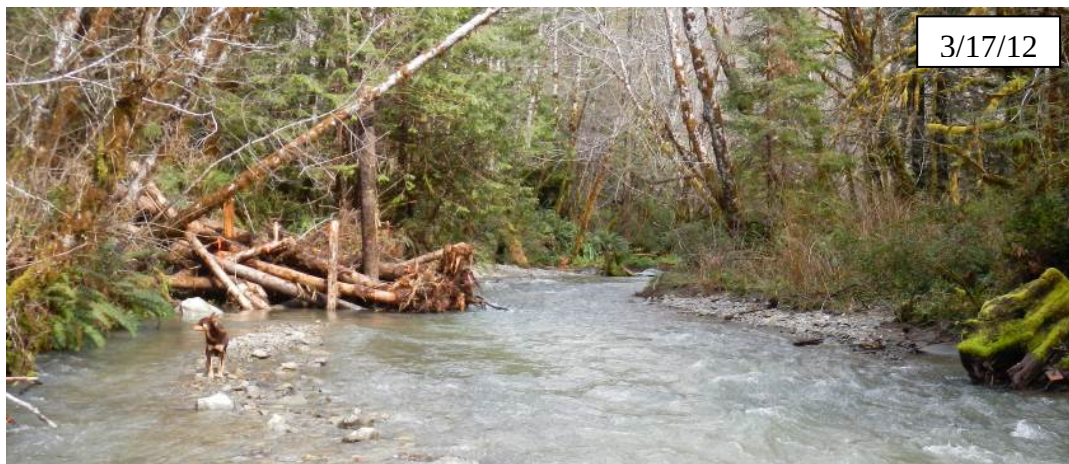
Figure 3. Constructed wood jam in East Fork Hunter Creek in the first spring post-construction.

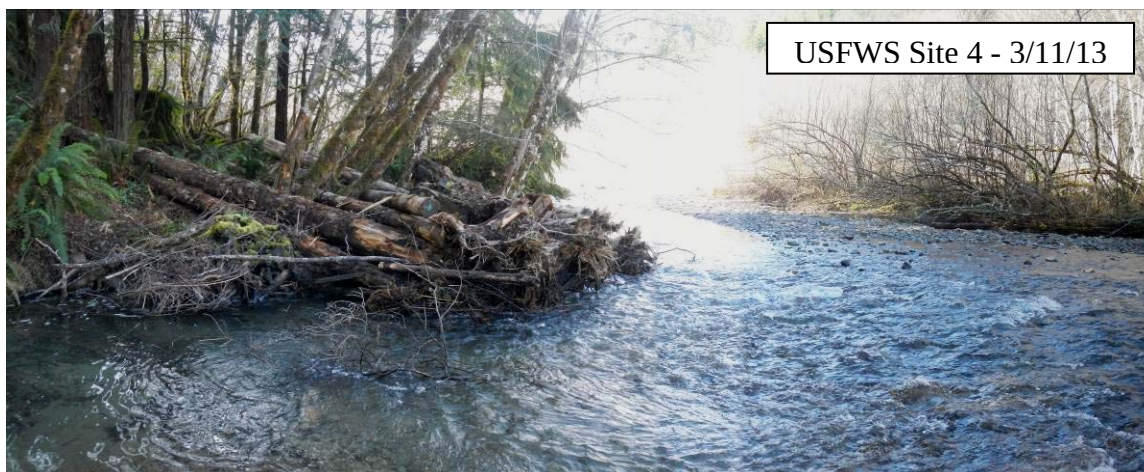
Figure 4. Constructed wood jam in Hunter Creek in the first spring post-construction.

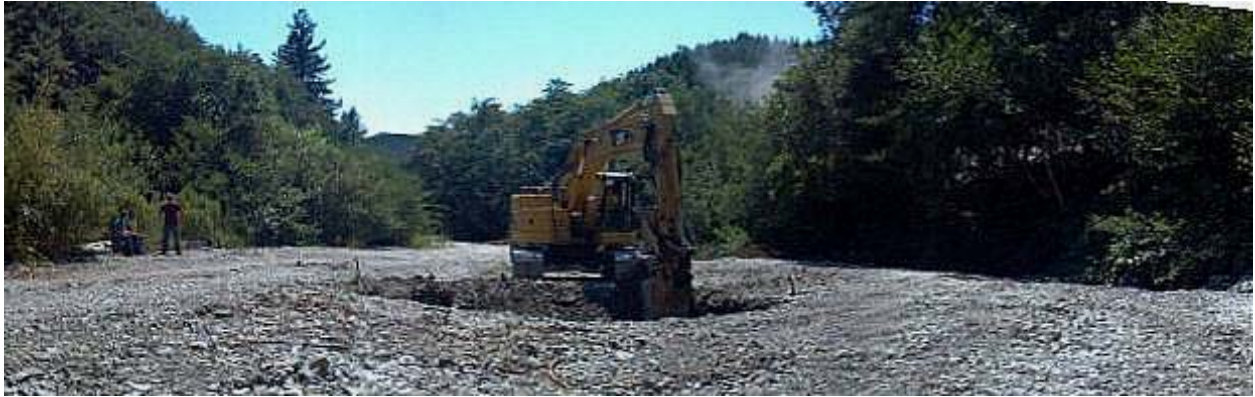
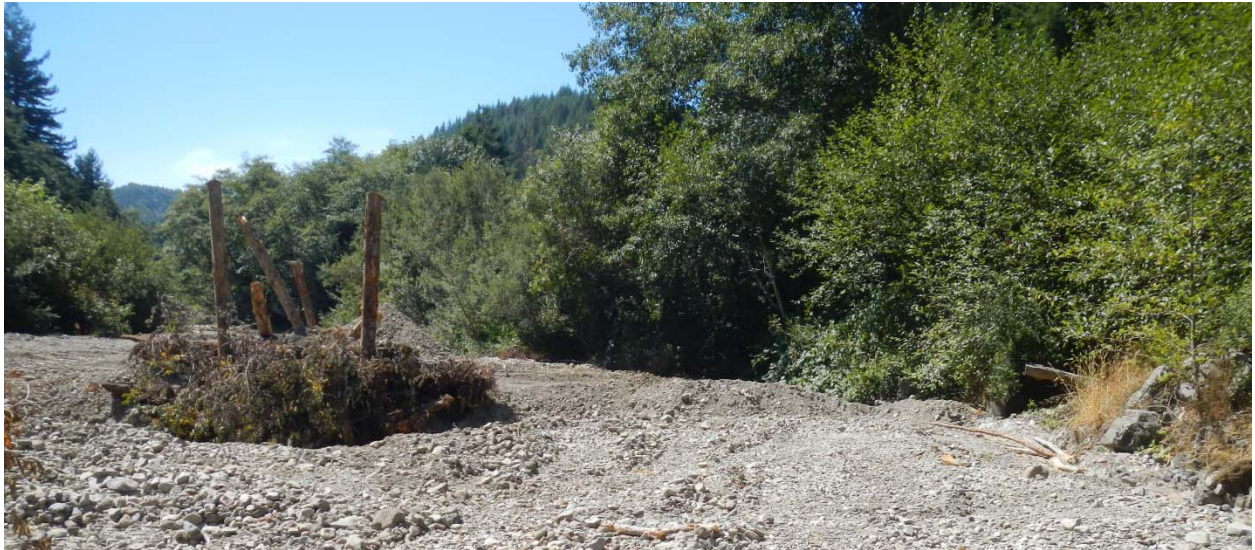
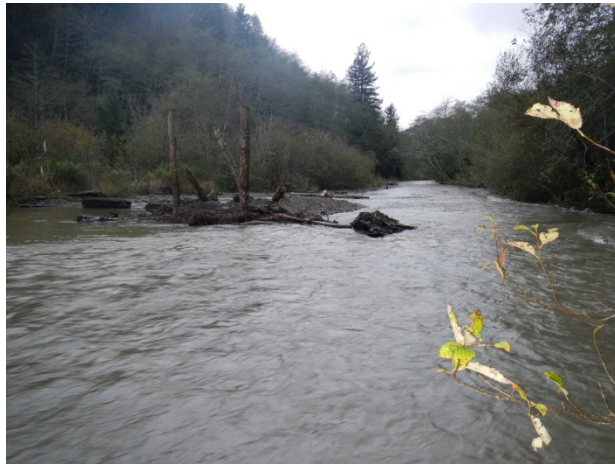
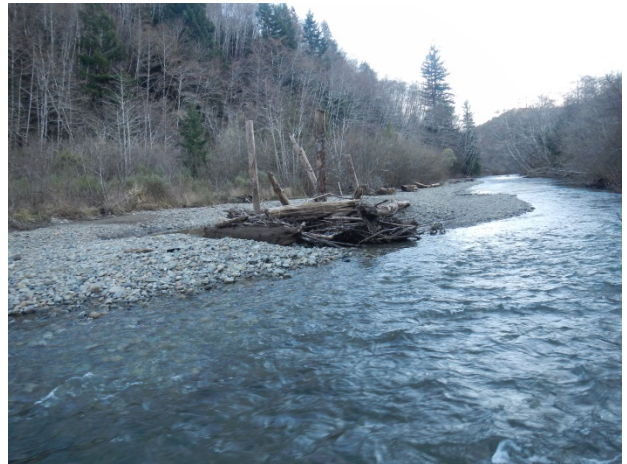
Figure 5. A bar apex jam (USFWS Site 2) during construction (Top, Middle – Aug. 2012) and during the first winter-spring post-construction (Bottom Left 11/20/12 – Bottom Right 3/7/13).

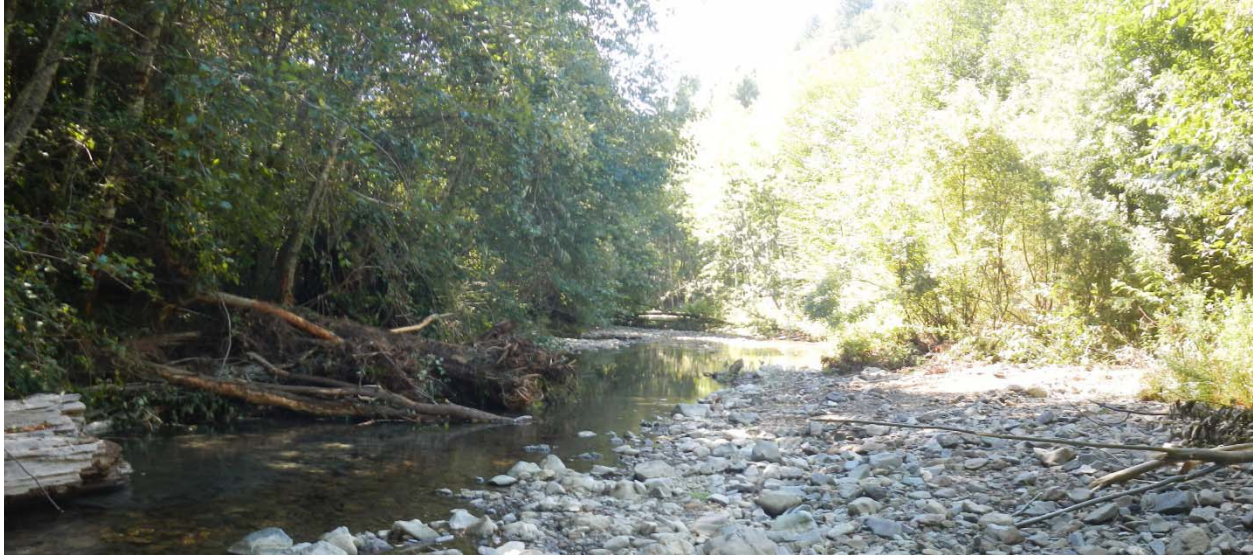
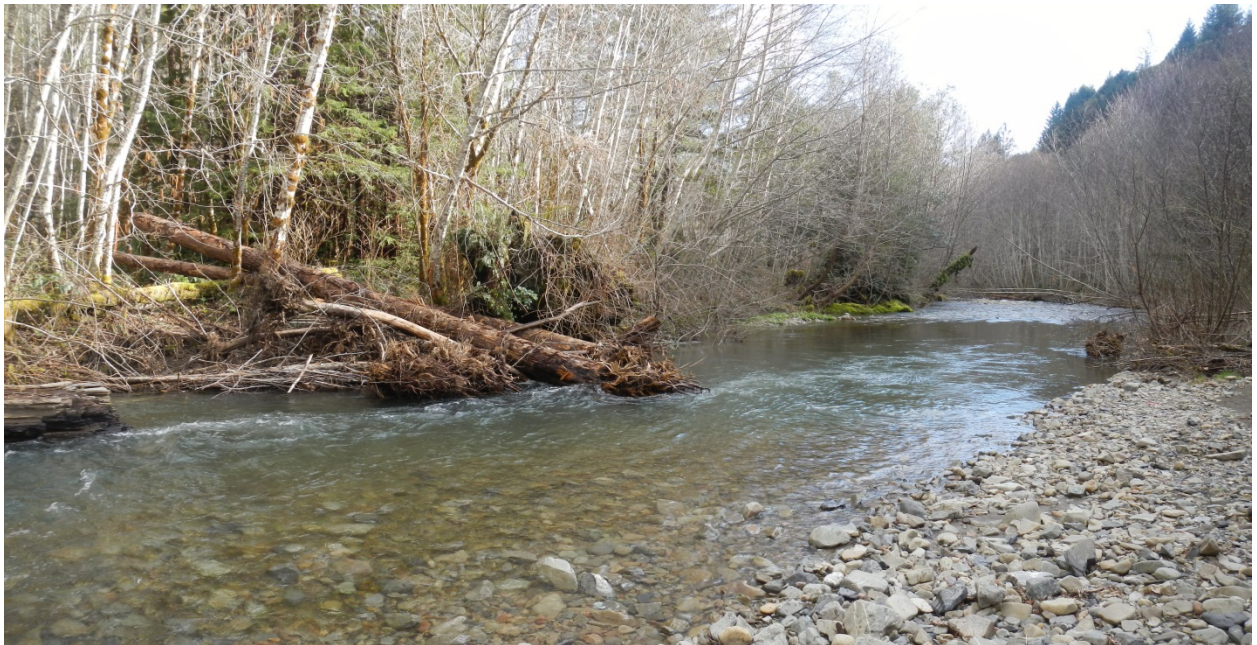
Left bank abutment jam - CDFW Site 1 - Photo-Site 1-1 (Top - 8/23/12; Bottom – 3/7/13)

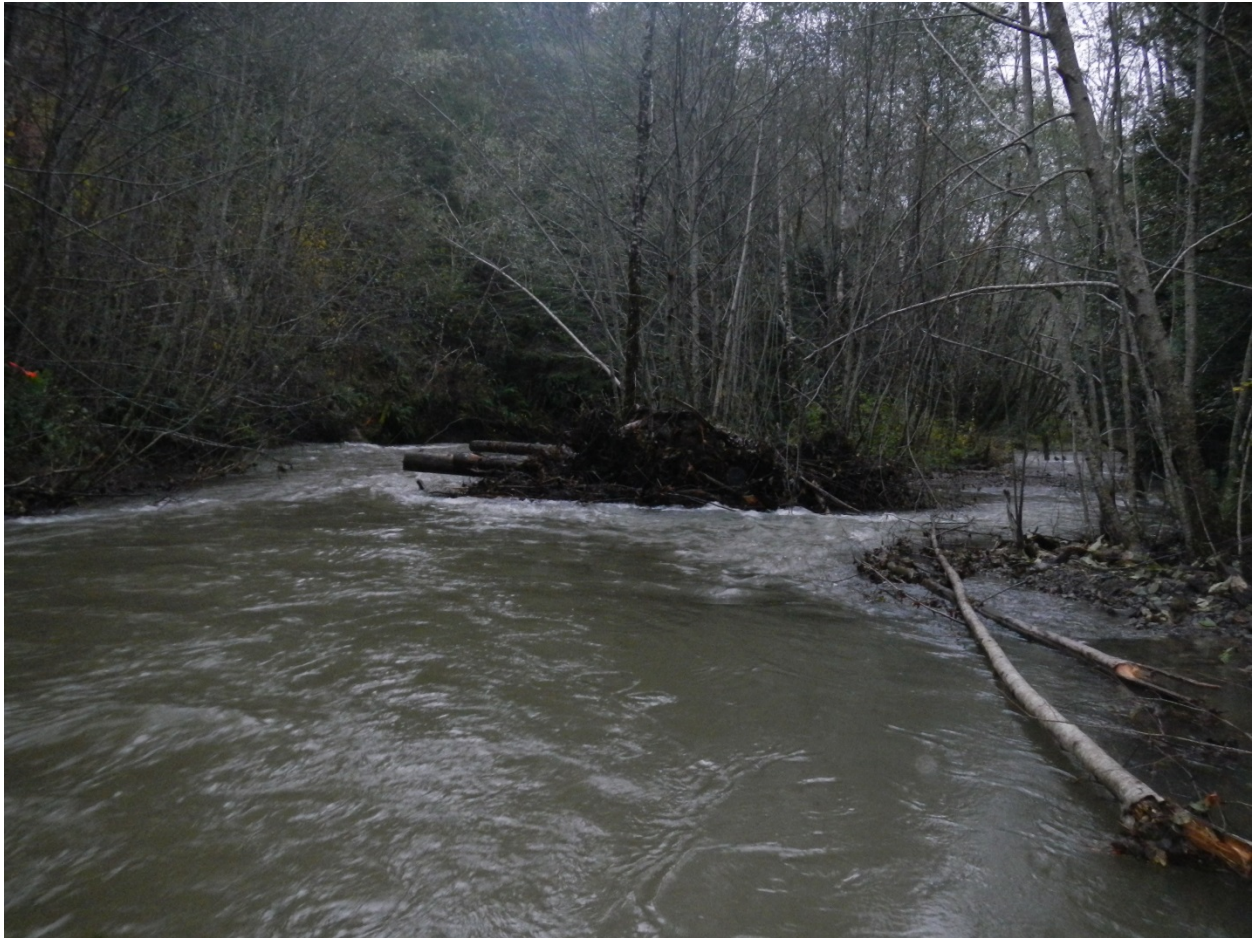
Bar apex jam - CDFW Site 4 – Photo-Site 2-1 (a - 08/11/12; b - 11/11/12; Bottom - 11/20/13)
