# **ENHANCEMENT OF REARING HABITAT FOR NATAL AND NON-NATAL SALMONIDS IN MCGARVEY CREEK - LOWER KLAMATH RIVER**

**Yurok Tribal Fisheries Program**

**March 2014**

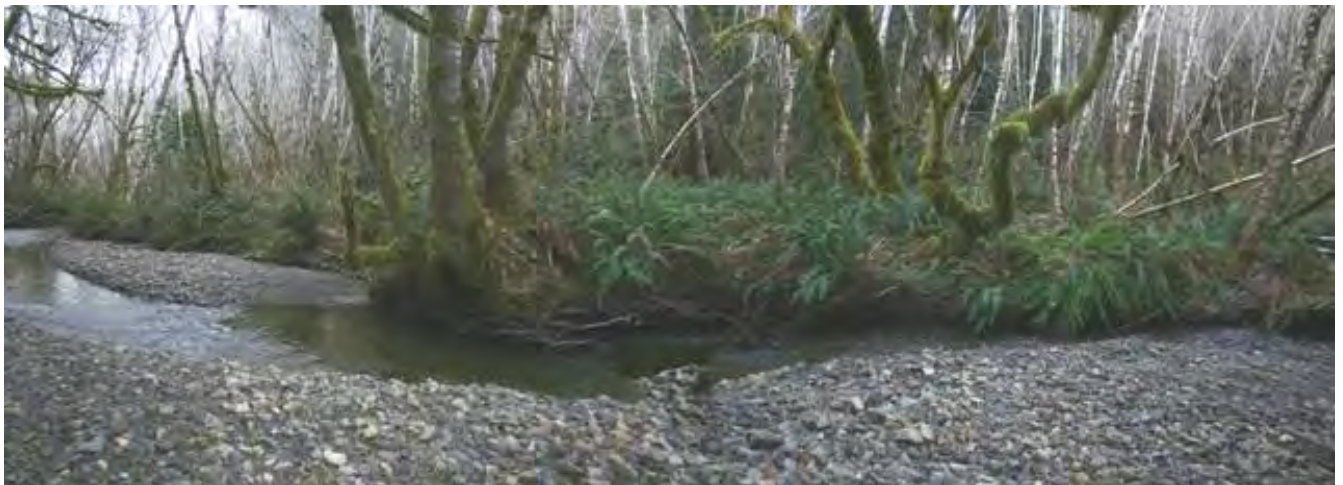
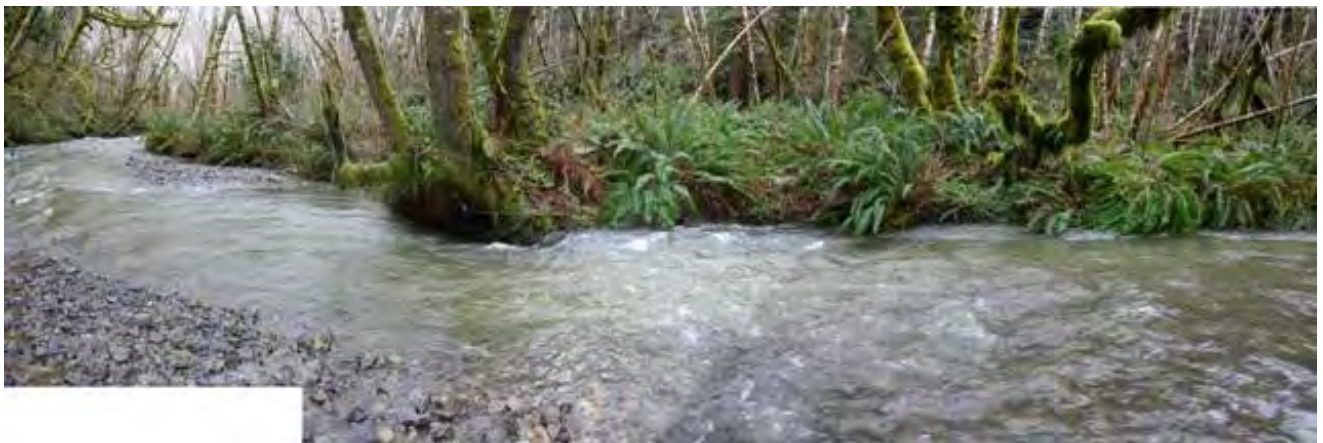
Figure 2. Photographs of a reach in upper McGarvey Creek prior to wood loading activities (Note: wood jams are lacking in the channel and mature alders dominate riparian habitats).

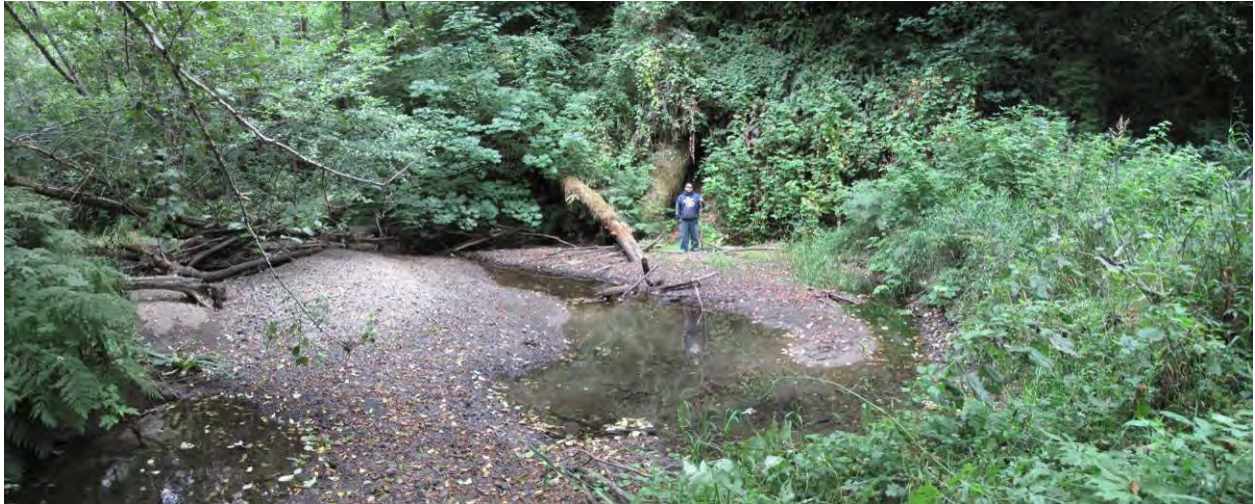
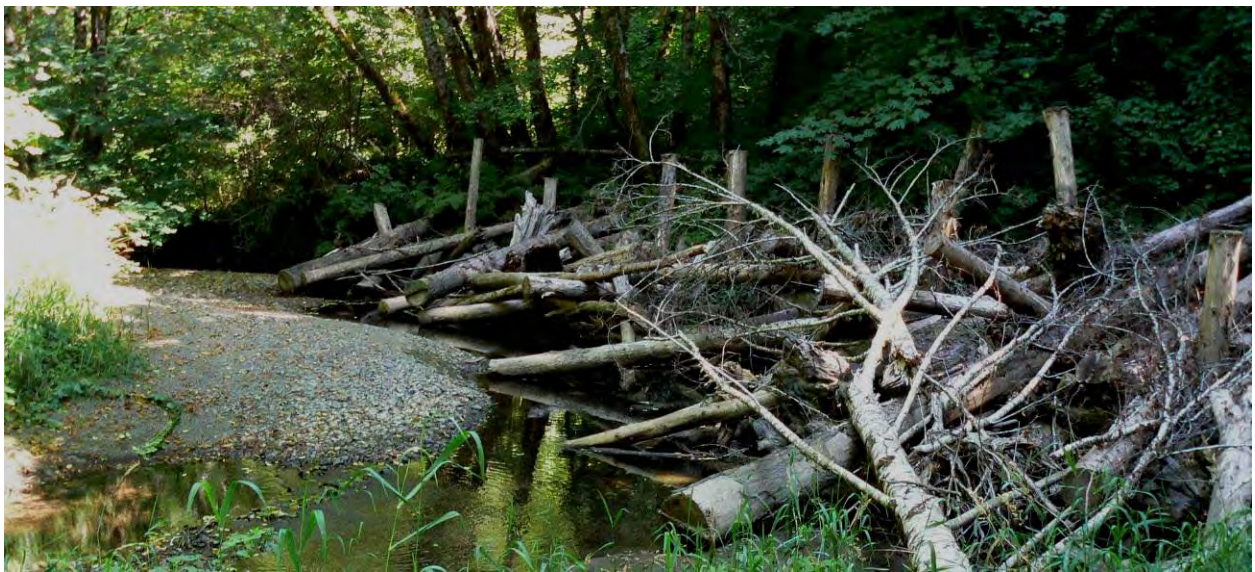
Figure 7. Photographs of McGarvey Creek 2009 wood loading Site #5 prior to construction (Top) and two years post-construction (Bottom).

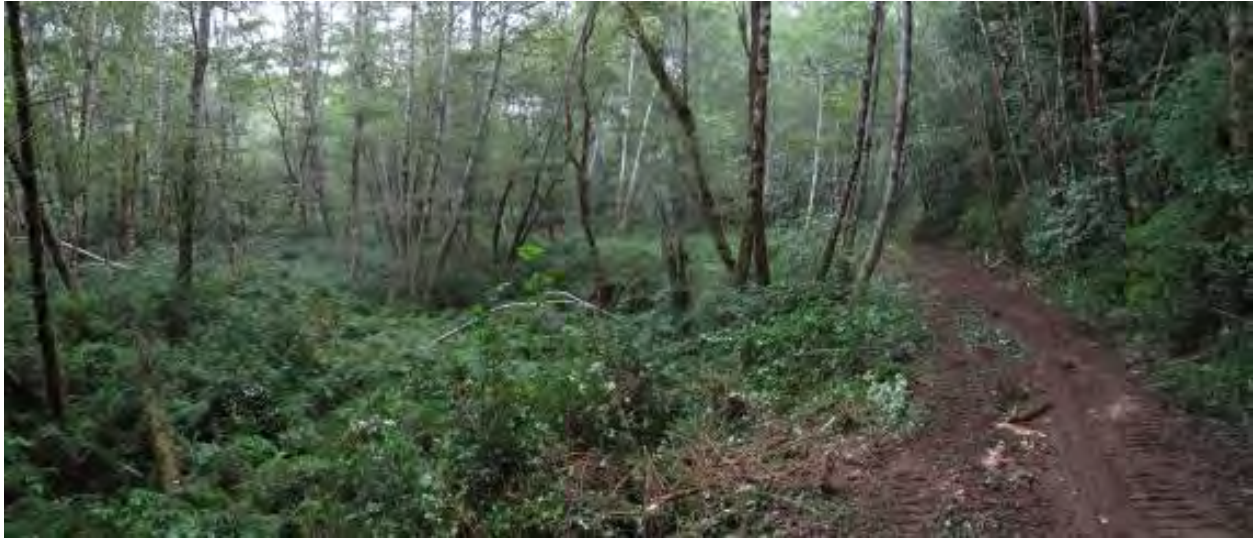
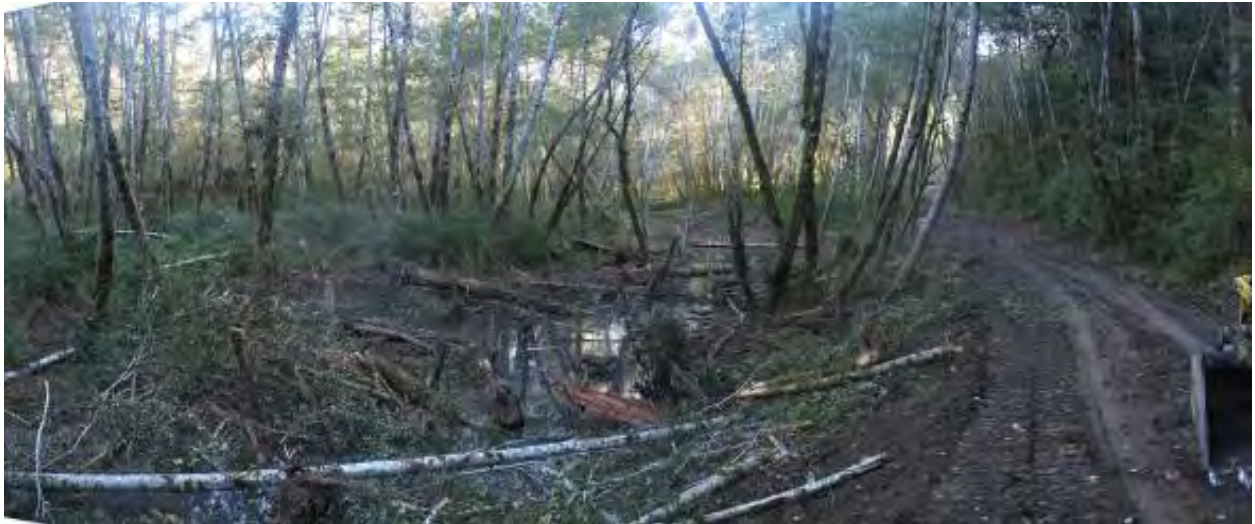
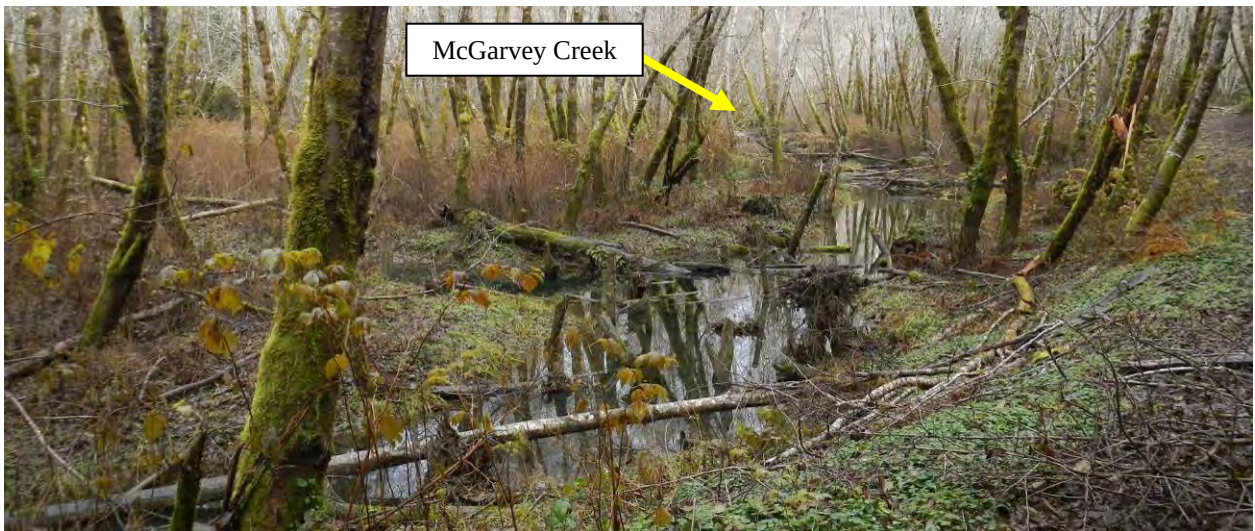
Figure 9. Photographs looking downstream at McGarvey Creek Alcove I prior to construction (Top-2010), post-construction (Middle-2010), and 2.5 years post-construction (Bottom-2013).

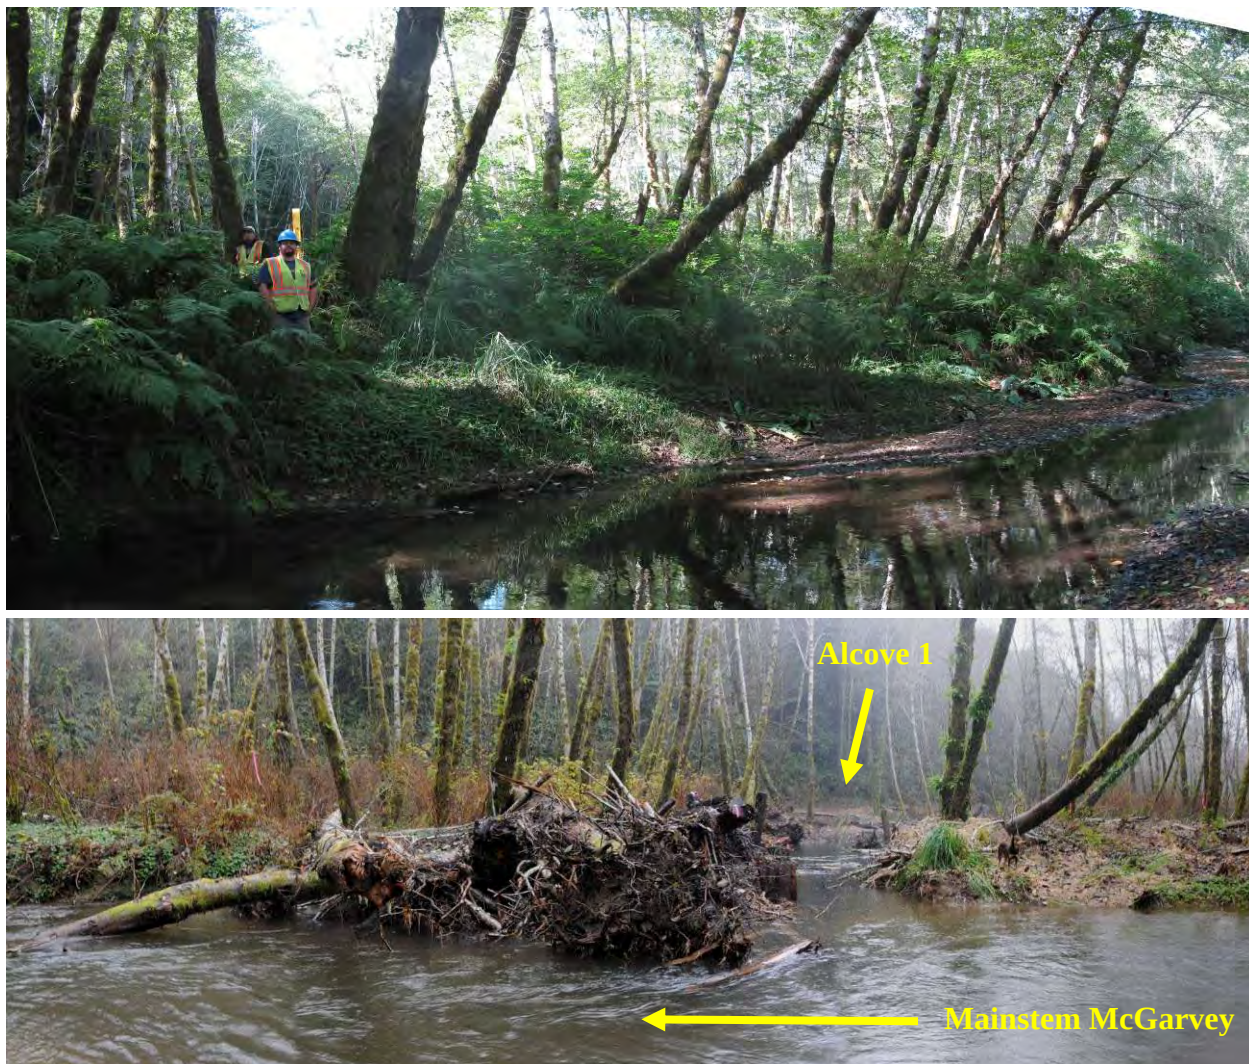
Figure 10. Photographs looking at the confluence of McGarvey Creek and Alcove I prior to construction (Top-2010) and during winter flows post-construction (Bottom-Winter 2011).

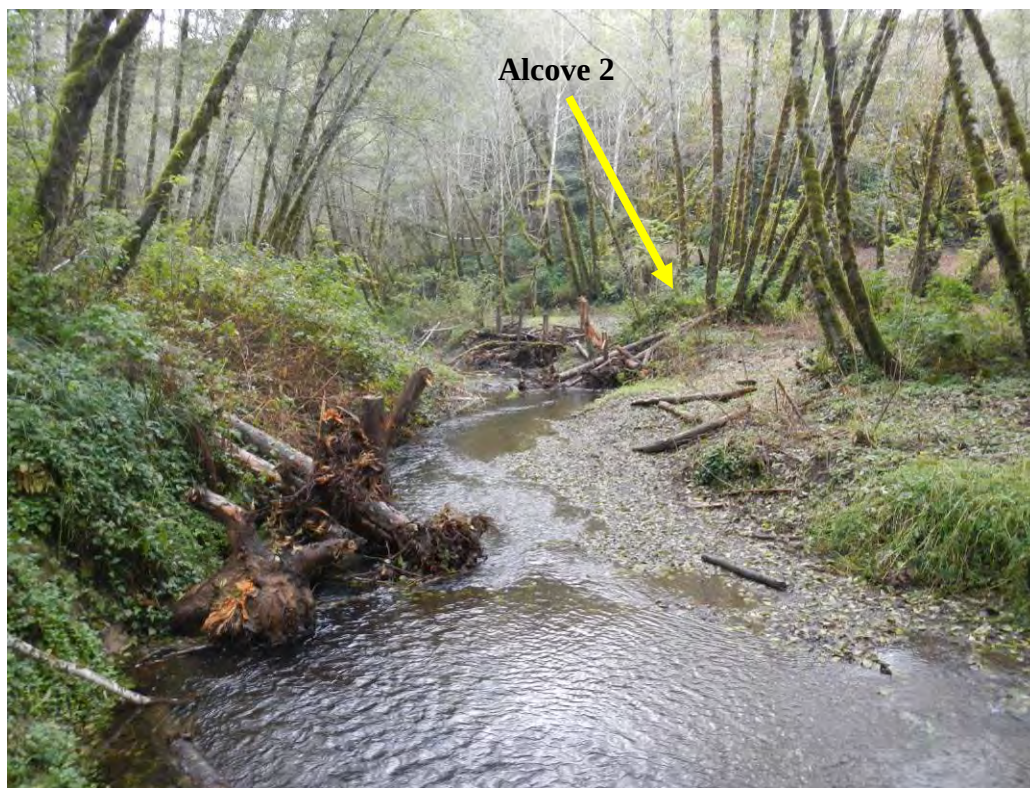
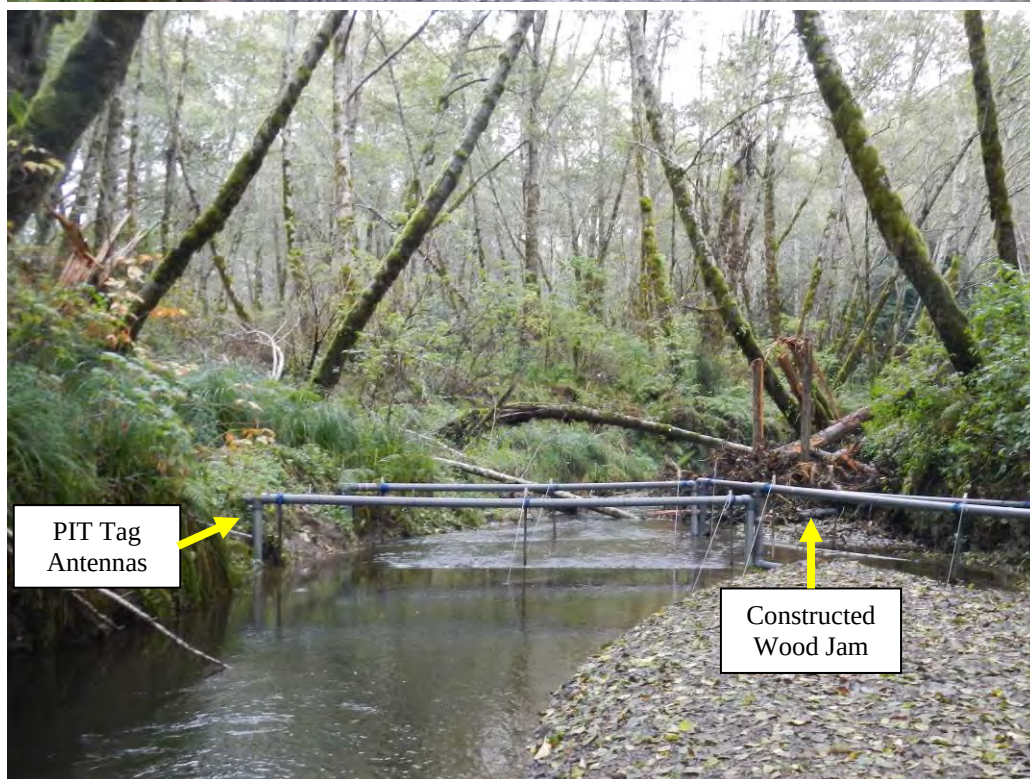
Figures 12. Photographs looking downstream at constructed wood jams installed in lower McGarvey Creek in summer 2012 (Photo Date: 11/13/12).

In summer 2012, YTFP and FGS installed eight CWJs and constructed the second off-channel habitat feature (McGarvey Alcove II) in the Lower McGarvey Creek Project Reach (Figures 12-18; Appendix A). McGarvey Alcove II is a fairly small off-channel habitat feature that was constructed on the eastern side of the valley just down valley from a small tributary (Figures 13-18). Alcove II and the outlet channel have fairly steep banks because the available footprint for the feature was relatively small. Large and small wood was placed within the main body of the alcove to increase rearing habitat complexity and a CWJ was installed at the outlet to promote long-term connectivity (i.e. fish passage) with the alcove (Figure 15).

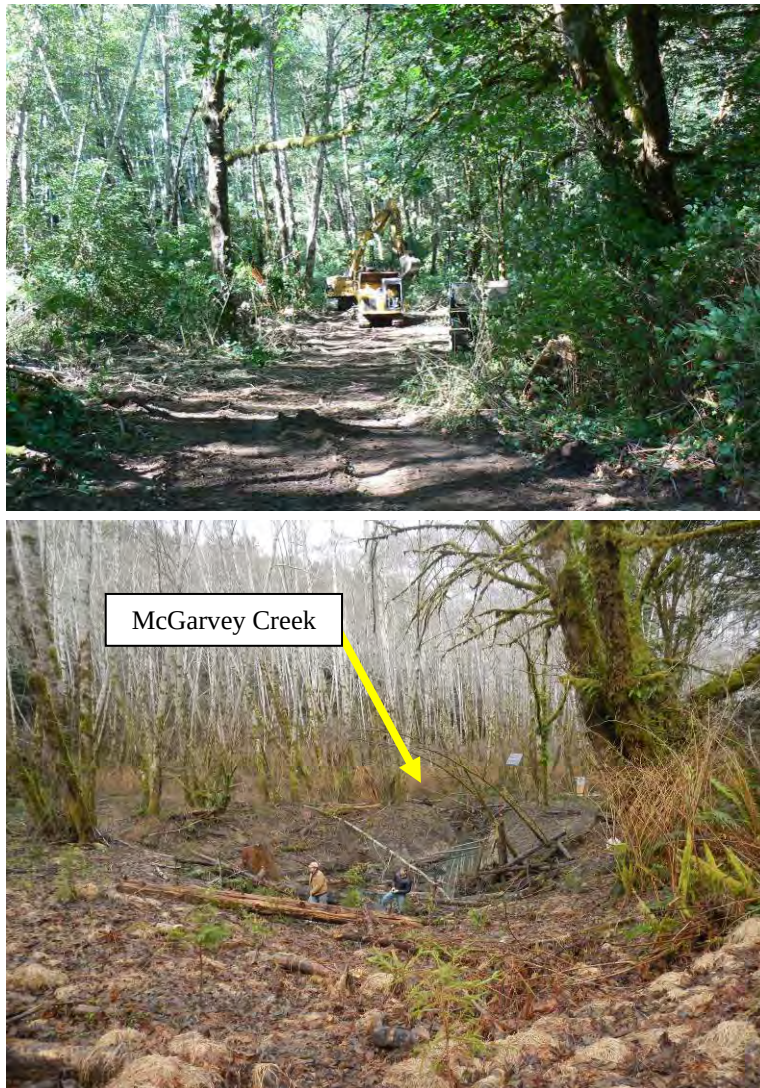
Figure 14. Photographs looking downstream at McGarvey Creek Alcove II prior to construction (Top-09/10/12) and during winter flows post-construction (Right-01/03/13).

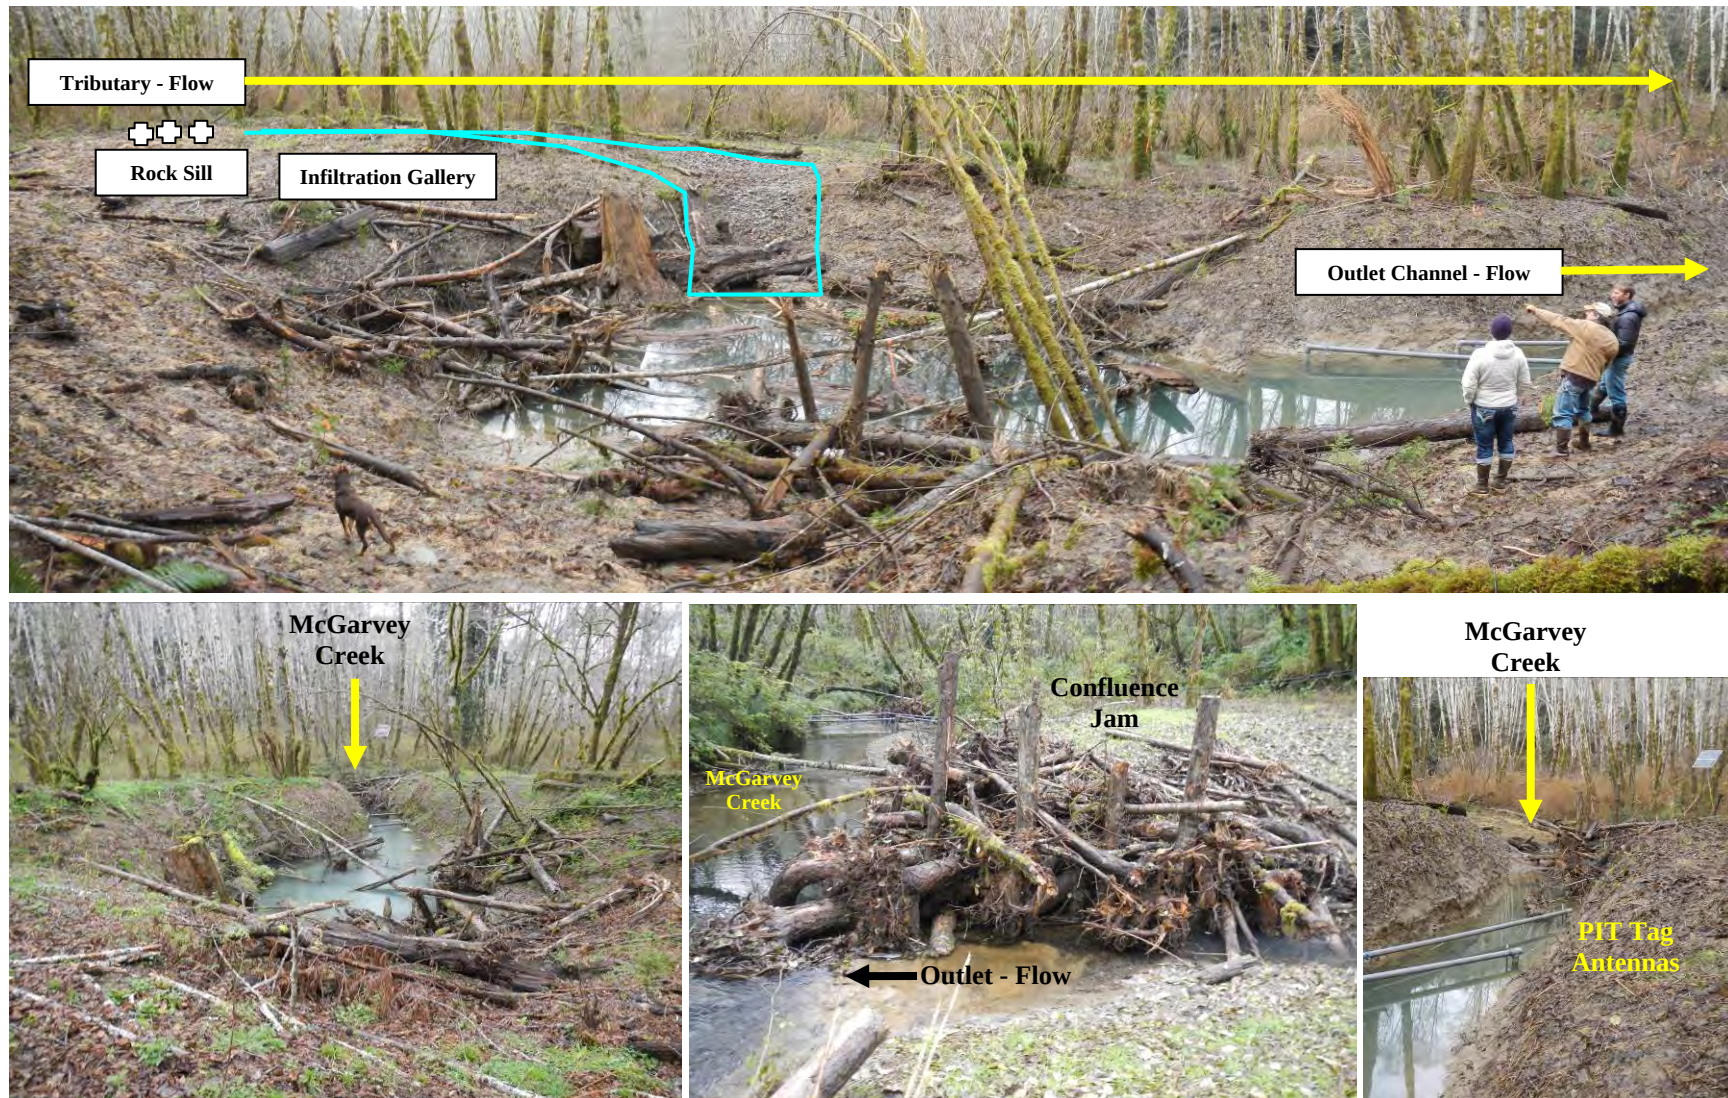
Figure 15. Photographs of McGarvey Creek Alcove II and the various design and habitat features constructed in summer 2012.

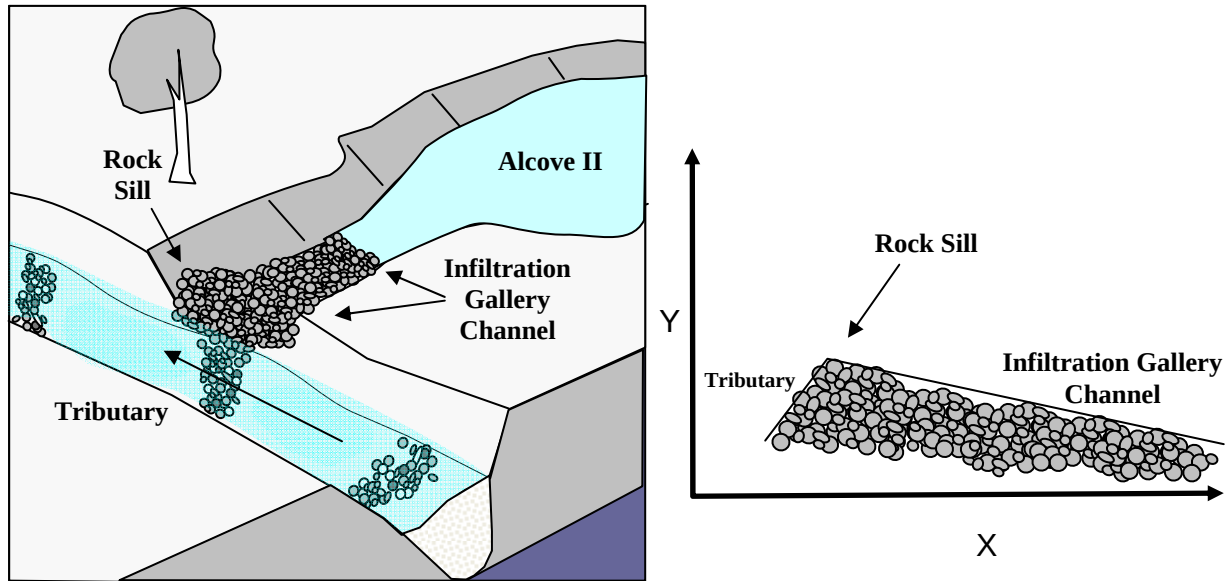
Figure 16. Diagrams depicting the infiltration gallery and rock sill constructed to promote increased delivery of tributary derived water (i.e. surface and ground water) into McGarvey Alcove II; while prohibiting delivery of tributary derived sediment into the constructed alcove.

FGS designed and constructed a rock sill and infiltration galley to promote increased surface and ground water inflow to the alcove from the tributary (Figures 15-17). The sill and infiltration

gallery were constructed using clean, river run rock obtained from an unrelated restoration project in Terwer Creek. The purpose of the sill was to allow surface waters to flow from the tributary to the infiltration gallery while discouraging sediment delivery to the constructed alcove. To create the infiltration gallery, a shallow channel was excavated from the tributary into Alcove II to transport surface and ground water flows. The channel was backfilled with river run rock to prohibit bank erosion during higher tributary flows and help promote improved water quality.

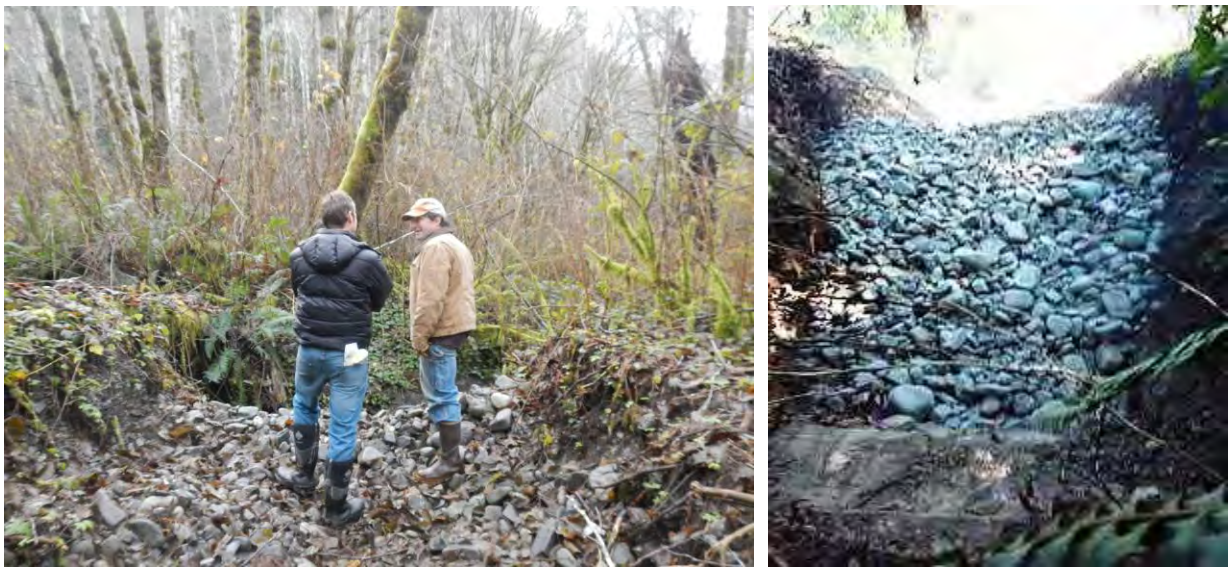
Figure 17. Photographs looking upstream at the rock sill during winter 2013 (Left) and the McGarvey Alcove II infiltration gallery channel post-construction in summer 2012 (Right).

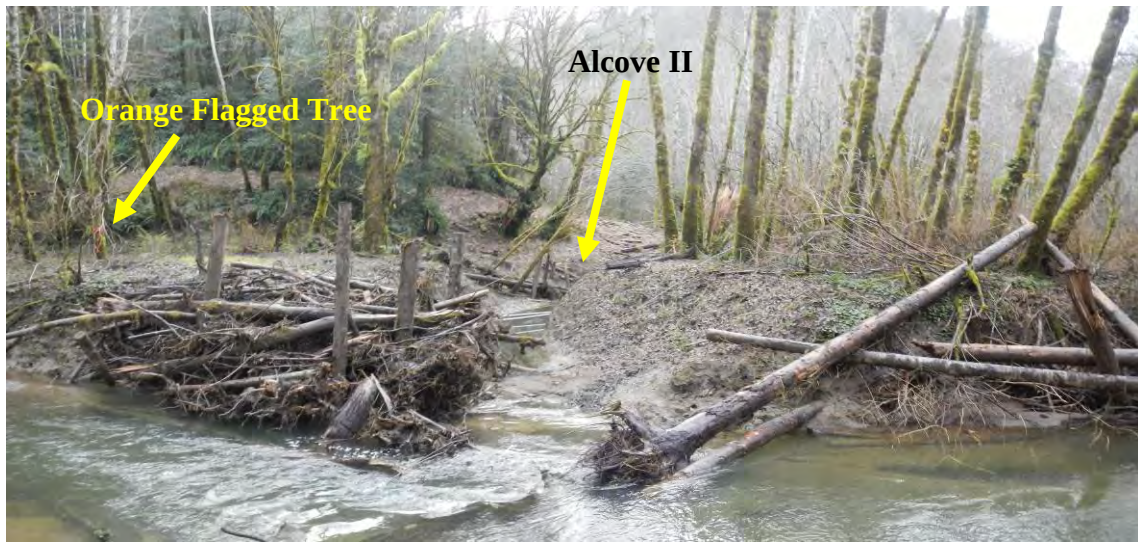
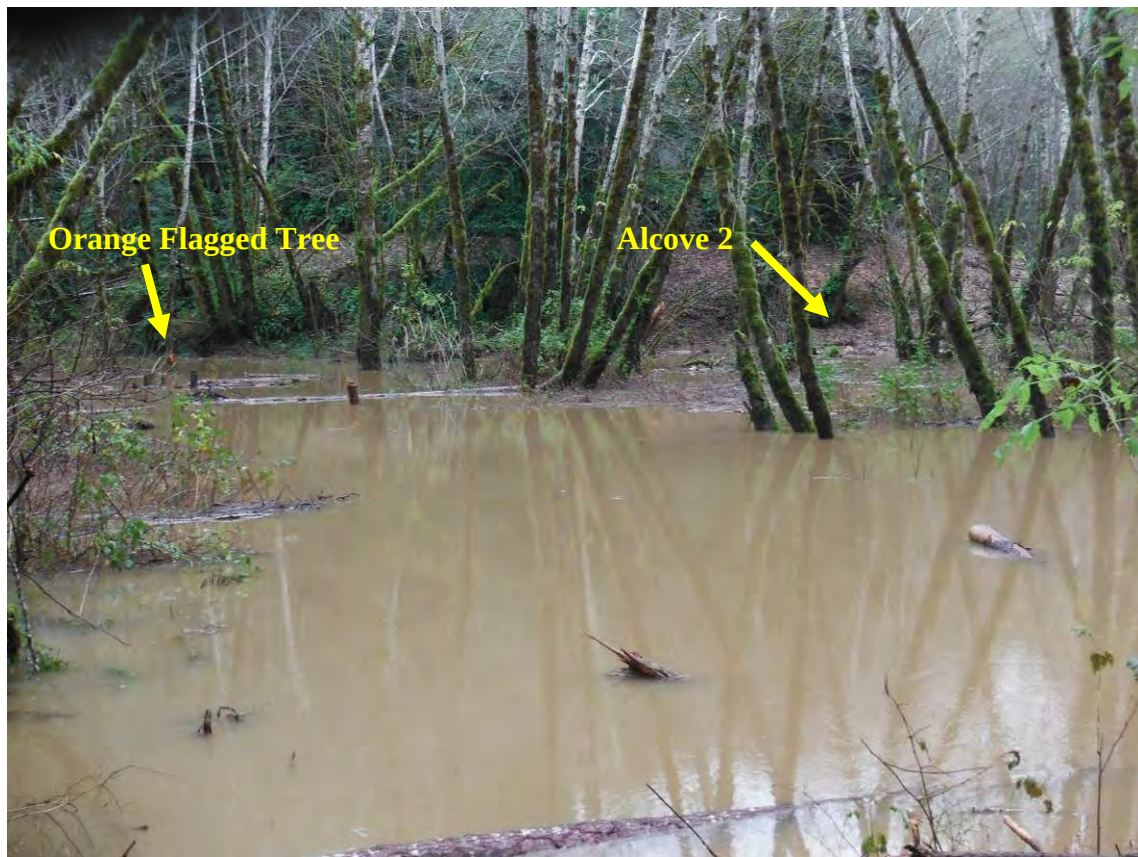
Figure 18. Photographs of McGarvey Creek Alcove II during low winter flows (Top-01/03/13) and during a Klamath River backwater flood event (Bottom-11/29/12).

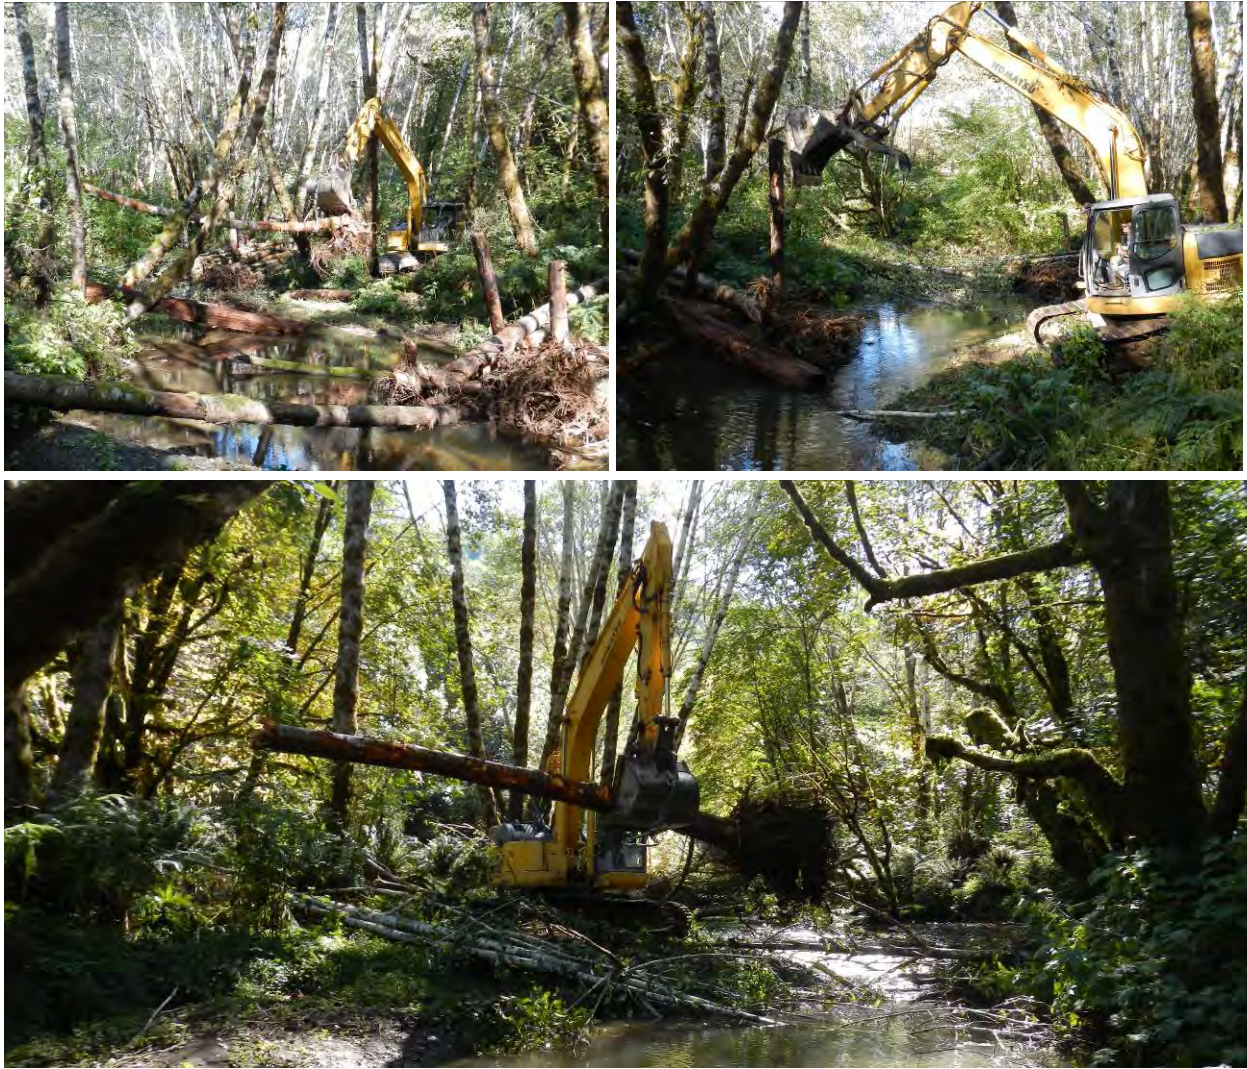
Figure 19. Rocco Fiori (Fiori GeoSciences) building constructed wood jams in McGarvey Creek, 2013 (Upper Left – Weaving a log with rootwad attached into riparian trees; Upper Right – setting a vertical pile for jam stability; Bottom – placing log with rootwad attached).

In summer 2013, YTFP and FGS installed 12 CWJs and constructed the third off-channel habitat feature (McGarvey Alcove III) in the Lower McGarvey Creek Project Reach (Figures 19-23; Appendix A). McGarvey Alcove III was constructed along the eastern valley side-wall just down valley from a small tributary. McGarvey Alcove III is a fairly large off-channel habitat feature relative to Alcove II and the form is more analogous to an abandoned channel segment. Alcove III is fairly deep throughout its footprint with intermediate to steep sides. The feature was receiving a significant amount of ground water inflow during construction, theoretically emanating from the tributary watershed. Therefore, FGS did not implement any additional measures to promote increased connectivity with the tributary as was done for Alcove II. We are currently monitoring water quality in this feature to help us assess habitat performance and determine if additional actions should be taken to increase surface and ground water inputs. As was done in Alcove II, large and small wood was placed in the alcove to increase salmonid rearing habitat complexity and provide sites for native amphibians to lay eggs, and CWJs were installed in the mainstem to facilitate long-term connectivity with Alcove III (Figures 21-22).

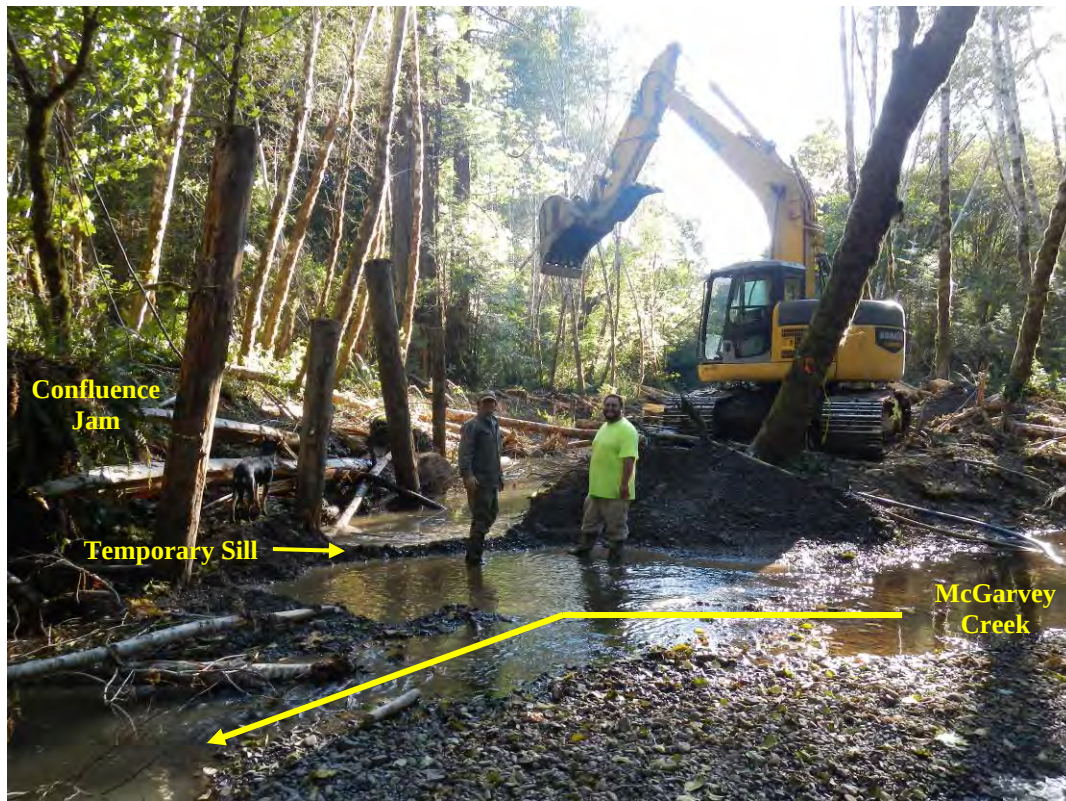
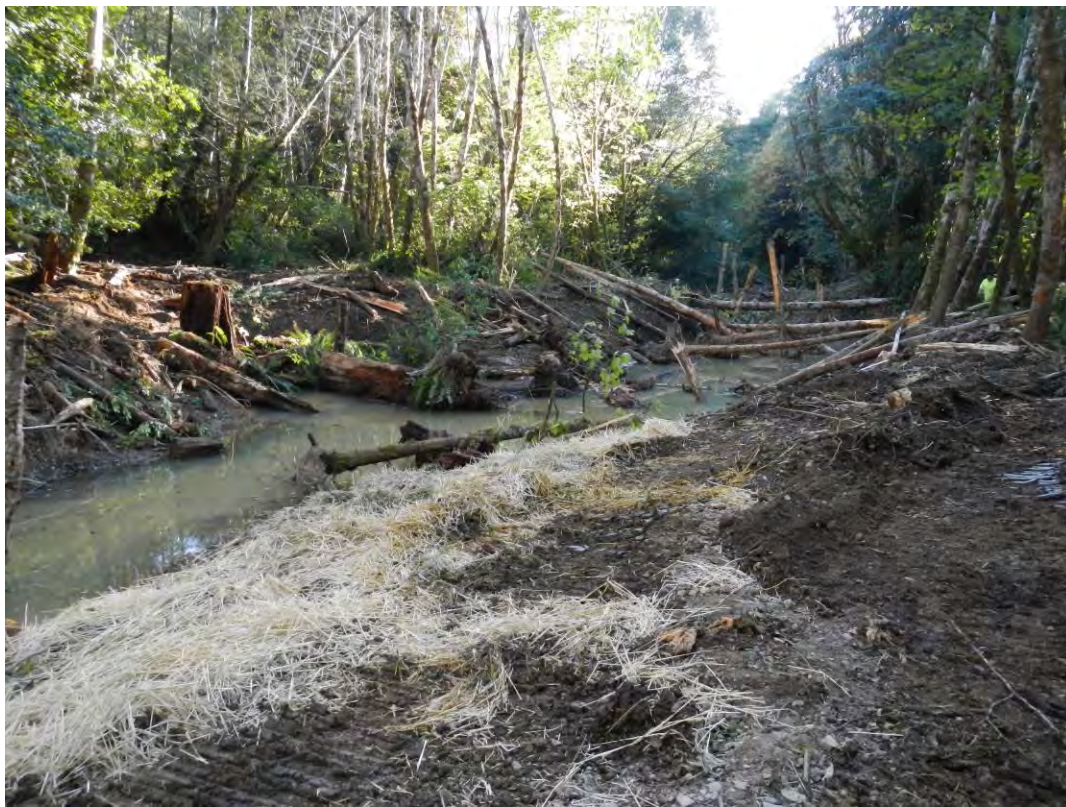
Figure 21. Looking upstream at McGarvey Alcove III during construction, 2013 (Top – alcove outlet prior to connecting the feature to McGarvey Creek; Bottom – alcove during excavation).

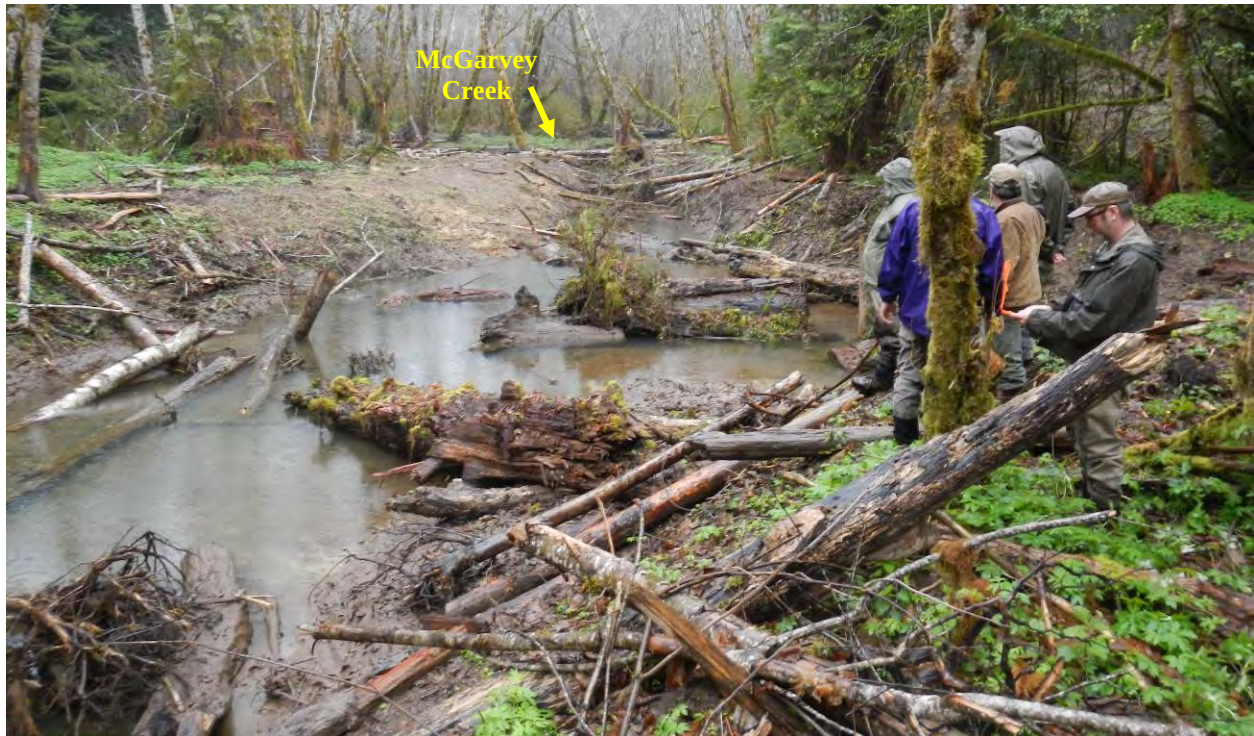
Figure 22. Looking downstream at McGarvey Alcove III post-construction (02/26/14).

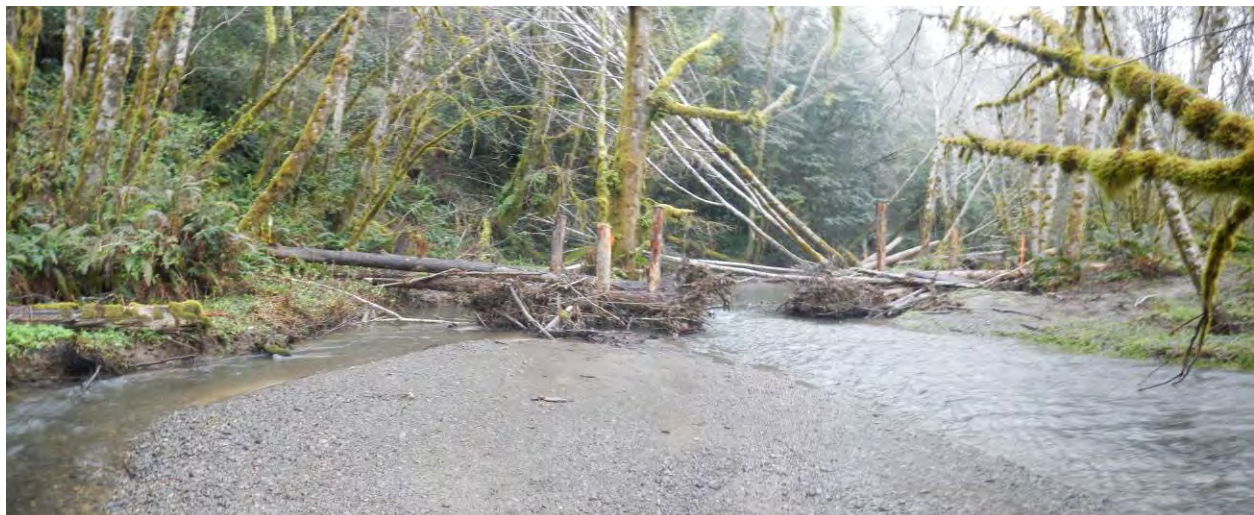
Figure 23. Looking downstream at constructed wood jams (McG\_2013 Sites 4-5) installed in lower McGarvey Creek (02/26/14).
