**Cooperative Restoration of Tribal Trust Fish and Wildlife Habitat in Lower
Klamath River Tributaries**

Prepared by:

Sarah Beesley
Yurok Tribal Fisheries Program
PO Box 339
Klamath, CA 95548

Summer 2008

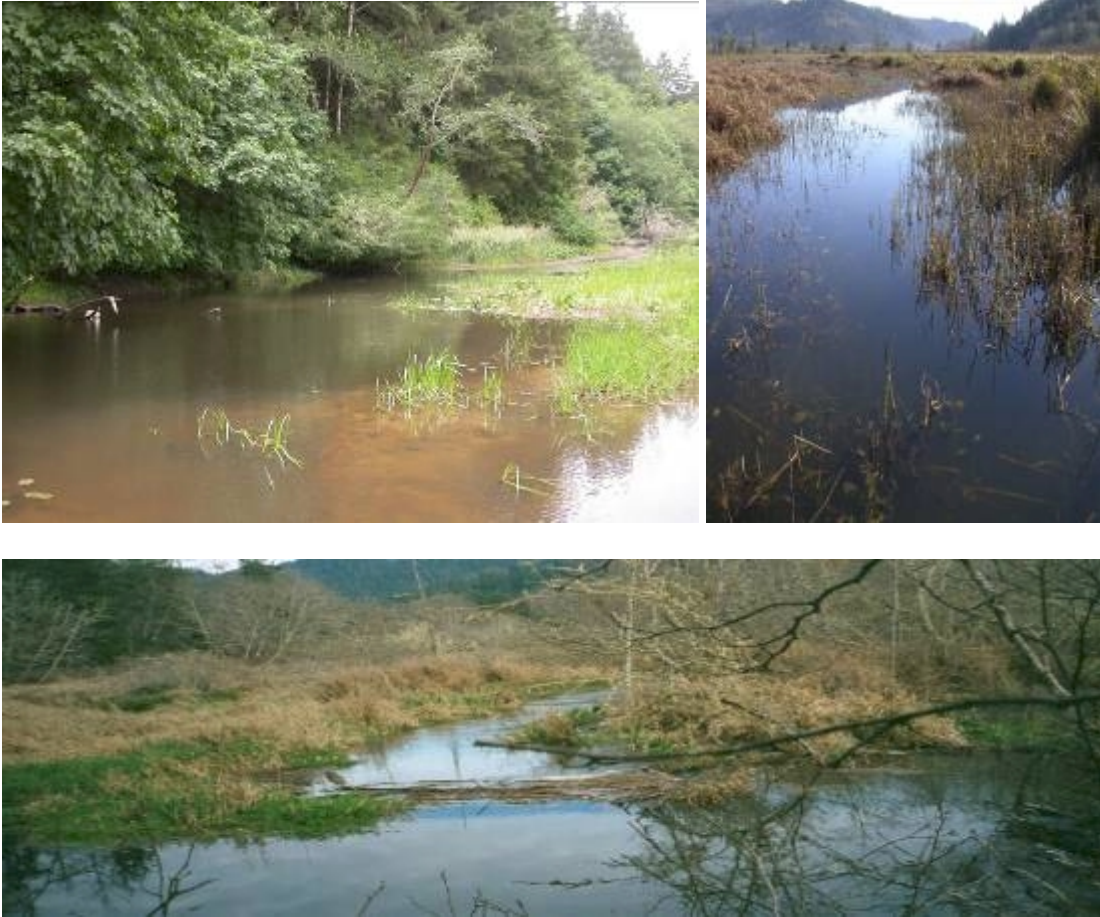
Figure 4. Photographs of the channel and marsh habitats of Salt Creek, Lower Klamath River Sub-basin, California (2002 - 2003).

Salt Creek is the lower-most anadromous tributary to the Klamath River, entering the estuary less than one mile upstream of the Pacific Ocean (Figure 3). The watershed is comprised of a diverse range of habitats including the deep ponds and shallow marshes of Salt Creek (Figure 4) and the alluvial reaches of High Prairie Creek (Salt Creek's major tributary) (Figure 5). Salt Creek provided a unique opportunity to examine conditions affecting salmonid habitats in an off-estuary watershed affected by beaver activity, wetland expansion, agricultural use, and upslope land use activities that result in excessive sediment yield. YTFP has produced

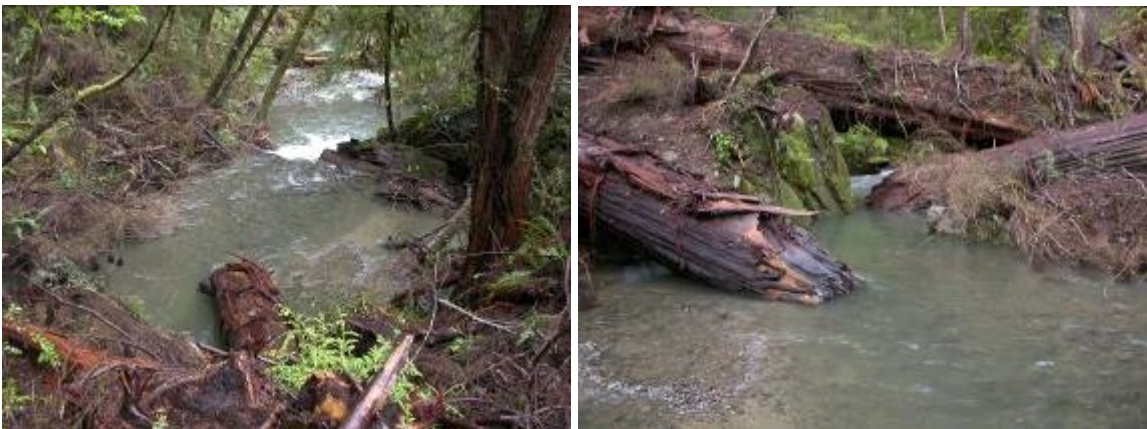
Figure 5. Photographs of a large wood accumulation in High Prairie Creek, Lower Klamath River Sub-basin, California (2004).

Another priority restorative action for High Prairie Creek includes protecting and enhancing large wood accumulations in the fluvial corridor of this drainage (Figures 5 – 6). These large wood accumulations retain significant amounts of channel stored sediment, meter sediment delivery to downstream habitats, and facilitate the formation of complex stream and riparian habitats. Although many of the large wood accumulations identified by Beesley and Fiori (2004) hindered fish passage at low flows, the benefits provided by these structures is essential to the existence and maintenance of the anadromous habitats in High Prairie Creek and the wetlands located in Salt Creek. Protecting and enhancing large wood accumulations within the fluvial corridor and addressing road related impacts in this drainage should alter sediment delivery and storage dynamics and facilitate the long-term success of future stream and wetland restoration programs.

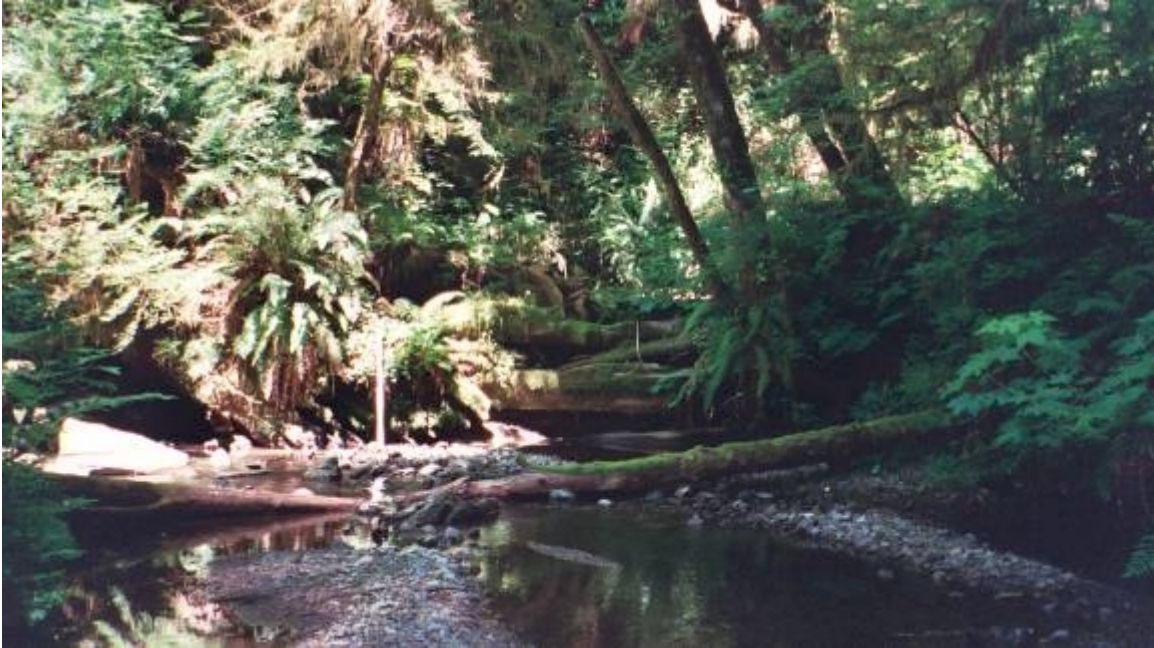
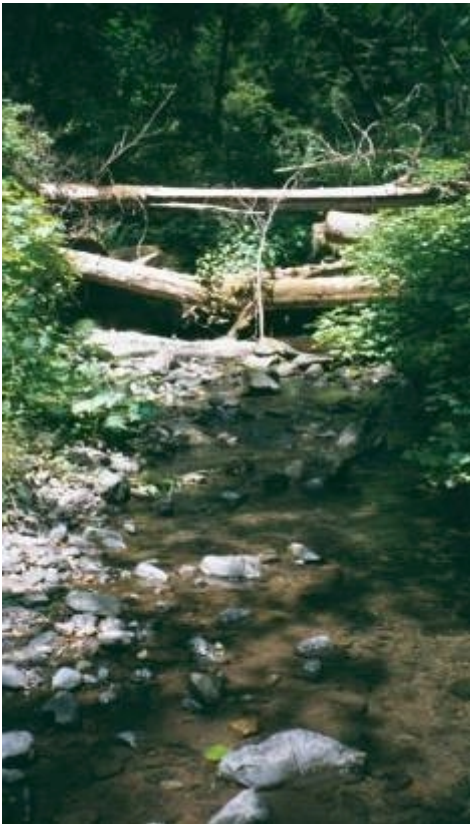
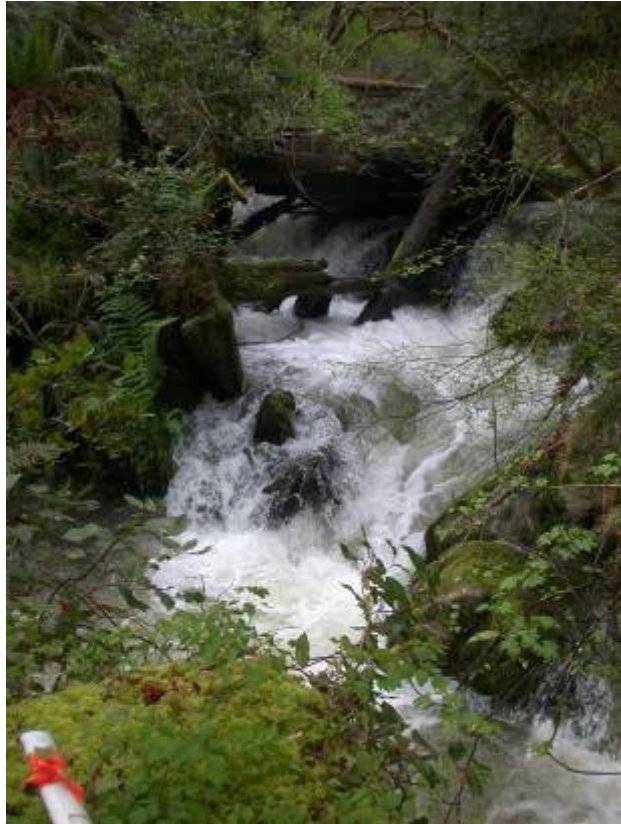
Figure 6. Examples of large wood accumulations located in High Prairie Creek, Lower Klamath River Sub-basin, California (2002 – 2003).

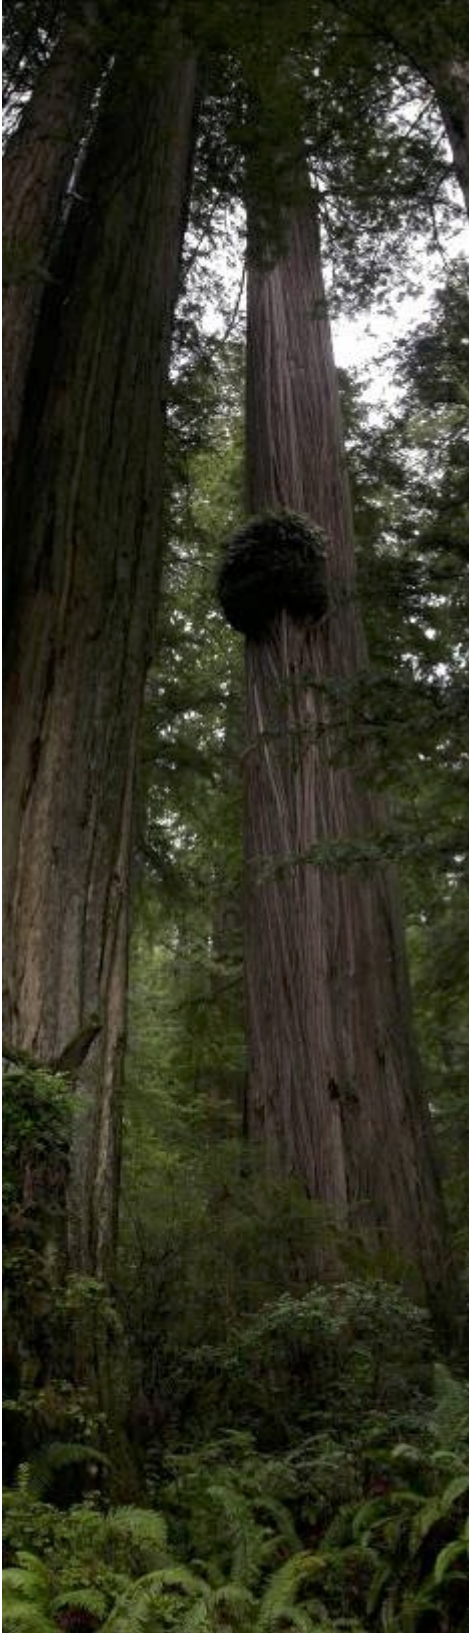
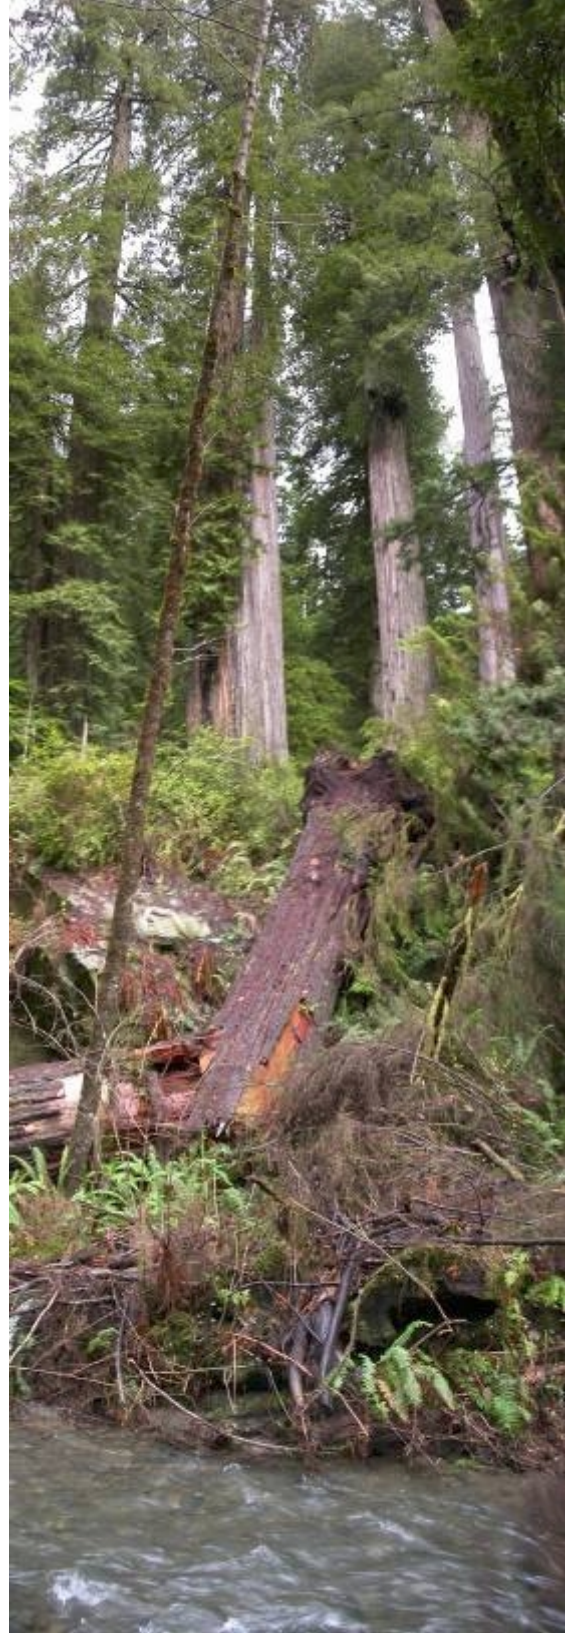
Figure 7. Mature conifer stands of the Yurok Redwood Experimental Forest located in High Prairie Creek, Lower Klamath River Sub-basin, California (2004).

The Yurok Redwood Experimental Forest (YREF) is a 1.46 square mile U.S. Forest Service research area located in High Prairie Creek. The YREF was established in 1940 to conduct silvicultural research on coastal redwoods (Figure 7) (USFS 1990). Approximately 45 percent of the experimental forest was clearcut between 1956 and 1985. However, a research and natural area was established in the YREF that comprises 16 percent of the total forest area. Ecological survey data for the research and natural area is presented in Taylor (1982).

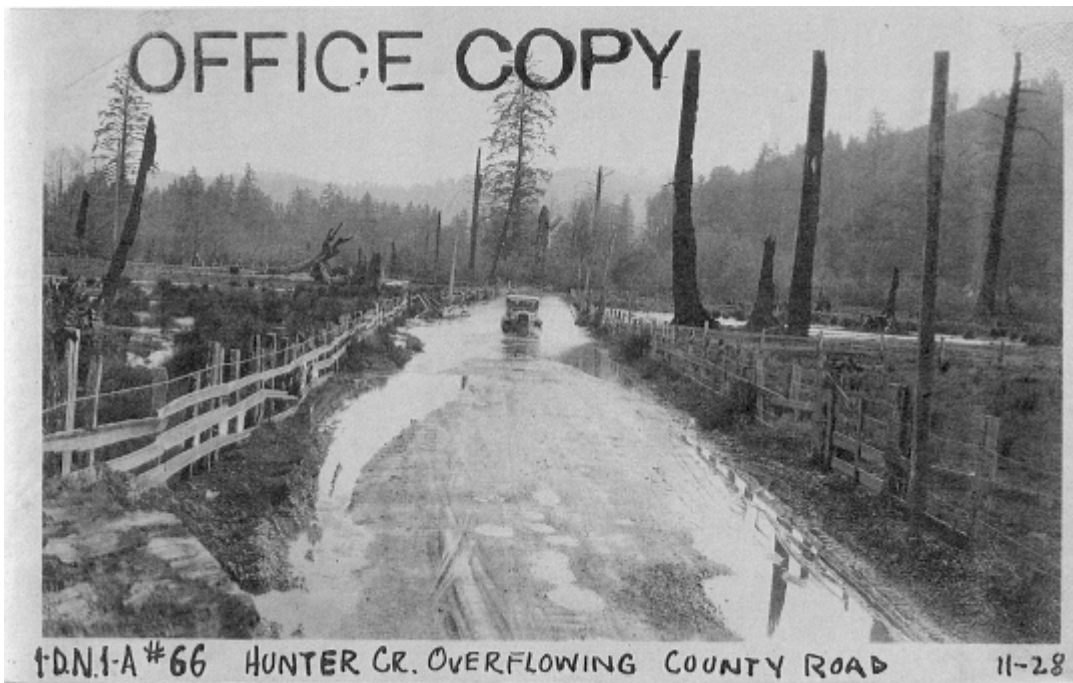
Figure 13. A historic photograph of lower Hunter Creek and Salt Creek in the vicinity of Requa, Lower Klamath Sub-basin, California (Provided by the California Department of Transportation, November 1928).

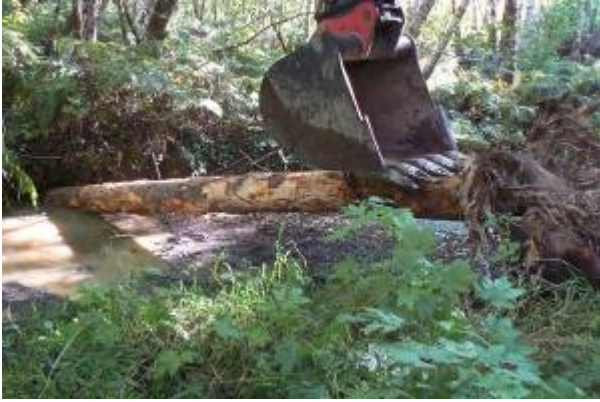
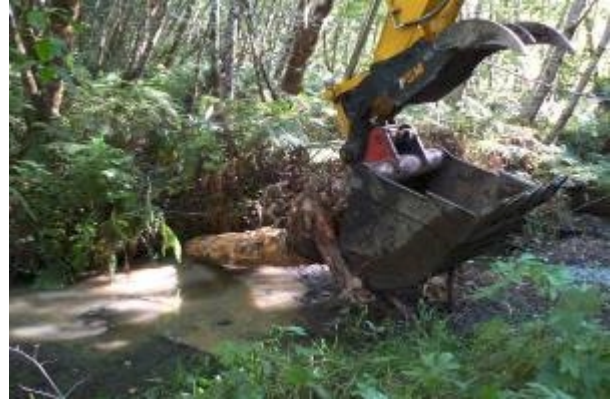
a. Using an excavator to insert large wood into the bank.

Figure 14. Examples of large wood placement techniques implemented in West Fork McGarvey Creek during summer 2007, Lower Klamath River Sub-basin, California.

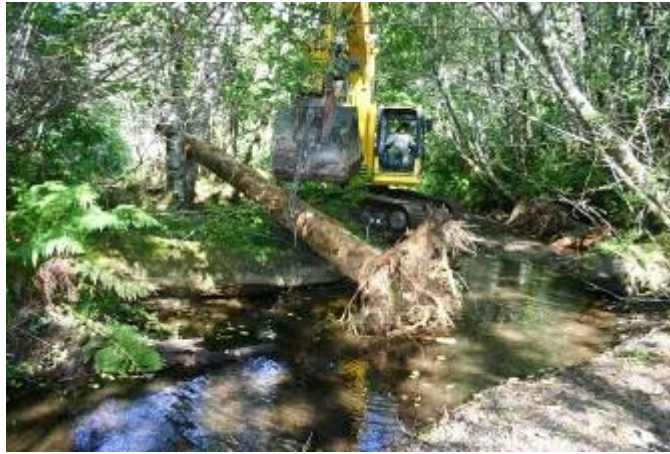
b. Using an excavator to wedge large wood into existing vegetation.
