Lower Terwer Creek Emergency Streambank Stabilization Project

California Department of Fish and Game
FY 2005 Adaptive Management Funding
PSMFC Grant Agreement #AWIP-N-32

February 25, 2006

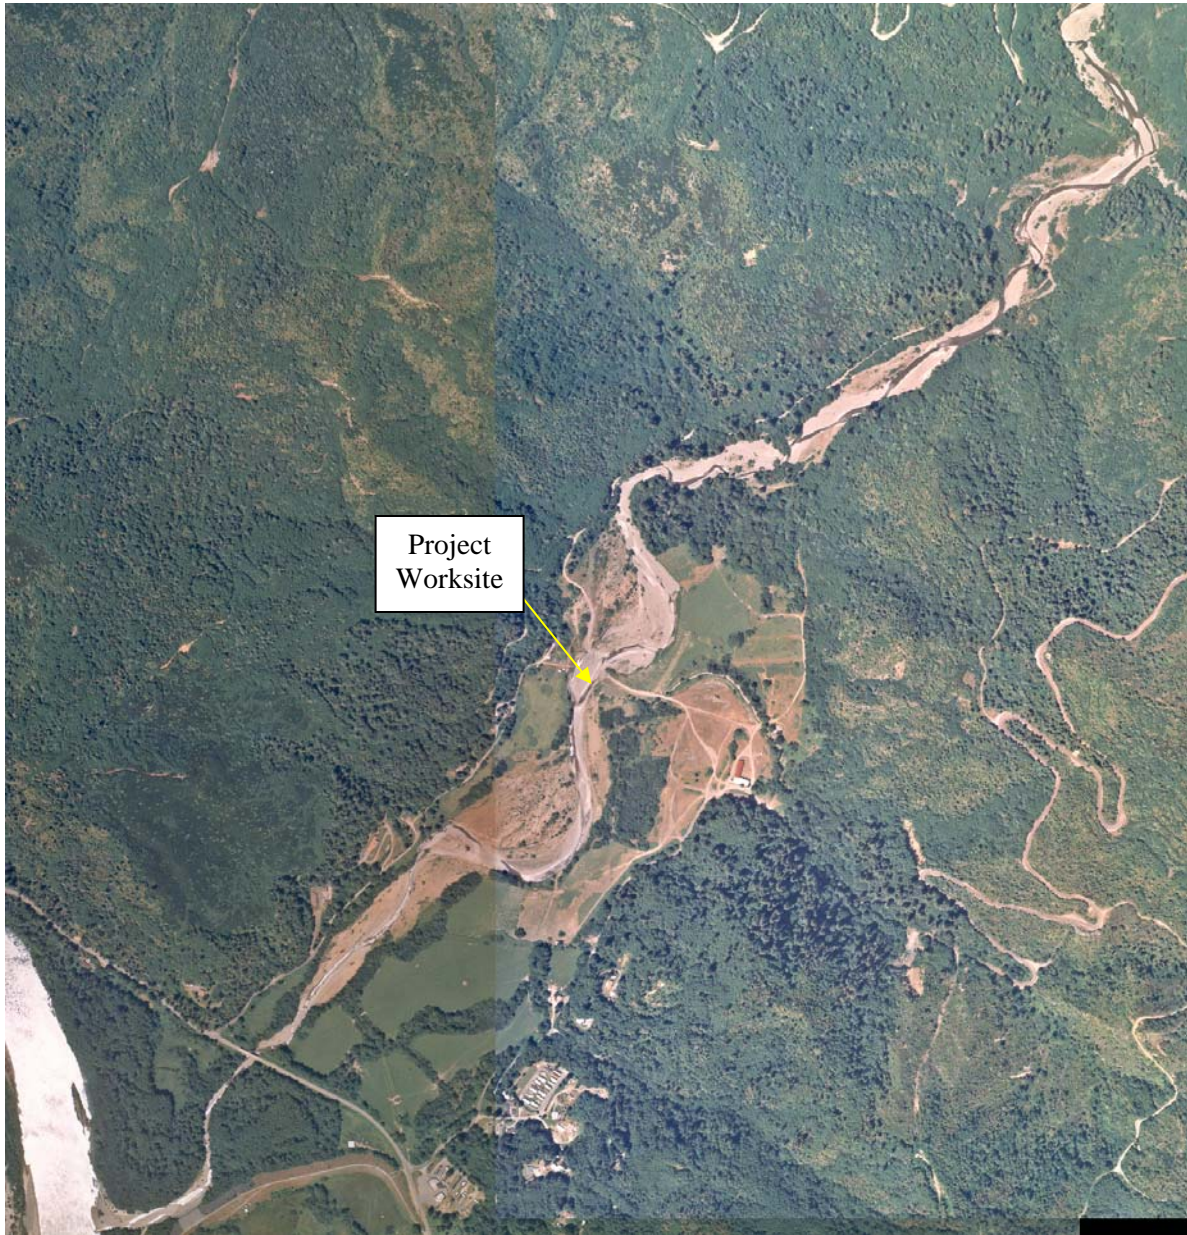
Figure 2. Aerial view of the lower 3.0 miles of Terwer Creek,
Lower Klamath River, California, 1997.

Terwer Creek is a fourth order stream that drains approximately 31.8 sq. miles of coniferous-forested mountains. The headwaters originate at an elevation of 1,600 ft. and flows southerly 13.9 miles, through mostly steep, highly confined stream channels. Terwer Creek is moderately to highly confined throughout most of its course, with “B” and “C” channel types dominant throughout (see Rosgen 1994 for channel type descriptions). The lower portion of the creek flows through a broad floodplain past the community of Klamath Glen (Figures 2-3). The Terwer Creek watershed supports anadromous populations of chinook salmon, coho salmon, steelhead trout, coastal cutthroat trout and Pacific lamprey. The East Fork is the largest tributary in the drainage, supporting populations of coho salmon, steelhead and coastal cutthroat trout.

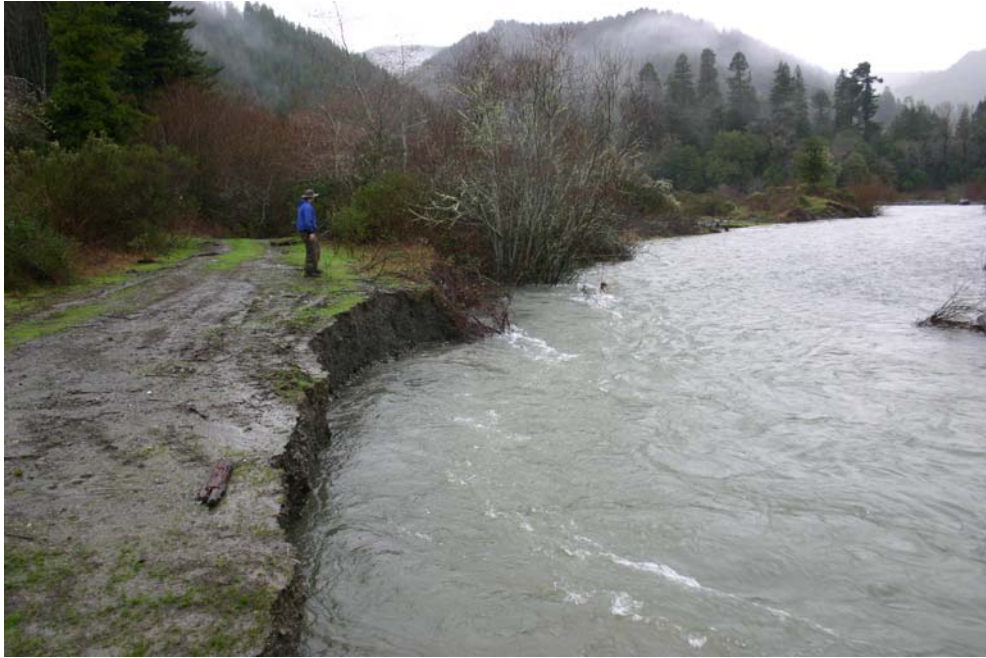
Figure 4. Streambank erosion at upper half of project site, Lower Terwer Creek , Lower Klamath River, California, January 20, 2006.

This project funded the purchase of boulders for emergency stabilization and protection of 100 feet of actively eroding streambank in Lower Terwer Creek on Ken Farley’s property. Repeated high flow events during this past winter (2005-2006) resulted in a 100’ stretch of streambank on Mr. Farley’s property to rapidly erode, resulting in over ten feet of lateral bank erosion and threatening to erode Mr. Farley’s access road to the north end of his property. The sudden loss of streambank in the 100-foot reach resulted in an emergency field visit between Mr. Farley and CDFG and YTFP staff to identify what measures could be taken to stabilize the bank until this summer when additional structure and bioengineering work can be implemented. It was agreed that the best approach is to place boulders along the eroding bank now to curb the bank erosion, with the plan of

repositioning this rock during summer 2006 dry stream channel conditions when the entire reach will be restored using bioengineering and log-boulder revetment methods.

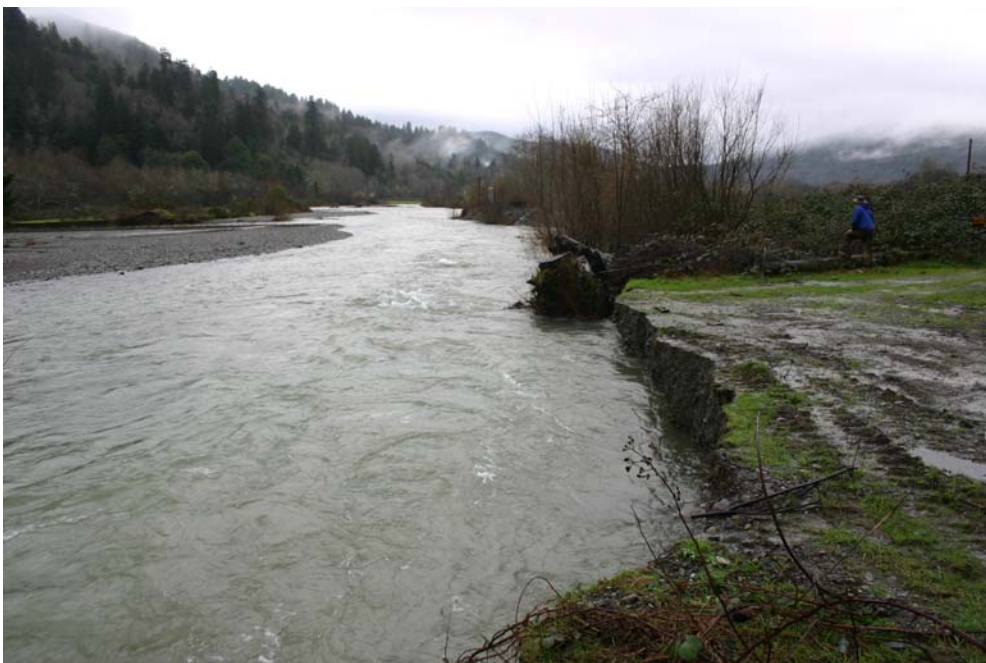
Figure 5. Streambank erosion at lower half of project site, Lower Terwer Creek , Lower Klamath River, California, January 20, 2006.

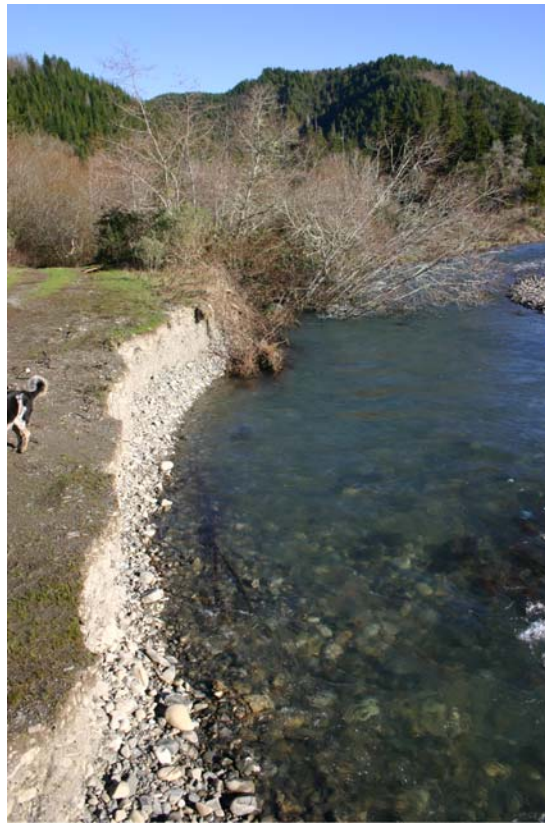
Figure 6. Streambank erosion at project site, Lower Terwer Creek ,
Lower Klamath River, California, January 24, 2006.

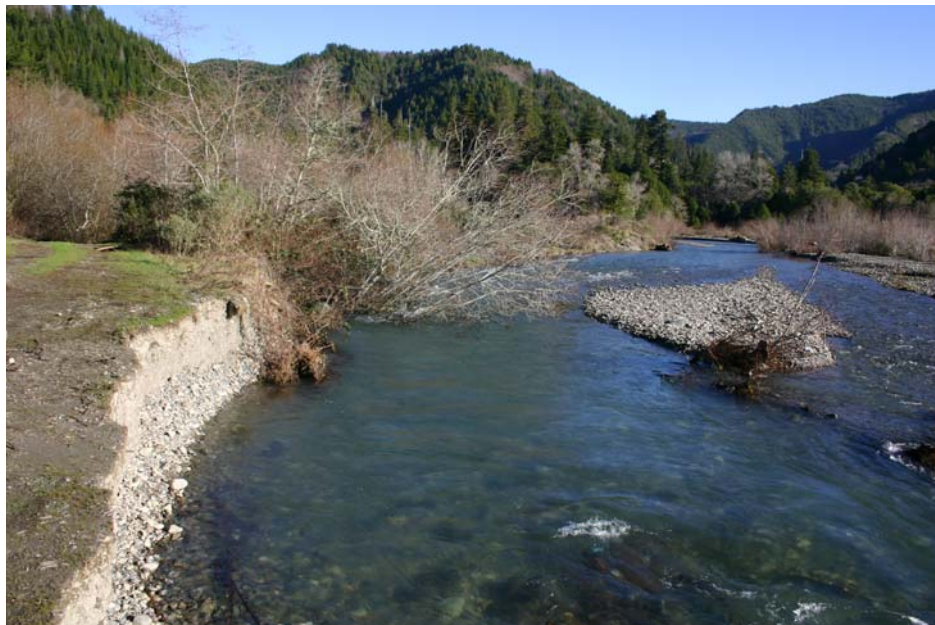
Figure 7. Streambank erosion at upper half of project site, Lower Terwer Creek ,
Lower Klamath River, California, January 24, 2006.

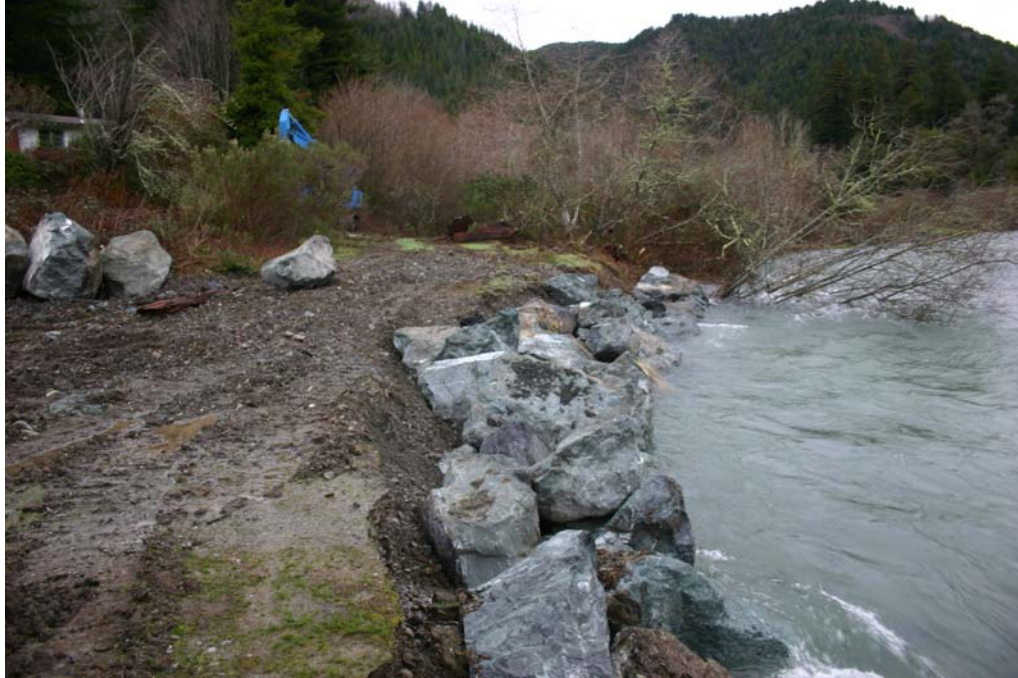
Figure 8. Upper half of project site during boulder placement, Lower Terwer Creek , Lower Klamath River, California, January 31, 2006.

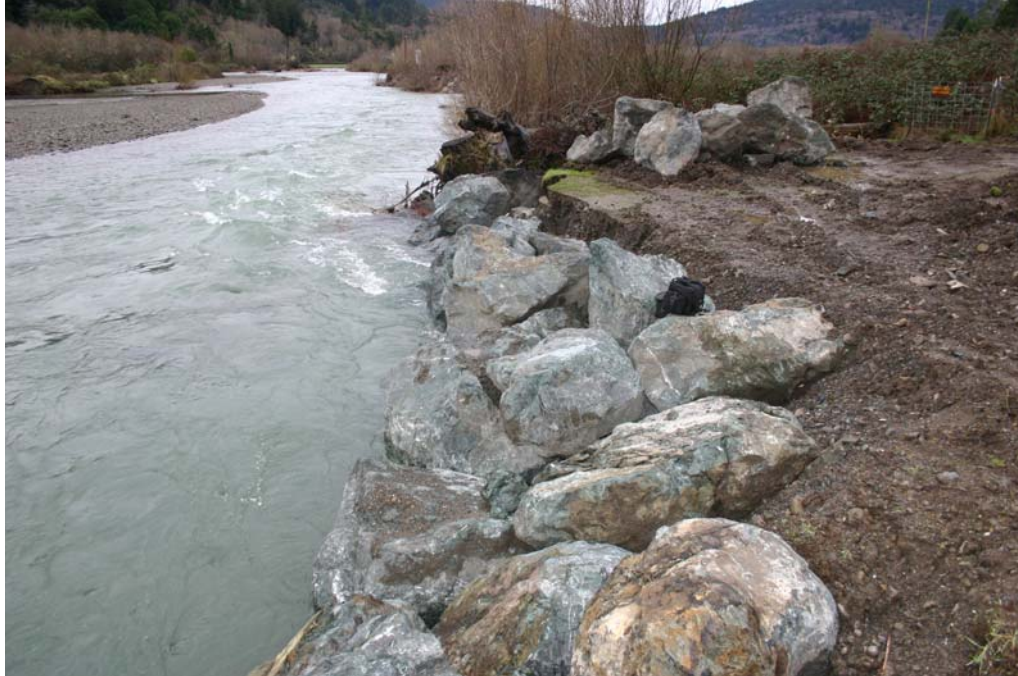
Figure 9. Lower half of project site during boulder placement, Lower Terwer Creek , Lower Klamath River, California, January 31, 2006.

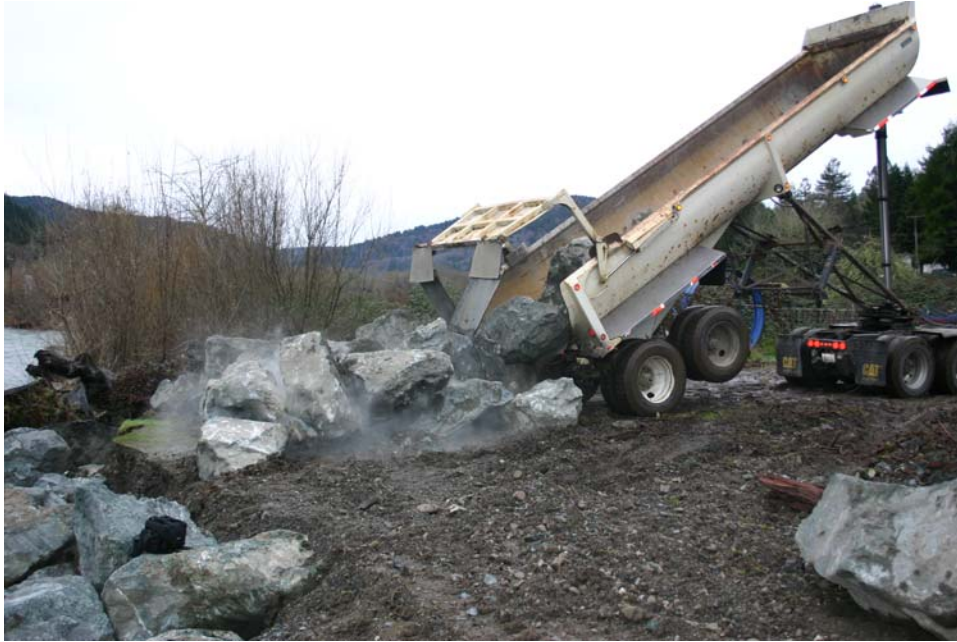
Figure 10. Boulders being delivered to project site, Lower Terwer Creek , Lower Klamath River, California, January 31, 2006.

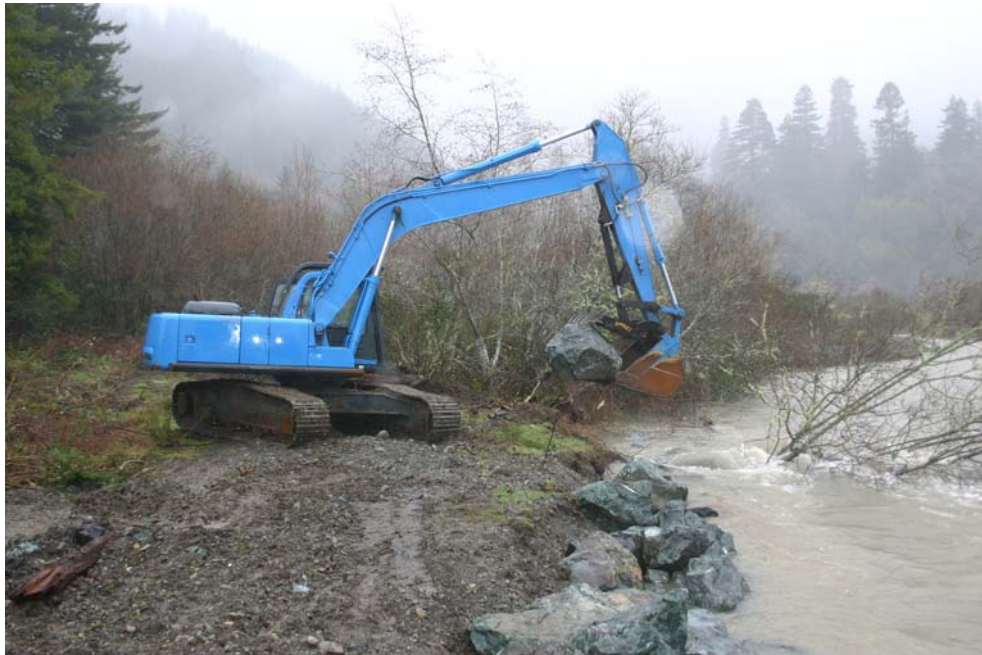
Figure 11. Excavator placing boulders at project site, Lower Terwer Creek , Lower Klamath River, California, February 01, 2006.

YTFP worked in conjunction with the Yurok Tribe Watershed Restoration Department (YTWRD) to place 200 tons of boulders on the eroding streambank. All boulder placement occurred with an excavator, which operated from Ken Farley's road immediately adjacent to (and affected by) the eroding streambank (Figure 11). We placed boulders along the affected streambank up to the level of the adjoining road to minimize any additional erosion or lateral stream channel migration.

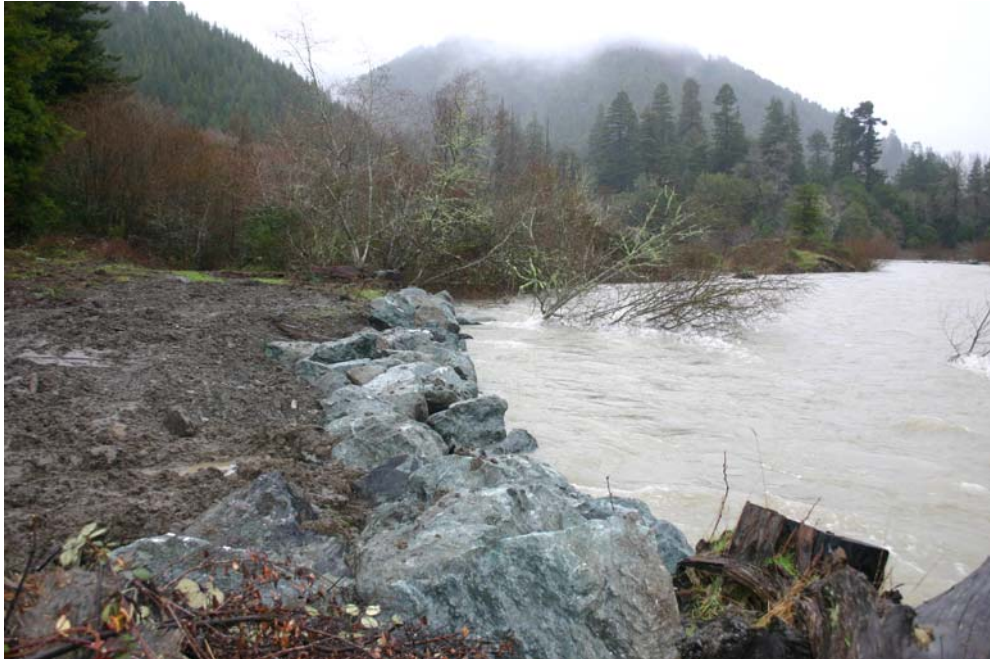
Figure 12. Stabilized streambank viewed from lower end of project site, Lower Terwer Creek ,Lower Klamath River, California, February 01, 2006.

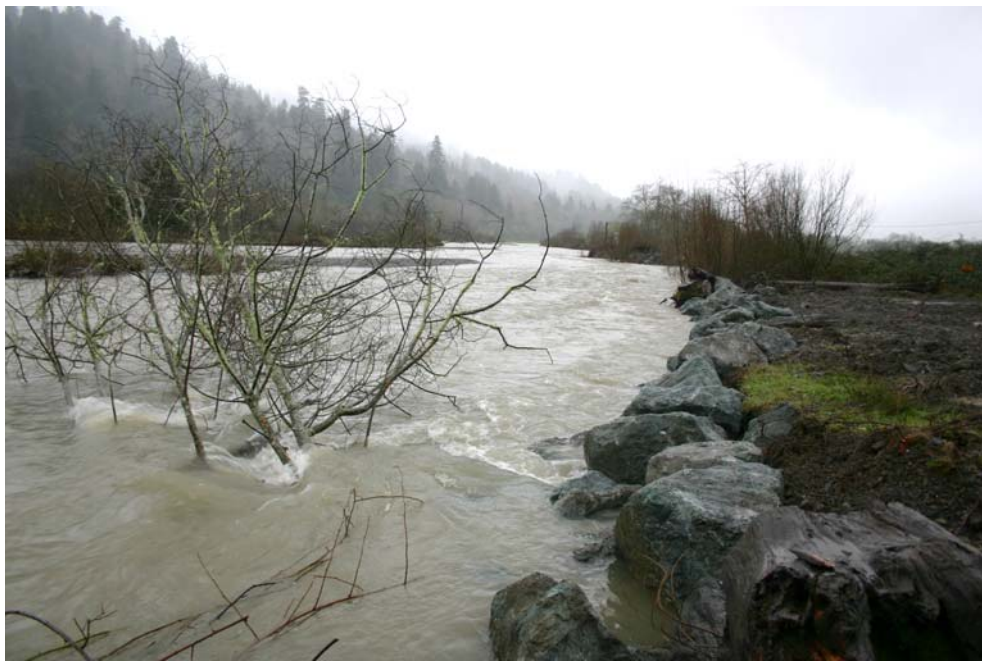
Figure 13. Stabilized streambank viewed from upper end of project site, Lower Terwer Creek ,Lower Klamath River, California, February 01, 2006.

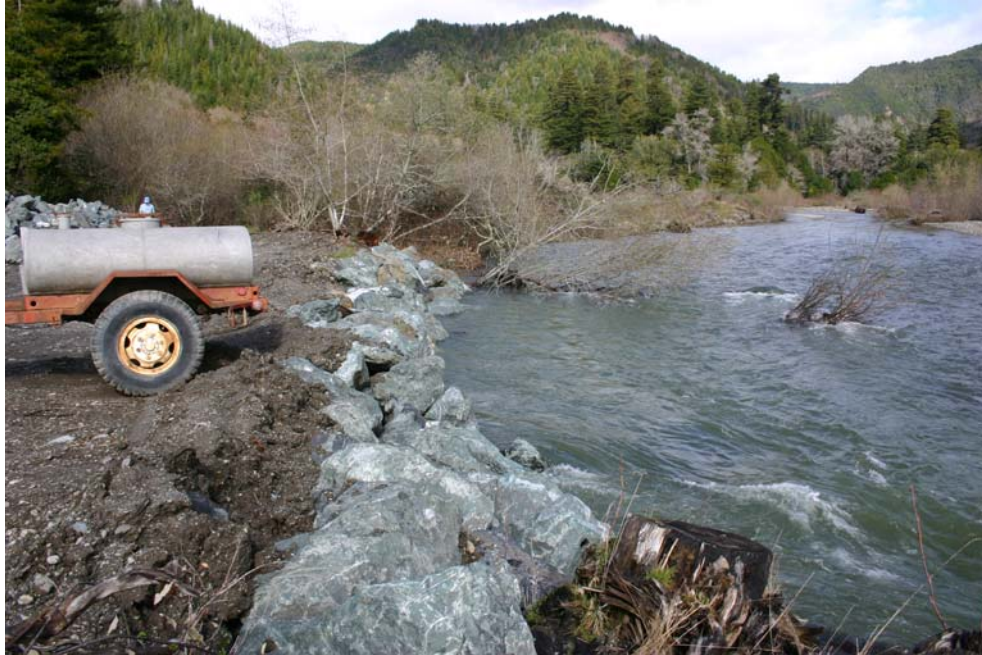
Figure 14. Stabilized streambank viewed from lower end of project site, Lower Terwer Creek, Lower Klamath River, California, February 28, 2006.

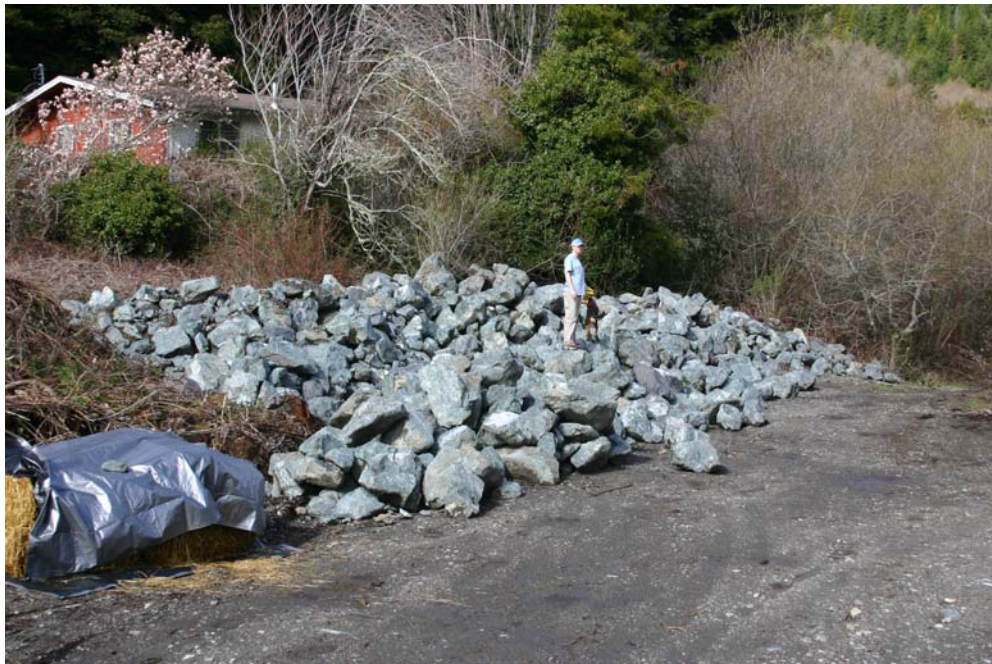
Figure 15. Stockpiled boulders at project site, Lower Terwer Creek, Lower Klamath River, California, February 28, 2006.

An additional 275 tons of boulders were stockpiled on the site to allow for rapid treatment of any additional erosion problems that may occur during the remainder of the winter and spring. Any surplus stockpiled rock will be utilized this summer when the bioengineering and structure placement work occurs in this project area.
