Arcata Fisheries Data Series Report DS 2013-33

Age 0 Chinook and Coho Salmon Rearing Habitat Assessment of Lowden Meadows, Reading Creek, and Trinity House Gulch Rehabilitation Sites 2009-2011, Upper Trinity River

Aaron Martin, Damon H. Goodman, and Justin Alvarez

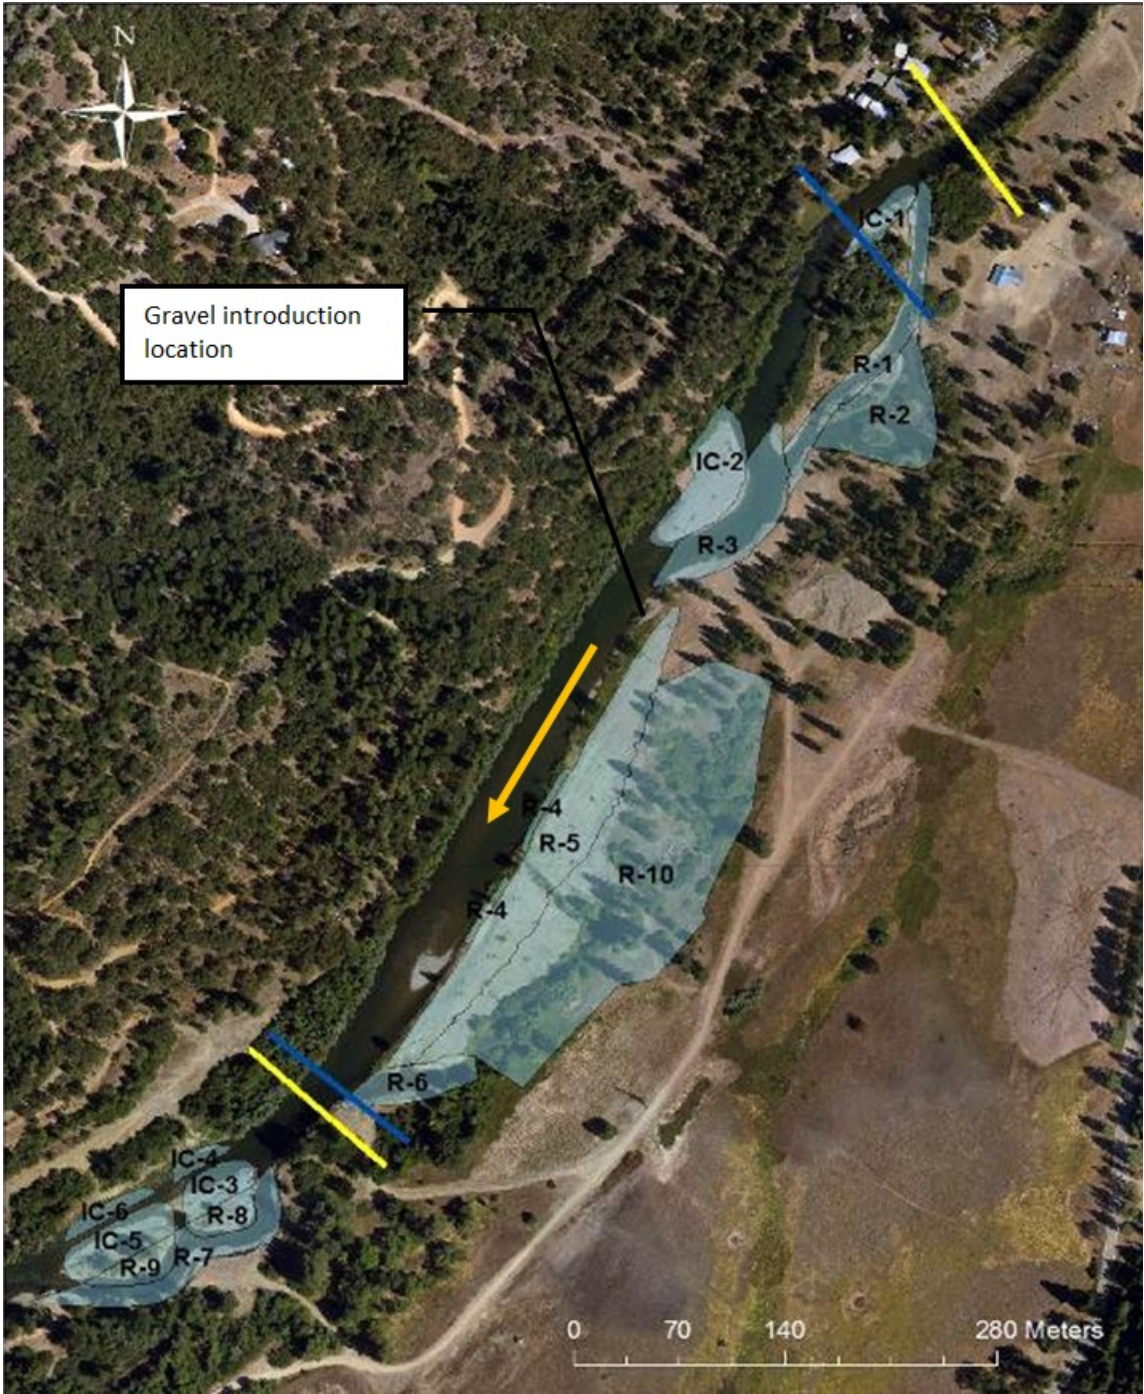
Figure 2. Aerial view of Lowden Meadows rehabilitation site design elements and habitat survey extents. Yellow lines indicate pre- and post-construction winter base flow mapping extents. Dark blue lines indicate pre- and post-construction multiple flow to habitat mapping extents. The orange arrow indicates flow direction.

The habitat assessment evaluated the upper 800 m of river channel (rkm 169.2-168.4; Figure 2). Pre- and post-construction mapping occurred at 5 flows between 8.7 cms (307 cfs) and 62.1 cms (2,193 cfs) during the late spring and summer months of 2009 and 2011 respectively. When preconstruction mapping was initiated during the spring of 2009, final construction designs were not available. Therefore, construction boundaries were estimated and the lower anastomosing islands were not included in the assessment. Features evaluated for changes in habitat in this report include the R-1 side channel, the R-2 off-stream rearing pond, the R-3 main channel realignment, the R-6 alcove, and the mainstem section adjacent to the R-4 low bench.

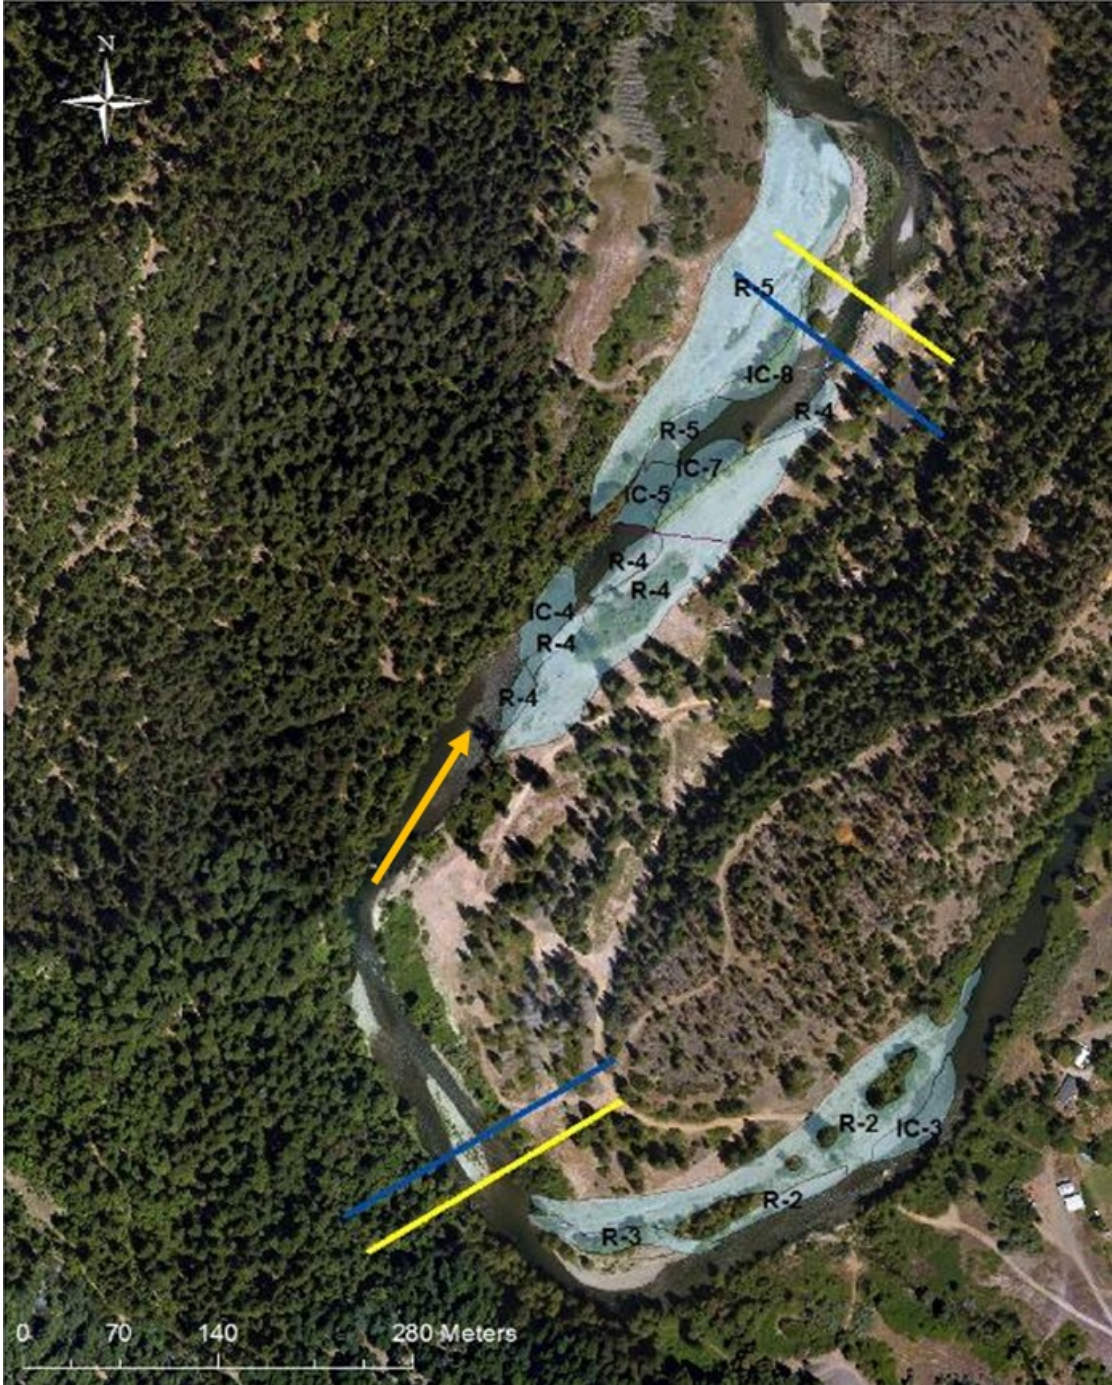
Figure 3. Aerial view of Reading Creek rehabilitation site design elements and habitat survey extents. Yellow lines indicate pre- and post-construction winter base flow mapping extents. Dark blue lines indicate pre- and post-construction multiple flow to habitat mapping extents. The orange arrow indicates flow direction.

The Lower Reading Creek site covers just over 600 m of mainstem channel. It is located just downstream of the Reading Creek confluence (rkm 149) and is adjacent to the Douglas City Campground. The right bank of the site is characterized by mature riparian berms along the campground section and a bedrock wall at the downstream end. The upper section of the left bank has a steep valley wall with some bedrock along the edge and a large terrace dominates the lower left bank of the site (HVT and McBain and Trush 2010). Rehabilitation actions at Reading Creek occurred in two main areas, Upper and Lower Reading Creek. During the time of pre-construction mapping it was unclear as to what, if any, type of rehabilitation work would occur within the Upper Reading Creek site. Habitat monitoring of pre- and post-construction conditions occurred within the Lower Reading Creek site only. The habitat assessment evaluated 745 m of river channel (rkm 149.5-148.8; Figure 3) at five flows ranging from 9.9 to 69.4 cms (348 – 2,451 cfs) during the late spring and summer months of 2009 and 2011. The upper 200 m that was mapped included the section of river that had no mechanical actions. Features evaluated for changes in habitat in this report include area R-4 low flow benches, the IC-4 and IC-5 transverse bars, IC-6 and IC-7 constructed point bars, and area R-5 which consisted of a forced meander, feathered edge, and a high flow scour channel (HVT and McBain and Trush 2010). The mapping did not incorporate the downstream end of the rehab site where the R-5 high flow scour channel connected to the mainstem through the alcove.

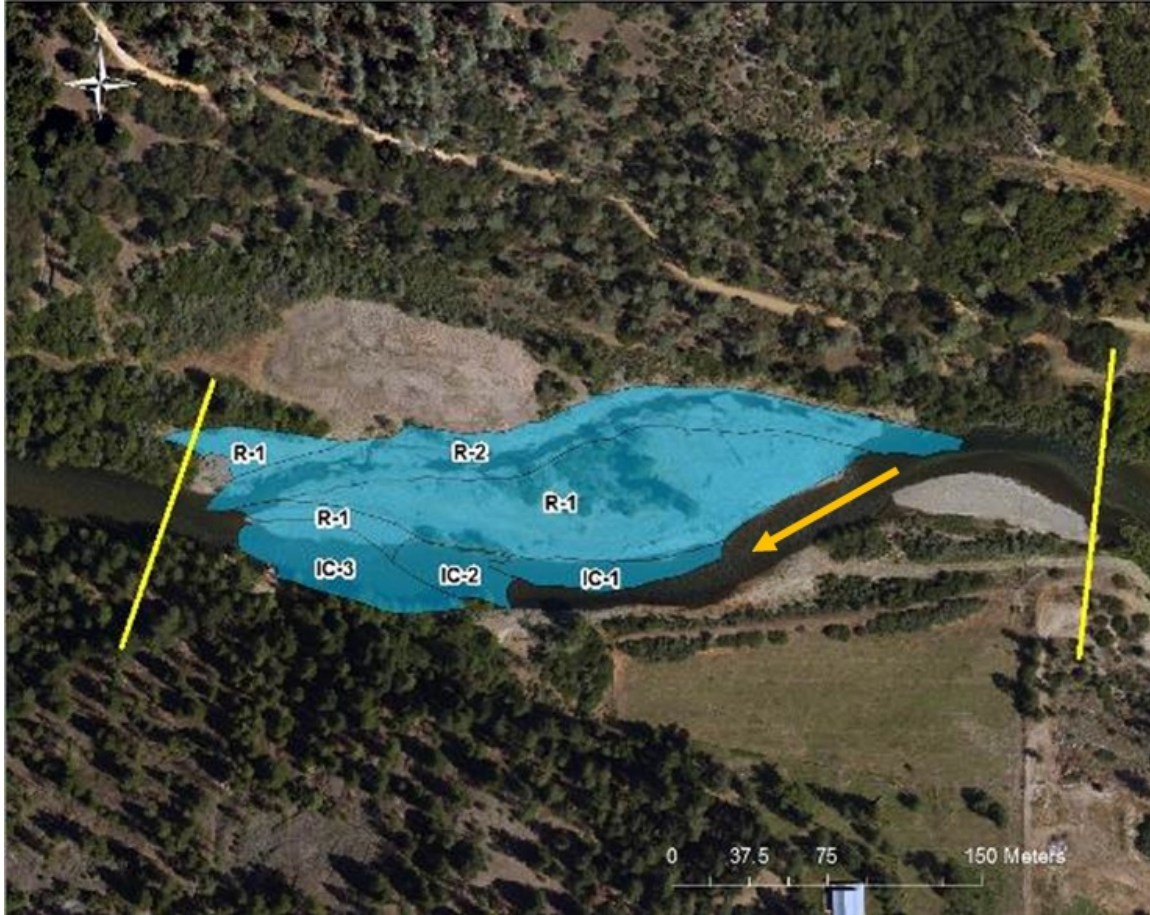
Figure 4. Aerial view of Trinity House Gulch rehabilitation site design elements and habitat survey extents. Yellow lines indicate pre- and post-construction summer base flow mapping extents. The orange arrow indicates flow direction.

The THG rehabilitation site extends along 400 m of mainstem channel. THG is located just downstream of the Grass Valley Creek confluence (rkm 167.6). Prior to construction the right bank of the site was described as a high terrace with dredger tailings that terminated at the downstream end at the THG confluence. The left bank of the site has a levee built to protect a private landowner's property along the upper half and had heavily vegetated banks on the downstream half. Rehabilitation actions at THG included the IC-1 and IC-3 gravel bar additions, construction of the R-1 forced meander, floodplain lowering at R-1 and construction of the R-2 low flow side channel (HVT and McBain and Trush 2010). The location of the THG rehabilitation site coincided with GRTS site 39 in Panel 3 of the systemic habitat assessment (Alvarez et al. 2013). Pre and post-construction/post 2011 spring release base flow mapping of THG was accomplished by adding 50 m to the bottom end of GRTS 39 in 2010 and 2011. The habitat assessment covered the entire area of rehabilitation (rkm 167.9-167.5; Figure 4) at a summer base flow discharge of 14.3 cms (505 cfs) pre-construction and 13.6 cms (480 cfs) post-construction.

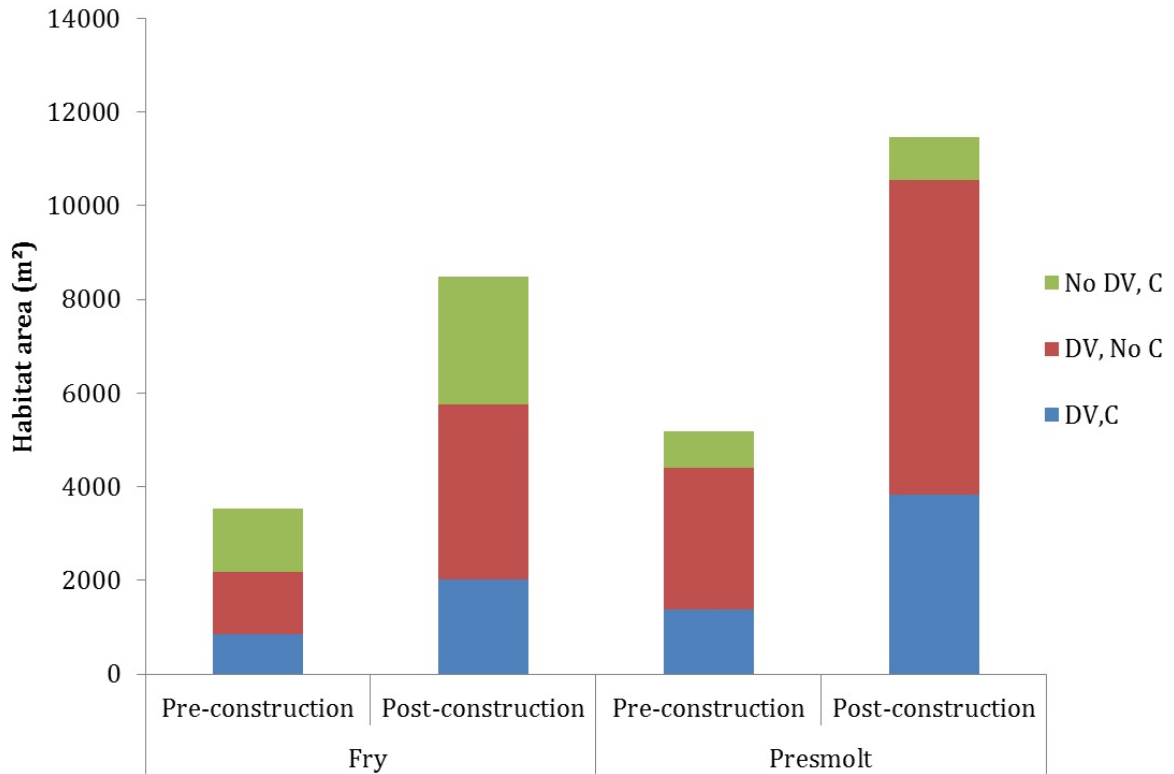
Figure 5. Chinook and Coho salmon rearing habitat quantities at the entire Lowden Meadows rehabilitation site (rkm 168.4-169.2). Pre-construction estimates were conducted at 8.7 cms (307 cfs) in 2009 and post-construction at 8.8 cms (311 cfs) in 2011. Habitat categories correspond to combinations of depth/velocity and in-water escape cover criteria.

Pre-construction rearing habitat surveys were conducted at the Lowden Meadows site during the late winter and spring of 2009. A winter base flow map 816 m long was produced at a discharge of 8.7 cms (307 cfs). The base flow post-construction assessment was conducted in the fall of 2011 at a discharge of 8.8cms (311cfs). At winter base flow, total fry and presmolt rearing habitat across the whole site increased by 140% and 121% respectively post-construction (Figure 5). Optimal

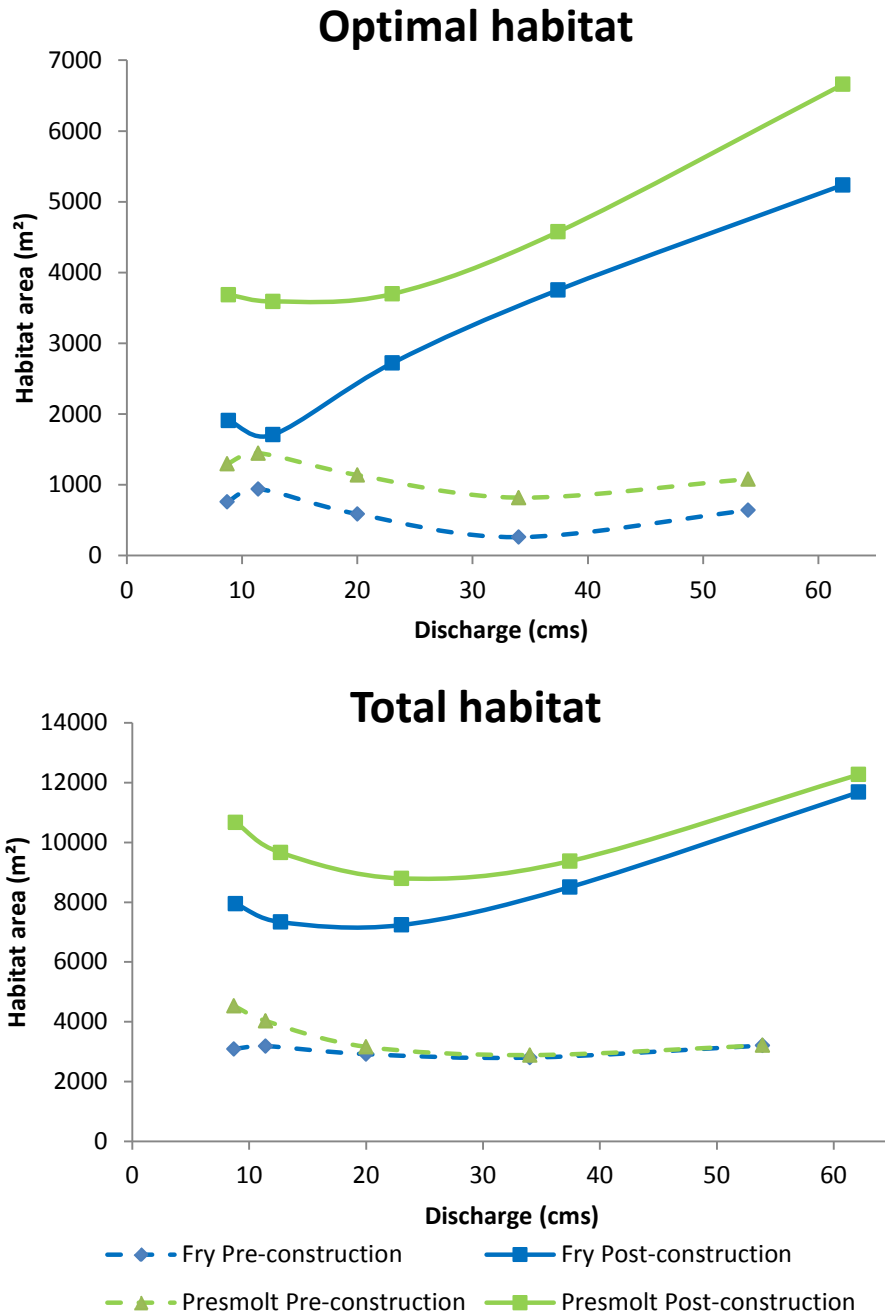
Figure 6. Estimates of Chinook and Coho salmon rearing habitat by streamflow at Lowden Meadows (A) rehabilitation site. Optimal Chinook and Coho salmon habitat was defined as areas within depth/velocity and in-water escape cover (DV,C) criteria. Total Chinook salmon rearing habitat (total habitat) was defined as areas that met any combination of depth/velocity or in-water escape cover criteria. The fry life stage is defined as fish <50 mm FL and presmolt as 50>X<100 mm FL.

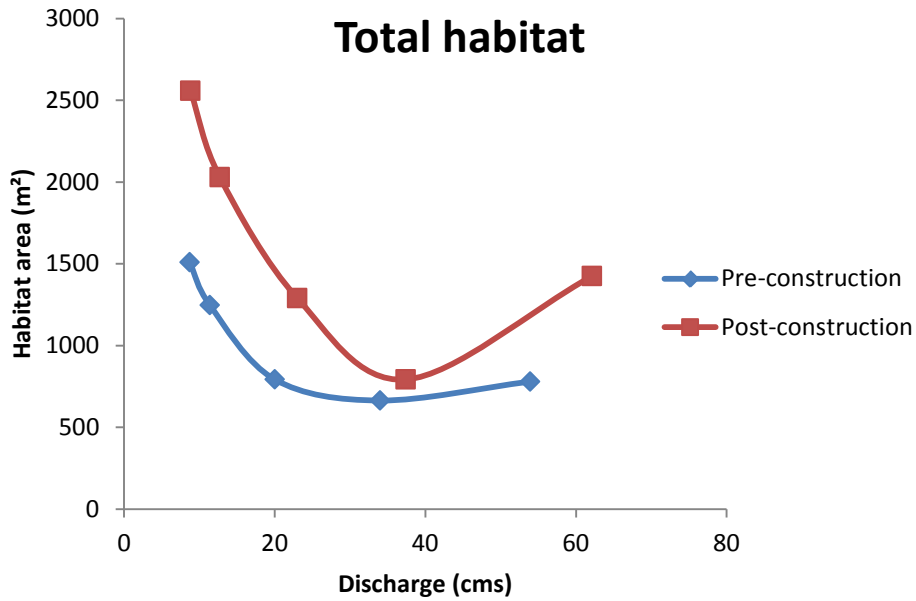
Figure 10. Total presmolt habitat before and after construction around the mid-channel bar formed near the R-4 low bench within the area highlighted in Figure 8.

The second mainstem section that exhibited positive increases in habitat occurred downstream of the gravel injection site adjacent to the R-4 low bench. The mid-channel bar area (area above low flow wetted edge) increased from 236 m² to 558 m², a 136% increase (Figure 9). It also, migrated towards the left bank (looking downstream), which caused an increase in slow water below the bar. As a result, winter base flow total habitat increased 1,048 m² or 69%, upstream and downstream of the bar where slow water was created. The post-construction flow-habitat curve exhibited a dip around the 34 cms (1,200 cfs) point. This occurred when the water overtopped the bar. Habitat began to increase again at higher flows as the water spread out across the left bank (Figure 10).

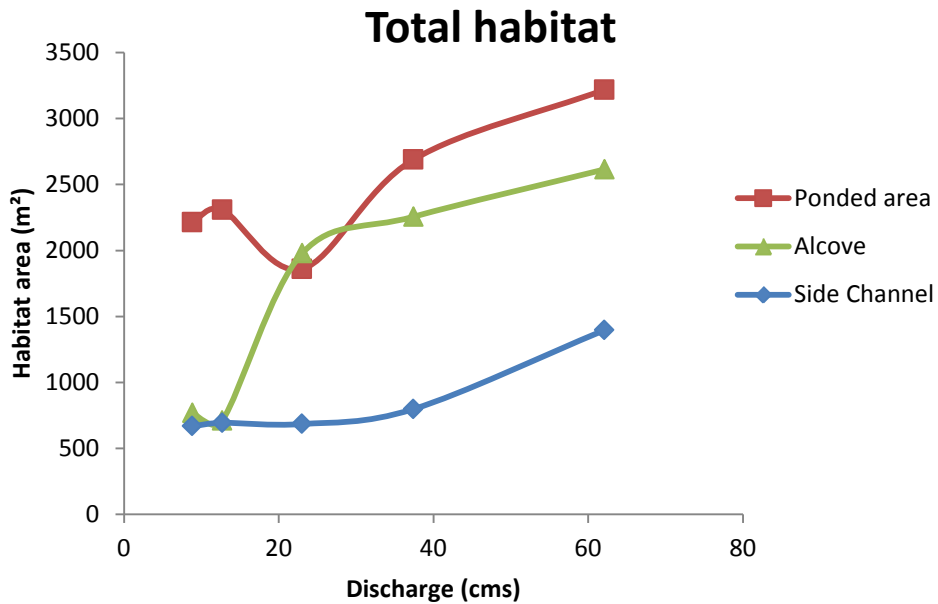
Figure 11. Total presmolt habitat measured at five flows post-construction within the R-1 side channel, R-2 ponded area and R-6 alcove/high flow channel at Lowden Meadows rehabilitation site.

Constructed off channel habitats including the R-1 side channel, R-2 ponded area and R-6 alcove/high flow channel were evaluated to compare habitat creation. All three features did not exist prior to construction at the discharges surveyed. Therefore results are focused on post-construction conditions. Also, optimal habitat results for all three features exhibited a similar response as total habitat (similar curve with lower values) and as such, reporting focuses on total habitat. The ponded area had the highest habitat values of the three features at all flows except 23.0 cms (812 cfs) where the alcove/high flow channel had slightly more habitat (Figure 11). It was at this flow monitoring bench that the alcove became a connected and flowing side channel, which explains the large increase in habitat. Percent optimal habitat was calculated for all three features at all flows. The ponded area and alcove/high flow channel had the highest values observed of any features evaluated to date. Percent optimal habitat within the ponded area ranged from 85% at winter base flow to 63% at the highest flows. Percent optimal habitat for the side channel ranged from 33% (at 12.7 cms) to 67% at the highest flow and the alcove/high flow channel had values ranging from 29% (at 12.7 cms) to 79% (at 37.4 cms).

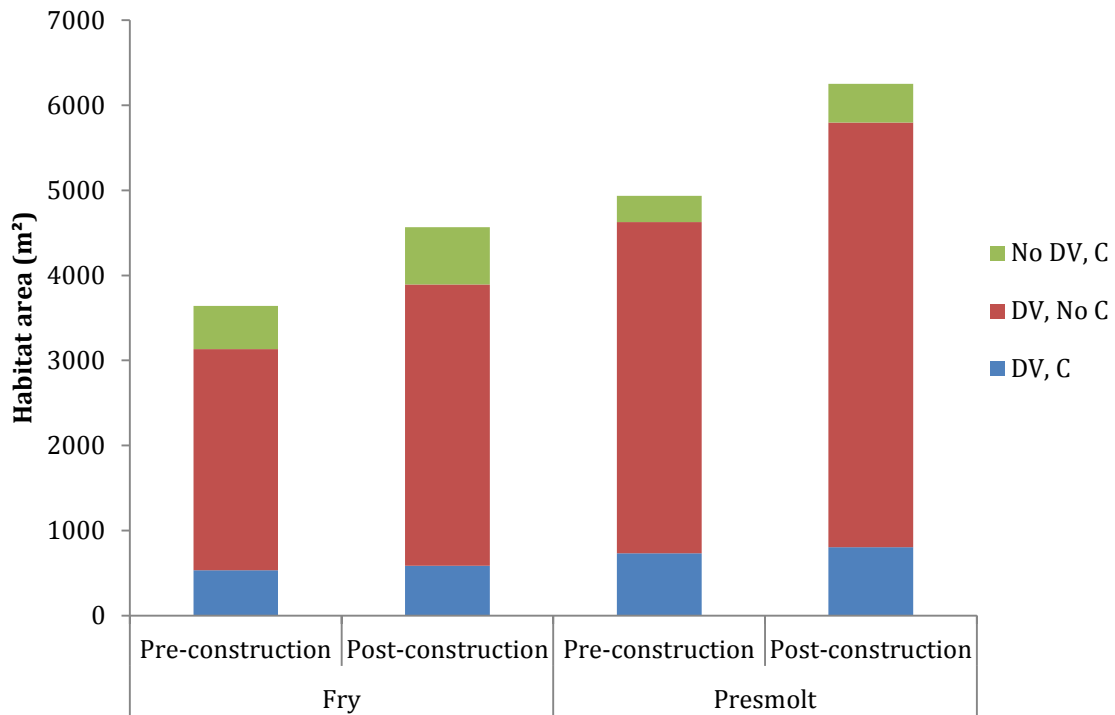
Figure 12. Chinook and Coho salmon rearing habitat quantities at the Reading Creek rehabilitation site (rkm 148.7-149.5).

Pre-construction rearing habitat surveys were conducted at the Lower Reading Creek rehabilitation site during the late winter and spring of 2009. The base flow post-construction assessment was conducted in the fall of 2011 at a discharge of 10.5 cms (371 cfs). At winter base flow, total fry and presmolt rearing habitat across the whole site increased by 25% and 27% respectively post-construction (Table 5, Figure 12). Optimal habitat increased 10% at base flow for both fry and presmolt.

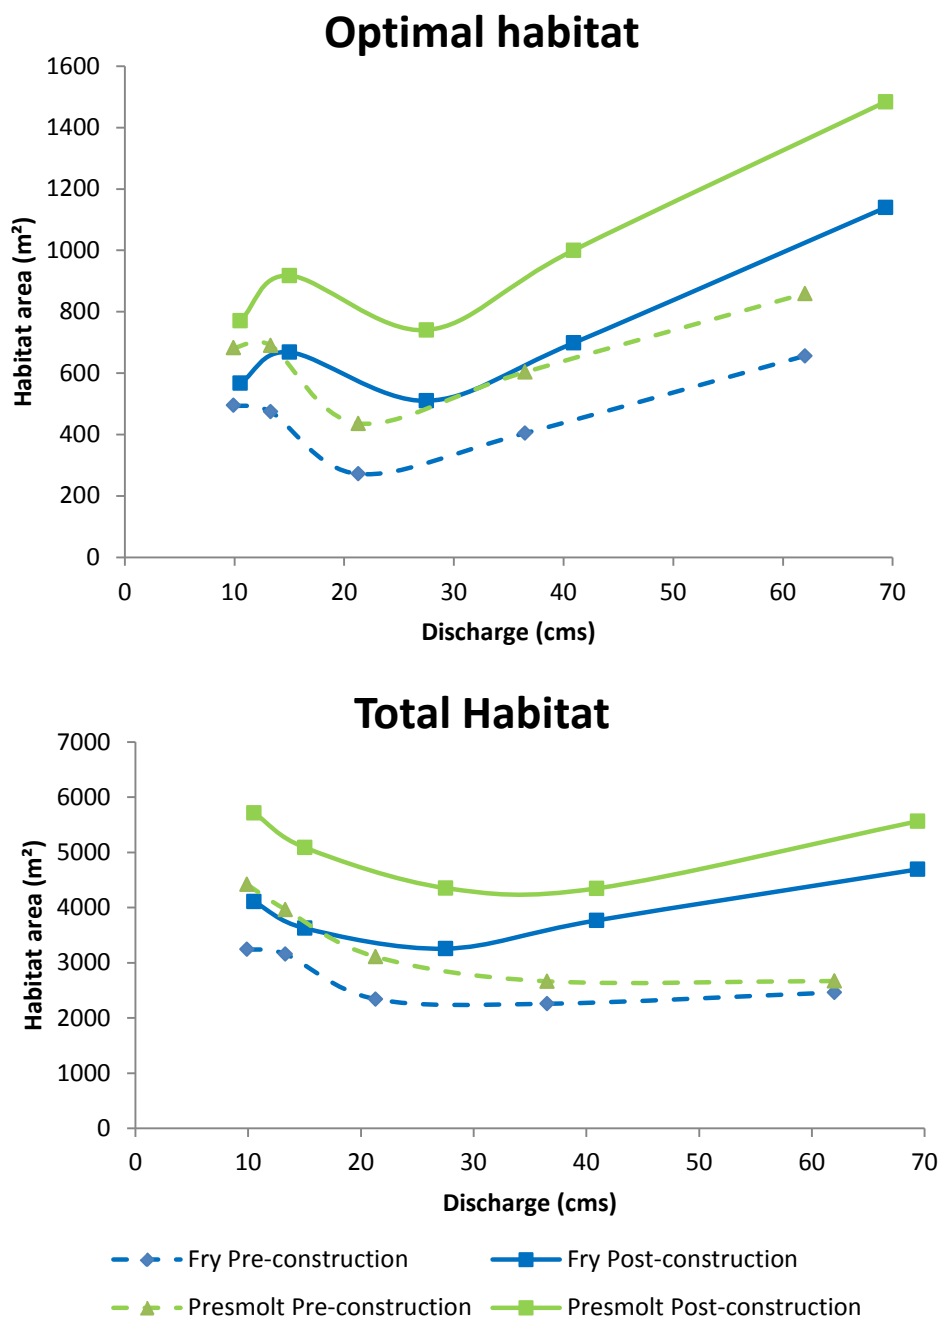
Figure 13. Estimates of Chinook and Coho salmon rearing habitat by streamflow at Reading Creek (A) rehabilitation site. Optimal Chinook and Coho salmon habitat was defined as areas within depth/velocity and in-water escape cover (DV,C) criteria. Total Chinook salmon rearing habitat (total habitat) was defined as areas that met any combination of depth/velocity or in-water escape cover criteria. The fry life stage is defined as fish <50 mm FL and presmolt as 50>X<100 mm FL.

A portion of the rehabilitation site was mapped at multiple flows ranging from 9.9 to 69.4 cms (348 – 2,451 cfs). The area extends over 745 m of the mainstem river and the intent was to evaluate the effects on rearing habitat through construction of the R-4 floodplain, R-5 main channel meander, IC-4 and IC-5 transverse bars and IC-7 and IC-8 point bars. This multi-flow section is referred to as Lower Reading Creek (A). Results of the flow-habitat mapping are presented in Table 6. A goal of the Lower Reading Creek project design was to “increase and sustain availability, quantity and quality of anadromous fish habitat between 8.5 and 56.6 cms (300 - 2,000 cfs) for all life stages” (HVT and McBain and Trush 2010). Figure 13 demonstrates increases in optimal and total habitat across all flows. The smallest increases in habitat occurred at the lowest flows (described above) and the largest increases were observed at the highest flows. At a discharge of 62.0 cms (2,190 cfs) optimal habitat increased post-construction by 56% and 58% for fry and presmolt and total habitat increased by 81% and 97% respectively. The shape of the curve shifted slightly to the right for optimal habitat and the slope of the curve at higher flows was slightly steeper post-construction. There was a slight change to the shape

of the total habitat curve where habitat was increasing post construction at the highest mapped flows instead of remaining stable (flat-lined).

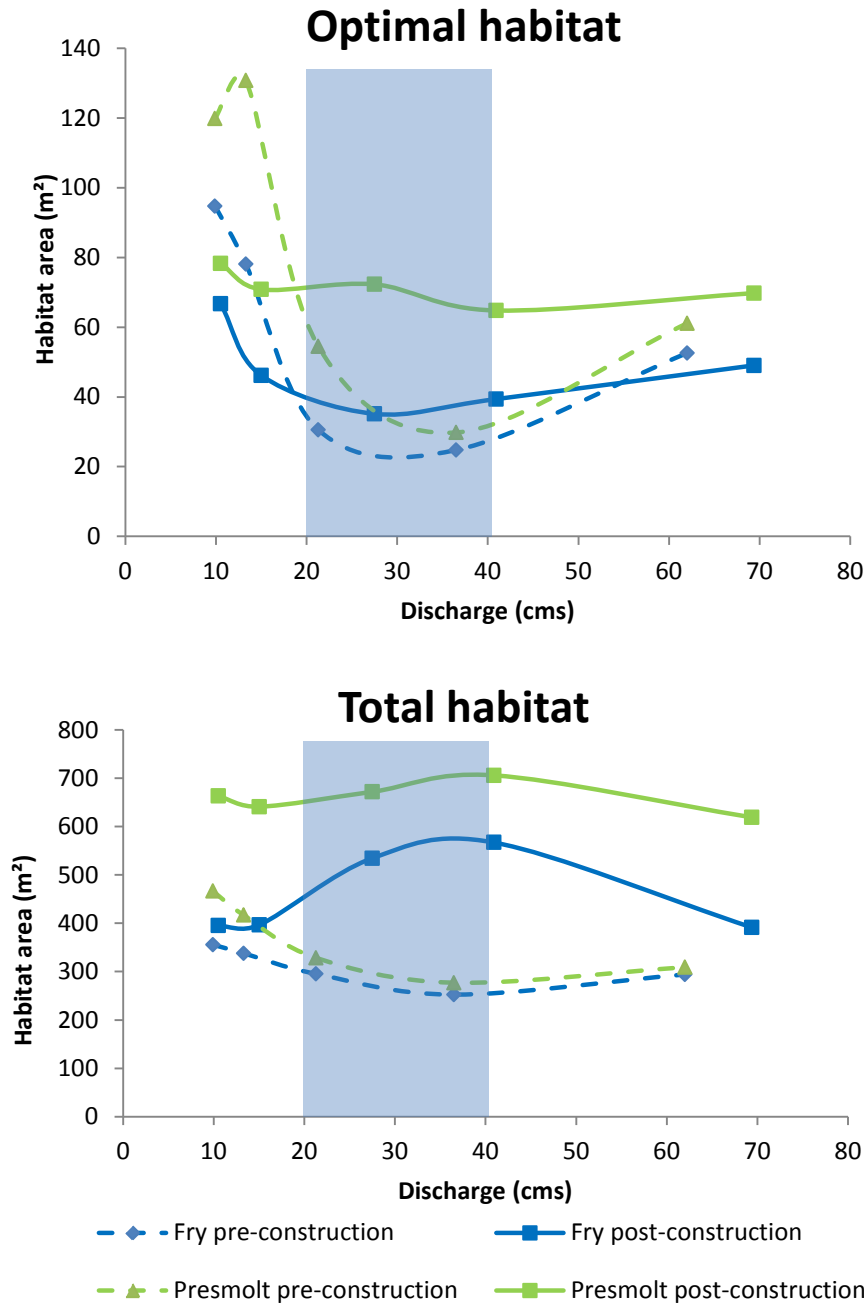
Figure 15. Estimates of Chinook and Coho salmon rearing habitat by streamflow within 10 m around the Reading Creek rehabilitation site R-4 benches. The blue shaded areas represent the intermediate range of discharges the features were designed to interact with to increase habitat. Optimal Chinook and Coho salmon habitat was defined as areas within depth/velocity and in-water escape cover (DV,C) criteria. Total Chinook salmon rearing habitat (total habitat) was defined as areas that met any combination of depth/velocity or in-water escape cover criteria. The fry life stage is defined as fish <50 mm FL and presmolt as 50>X<100 mm FL.

The primary goal of the R-4 500 cfs benches was to increase bankfull channel width and encourage sediment deposition within the mainstem channel flows (HVT and McBain and Trush 2010). A secondary goal of the R-4 500 cfs benches was to provide temporary habitat at intermediate flows (HVT and McBain and Trush 2010). Habitat availability in and 10 m around (buffered to capture any localized effects) the R-4 low benches is displayed in Figure 15. Polynomial equations were used to calculate change at 28.3 cms (1,000 cfs) for total habitat. Fry total habitat increased 286 m² or 106% and presmolt total habitat increased 385 m² or 132%. Pre-construction total habitat dipped with increasing flows. Post-construction conditions exhibited increases in total habitat as flows overtopped the benches, as hypothesized in the design document. Optimal habitat around the R-4 benches displayed some increases in habitat and the shape of the streamflow to habitat curve changed dramatically. Polynomial equations did not fit the optimal habitat curves very well, therefore changes are described qualitatively. Pre-construction optimal habitat decreased sharply between the low and intermediate discharge, then increased slowly. Post-construction optimal habitat availability remained relatively stable across flows.

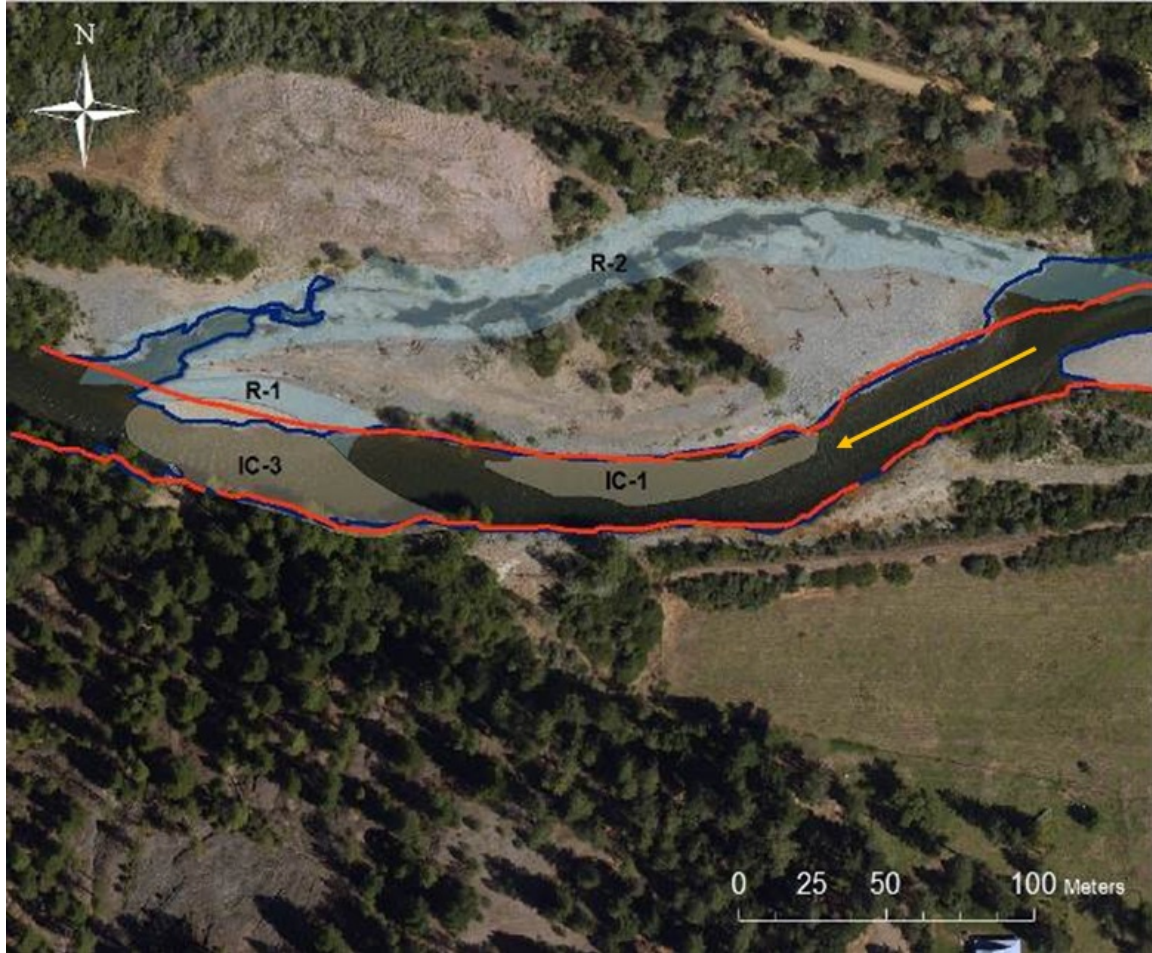
Figure 18. Aerial photo taken in 2011 of the Trinity House Gulch rehabilitation site (rkm 167.5-167.9). IC-1 and IC-3 were designed point bars constructed in 2010. R-1 was a designed river meander and R-2 was a designed low flow side channel also constructed in 2010. The red lines represent pre-construction wetted edge surveyed in 2010 at 14.3 cms (505 cfs). The blue lines represent post-construction wetted edge surveyed in 2011 at 13.6 (480 cfs). The orange arrow indicates flow direction.

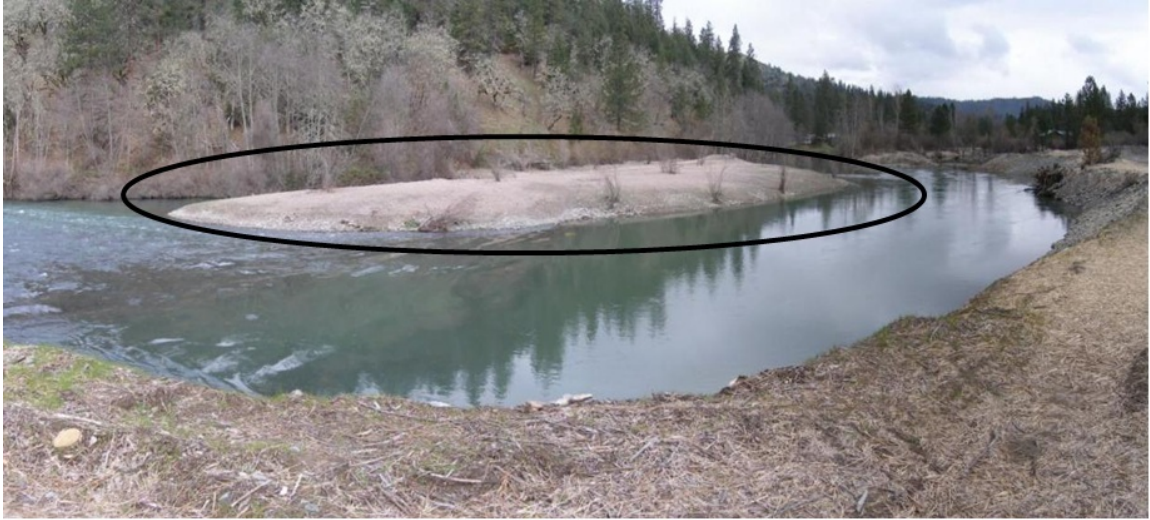
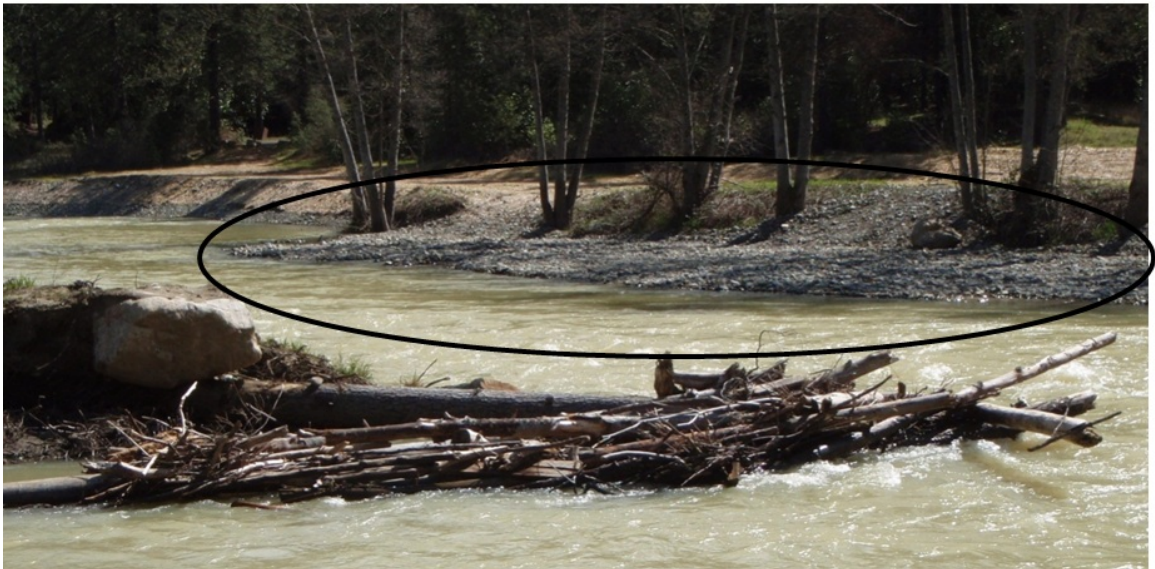
Figure 21. Post-construction (pre-high-flow) photos of the IC-2 constructed point bar at Lowden Meadows rehabilitation site (upper photo) and the IC-7 constructed point bar (pre-high flow) at Reading Creek rehabilitation site (lower photo). Discharges at the Lowden Meadows site were 14.3 cms (506 cfs) and were 31.1 cms (1,100 cfs) at the Reading Creek site during the time the photos were taken.

A common feature implemented at all three sites was a 'forced meander'. All constructed point bars were similar in length (90-100 m). However, there was a significant difference between the one constructed at Lowden Meadows and the other ones built at THG and Reading Creek. The IC-2 forced meander bar at Lowden was intended to act similar to a floodplain and not be easily mobilized. Also a wood jam was constructed at the top of the Lowden Meadows IC-2 bar to deflect water and help minimize scour of the bar. The Lowden Meadows IC-2 bar was designed to be 3 m in height above the mainstem channel elevation (DWR 2010), meaning the top of it would become inundated at 8,500 cfs (DWR 2010). This required approximately 9,000 yds³ of coarse sediment additions for the single feature. By contrast, the two THG constructed point bars and transverse bar (IC-1, IC-2, IC-3) required 3,000 yds³ of gravel (HVT and McBain and Trush 2010) and the Reading Creek IC-7 and IC-8 constructed point bars required 3,100 yds³ of coarse sediment additions (HVT and McBain and Trush 2010) (Figure 21). There are several factors that determined the differences between the forced meander designs; (1) FEMA requirement to not raise water surface elevations by more than one foot; (2) the different site conditions across the three sites that enable different sized bars in some locations while they were precluded in other locations; and (3) the decision to use 5 inch minus coarse sediment to build the bars at THG and Reading Creek with the purpose of placing material easily transported by ROD flows. The 2011 high flow event mobilized most of the constructed point bars at THG and Reading Creek, whereas the IC-2 point bar at Lowden received some scour, but remains intact and functioning as intended (Figure 22).

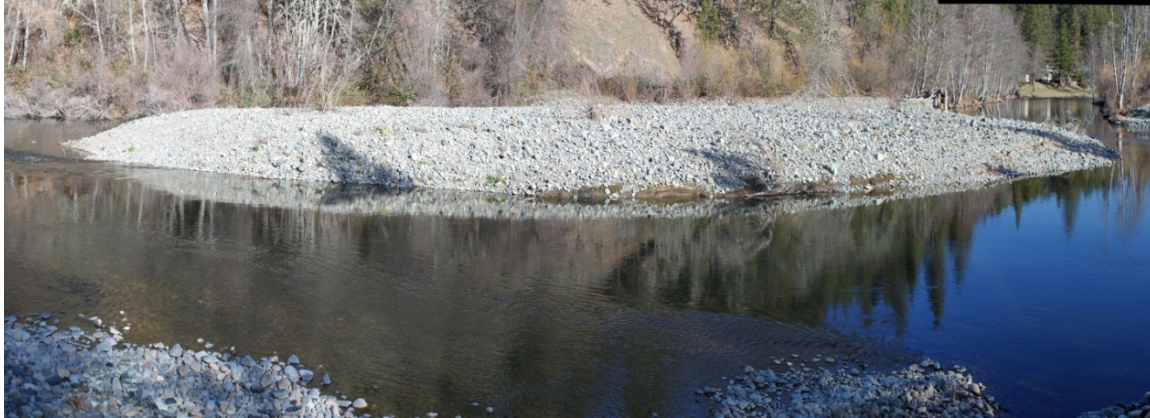
Figure 22. Post-2011 high flow photo of the IC-2 constructed point bar at Lowden Meadows.
