ENHANCEMENT OF SALMONID REARING HABITAT IN MCGARVEY CREEK - LOWER KLAMATH RIVER

Yurok Tribal Fisheries Program

FINAL REPORT – December 2016

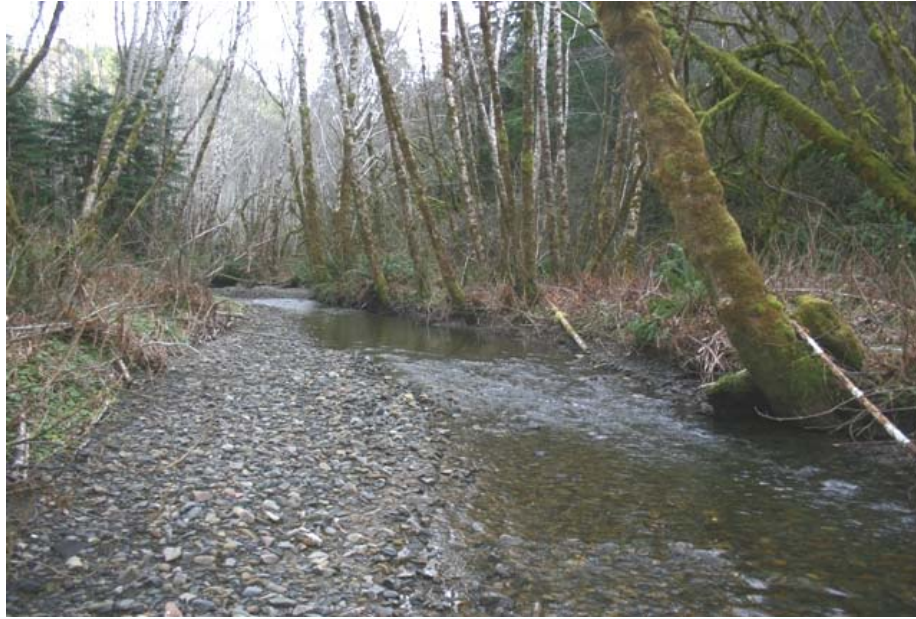
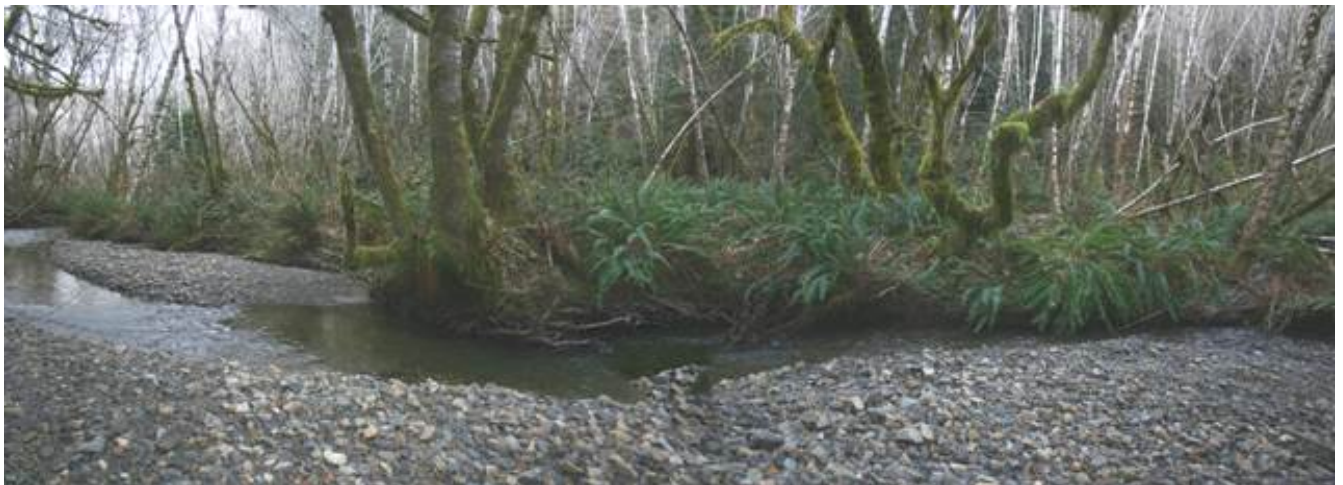
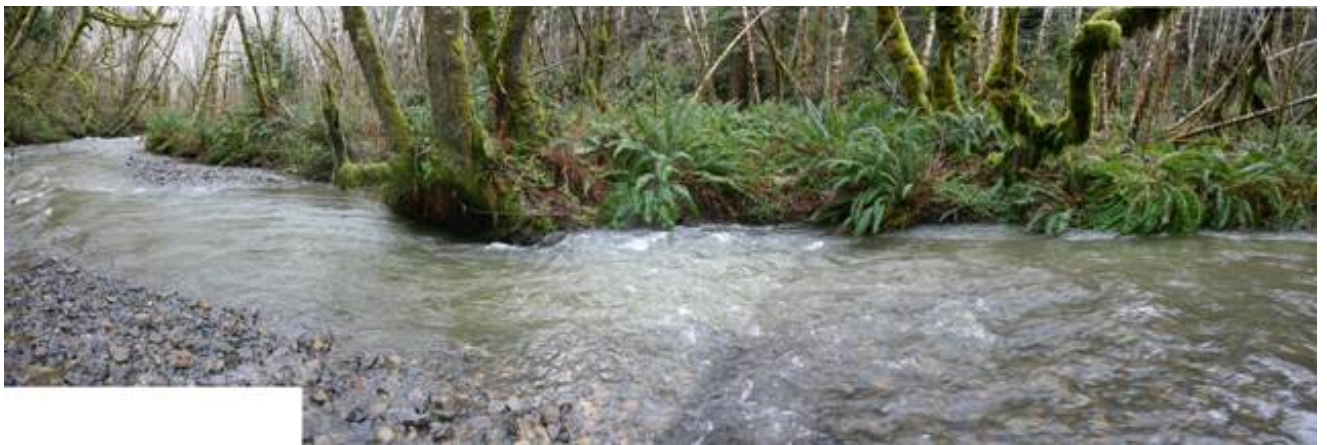
Figure 2. Photographs of a reach in upper McGarvey Creek prior to wood loading activities (Note: wood jams are lacking in the channel and mature alders dominate riparian habitats).

mid-1980's (Gale and Randolph 2000). Historic and ongoing land management activities have resulted in removal of old growth conifers from riparian habitats, substantial simplification of fisheries habitats, increased rates of channel sedimentation, and loss of large wood and naturally formed jams in fluvial habitats (Figures 2-4) (Gale and Randolph 2000; Beesley and Fiori 2007).

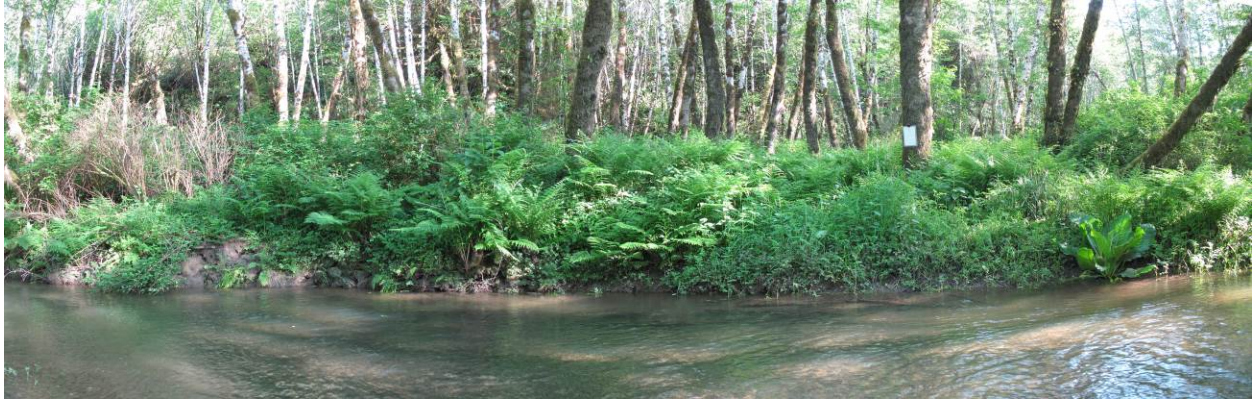
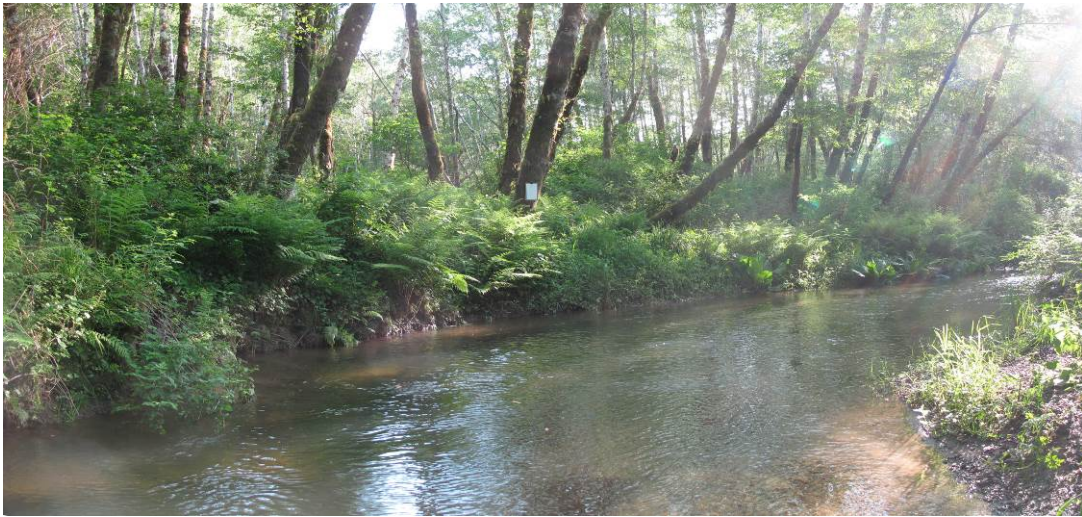
Figure 3. Photographs of a typical reach in lower McGarvey Creek where complex wood jams are lacking and mature conifers have been virtually eliminated from riparian recruitment zones.

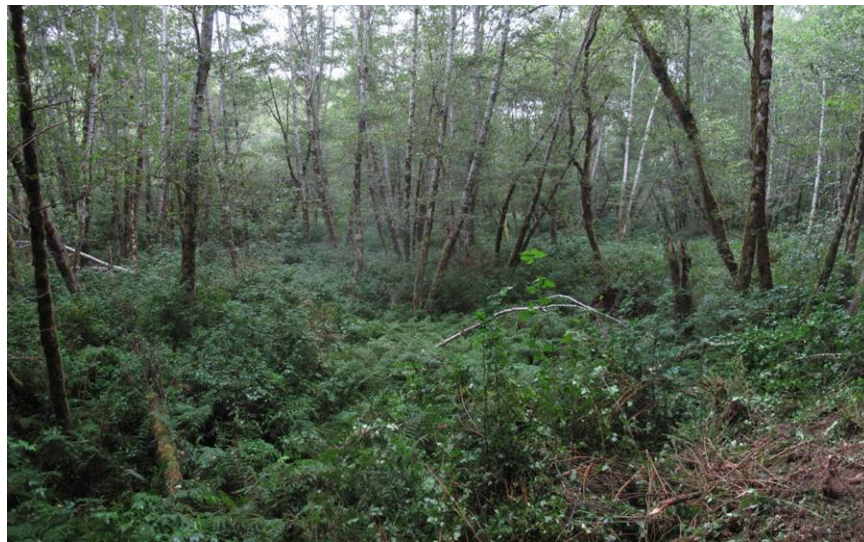
Figure 4. Photograph of a typical floodplain in lower McGarvey Creek (Note: mature conifers have been eliminated from riparian recruitment zones and mature alders dominate the forests).

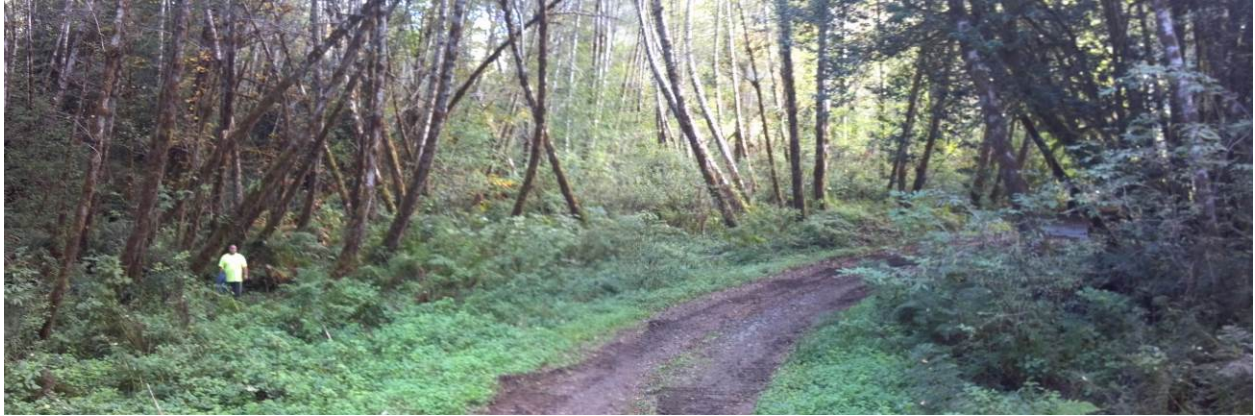
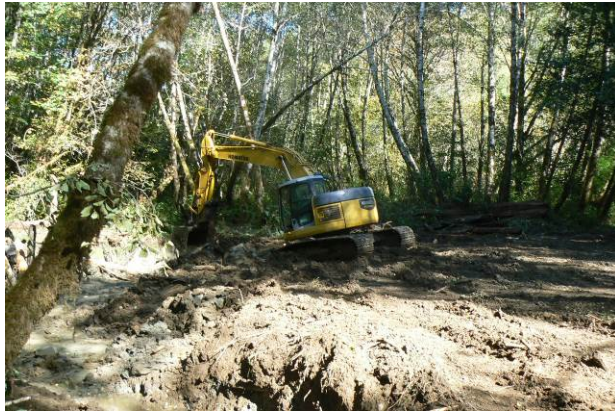
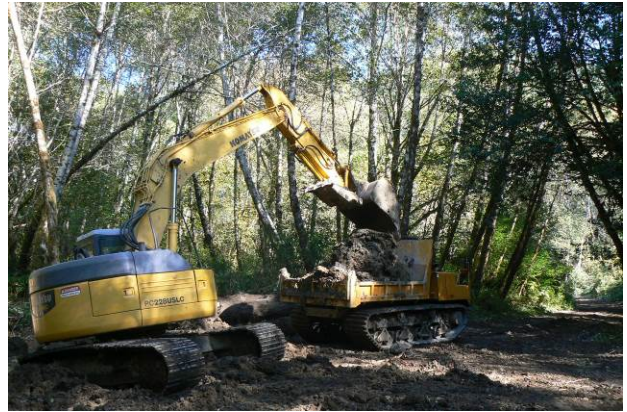
Figure 7. McGarvey Creek Alcove IV construction photographs (Top – Looking downstream at alcove site prior to excavation 10/08/14; Bottom – Alcove excavation 10/08/14).

In summer 2014, YTFP and FGS constructed the fourth off-channel habitat feature (McGarvey Alcove IV) in the Lower McGarvey Creek Project Reach (Figures 7-10; Appendix A). McGarvey Alcove IV was constructed on the western side of the valley within the 2009 wood loading reach (Figures 6-11). The alcove was sited in this location to take advantage of ground water inputs and rain driven surface flows derived from the historic Den Creek channel located along the western valley wall. The alcove was excavated within this former channel and was tied into the existing outlet channel that drains to mainstem McGarvey Creek (Figures 6-10). Several key pieces of wood were placed in Alcove IV to increase salmonid rearing habitat complexity and to provide sites for native amphibians to lay eggs (Figures 9-10).

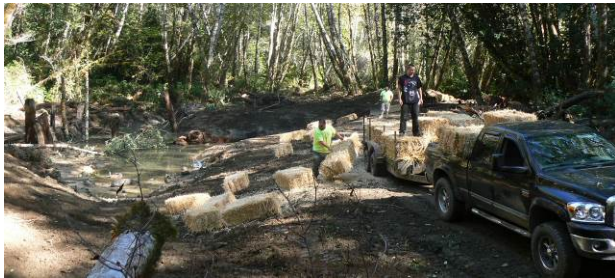
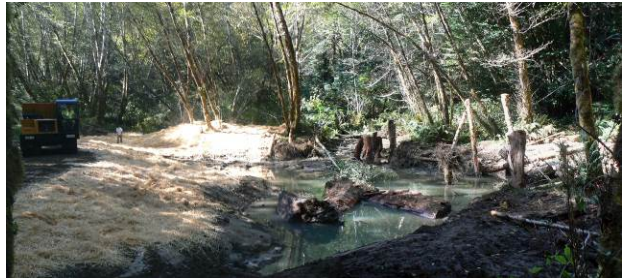
Figure 8. Placement of erosion control hay at McGarvey Creek Alcove IV following construction (Left – Looking downstream 10/13/14; Right – Looking upstream 10/13/14).

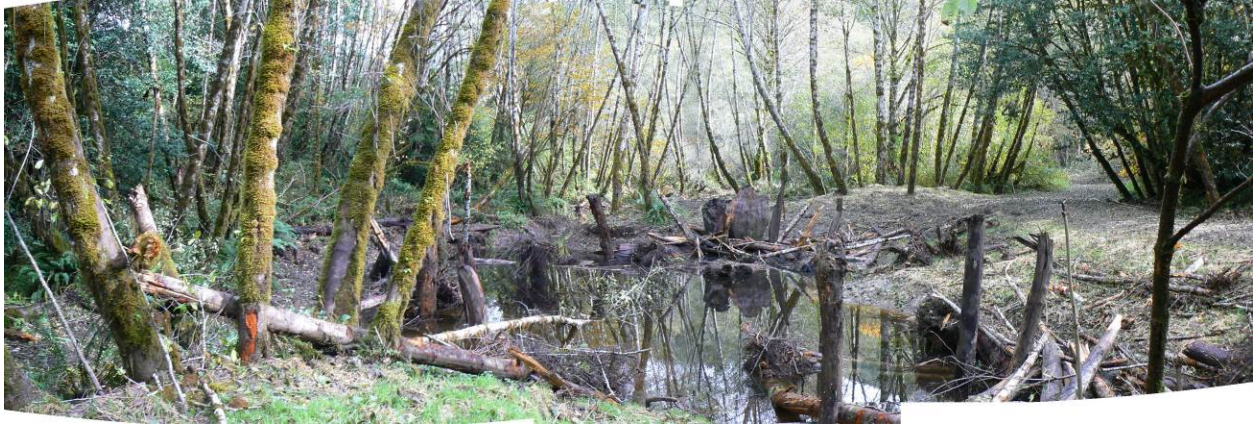
Figure 9. McGarvey Creek Alcove IV following construction and the first flow event (10/31/14).

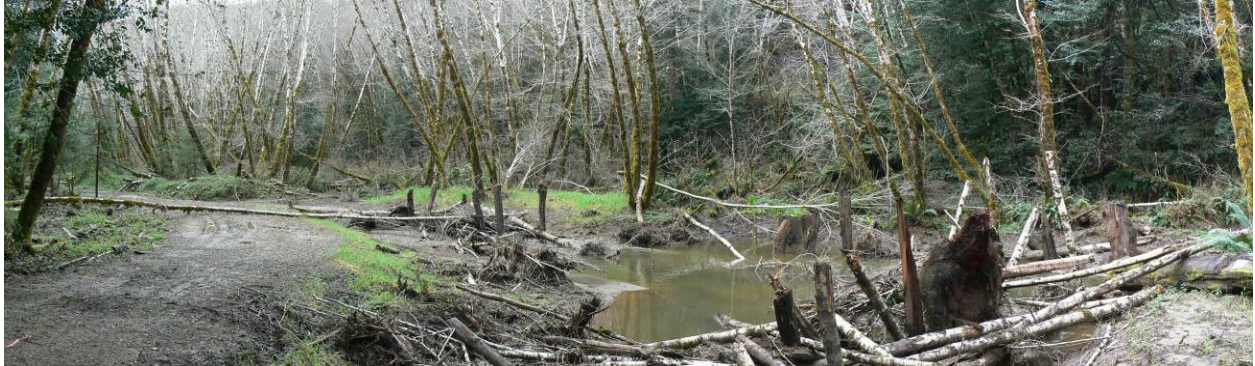
Figure 10. McGarvey Creek Alcove IV during the first winter post-construction (02/12/15).

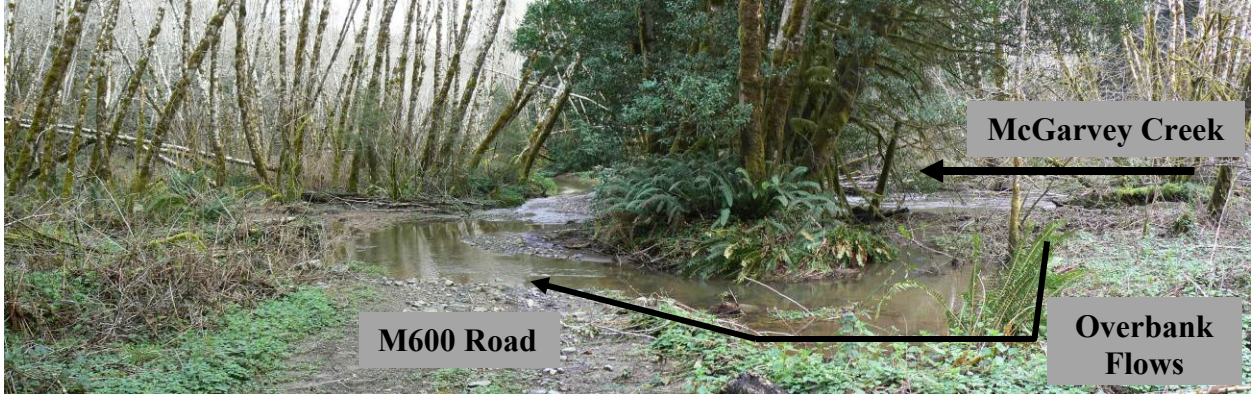
Figure 11. McGarvey Creek during an overbank flow event (note: flows onto M600 road 02/12/15).

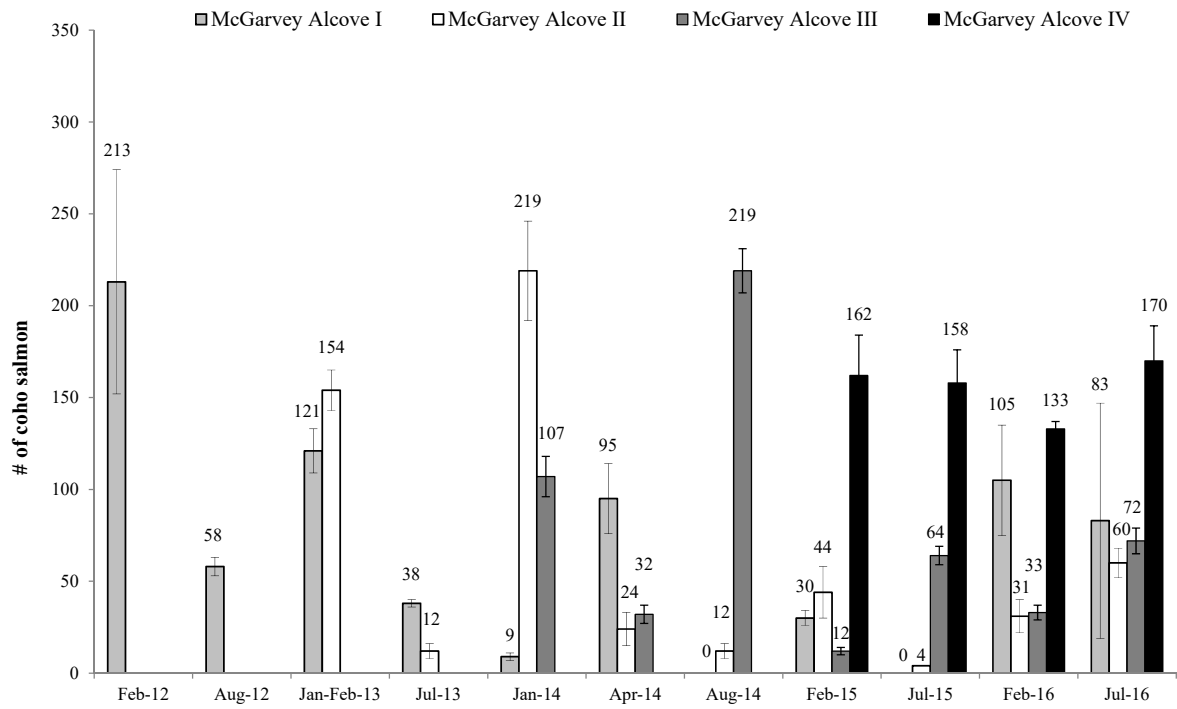
To document fish use within the constructed alcoves, YTFP has been conducting mark-recapture population estimates using the Chapman modification of the Petersen estimator (Ricker 1975). Juvenile coho salmon abundance data for the four constructed alcoves in McGarvey Creek are presented in Figure 17. Although coho abundance estimates vary within and among the four sites during the monitoring period, the data indicates consistent use of these constructed features. These monitoring efforts also indicate significant use of these features by native amphibians (YTFP Unpublished Data). Since construction in 2014, YTFP has documented relatively high and consistent use of Alcove IV by juvenile coho with estimates ranging from a low of 133 individuals in February 2016 to a high of 170 individuals in July 2016 (Figure 17).

Figure 17. Mark-recapture population estimates for juvenile coho in McGarvey Creek alcoves.

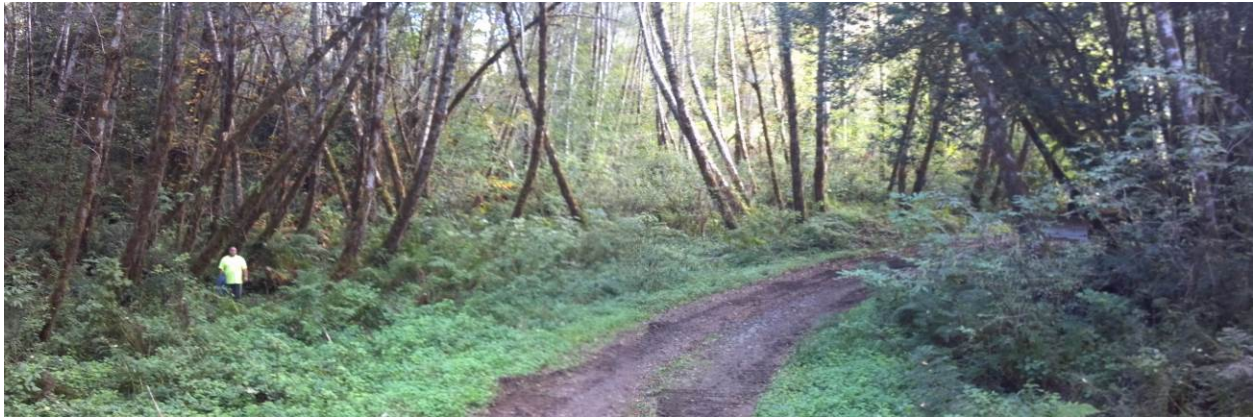
Photo-Site McGAlcoveIV_1: McGarvey Creek Alcove IV prior to construction (10/08/2014).

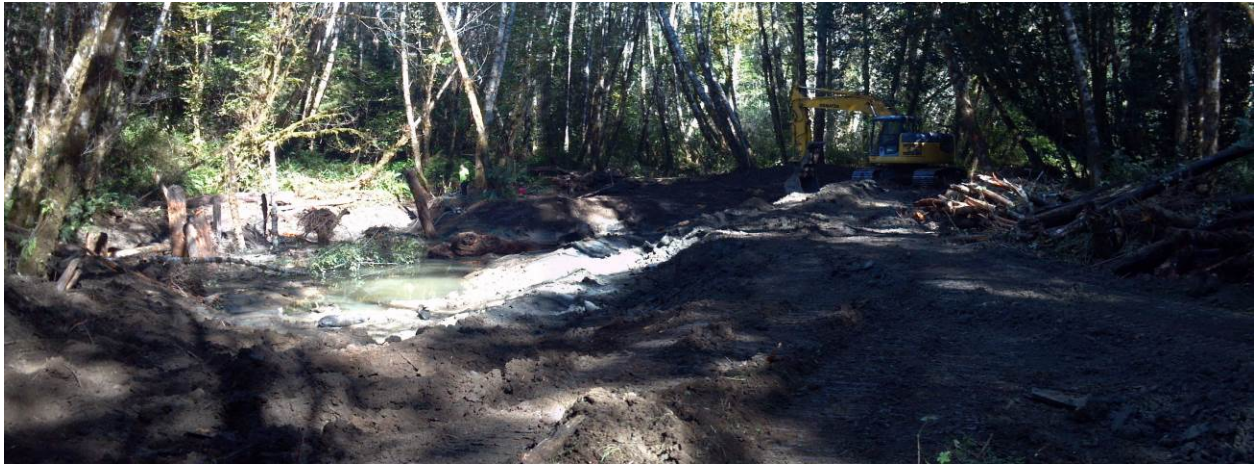
Photo-Site McGAlcoveIV_1: McGarvey Creek Alcove IV during construction (10/12/2014).

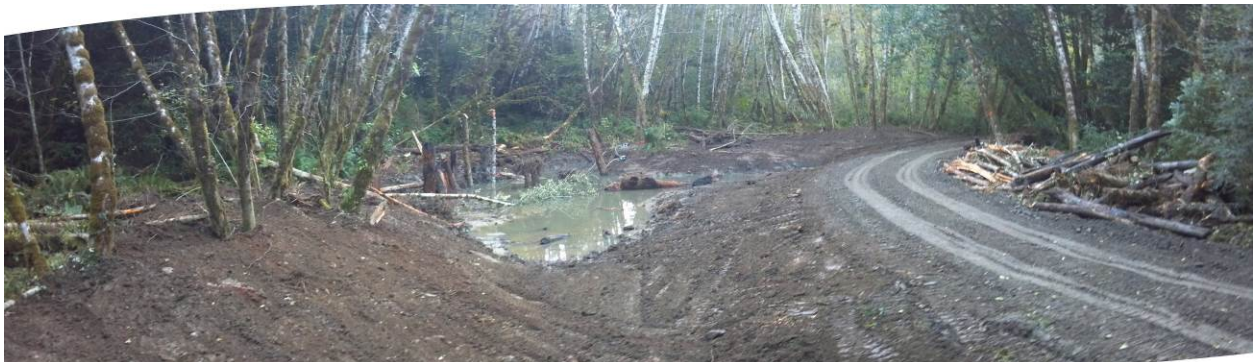
Photo-Site McGAlcoveIV_1: McGarvey Creek Alcove IV during construction (10/13/2014).

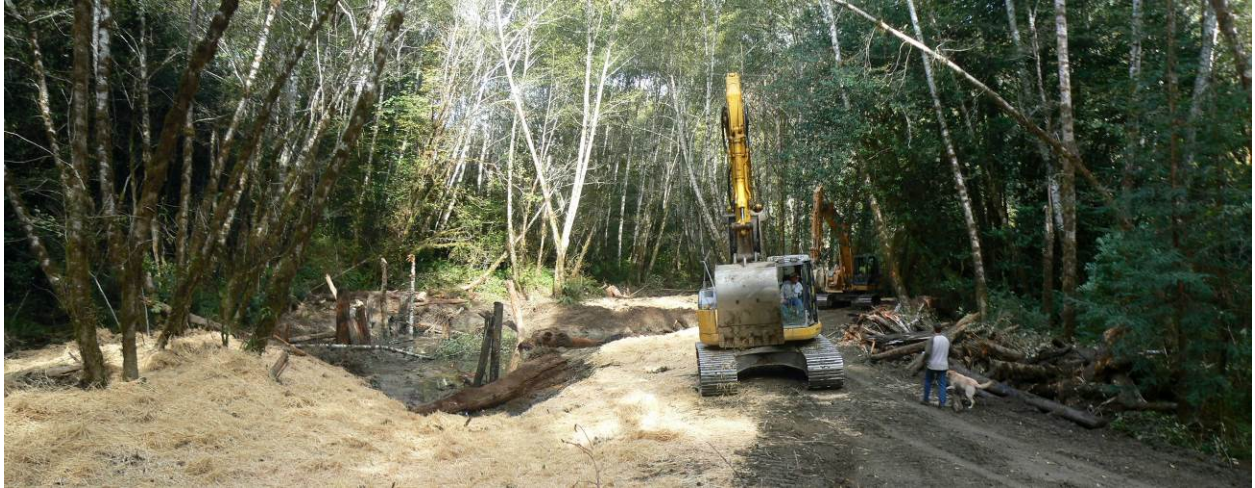
Photo-Site McGAlcoveIV_1: McGarvey Creek Alcove IV during construction (10/14/2014).

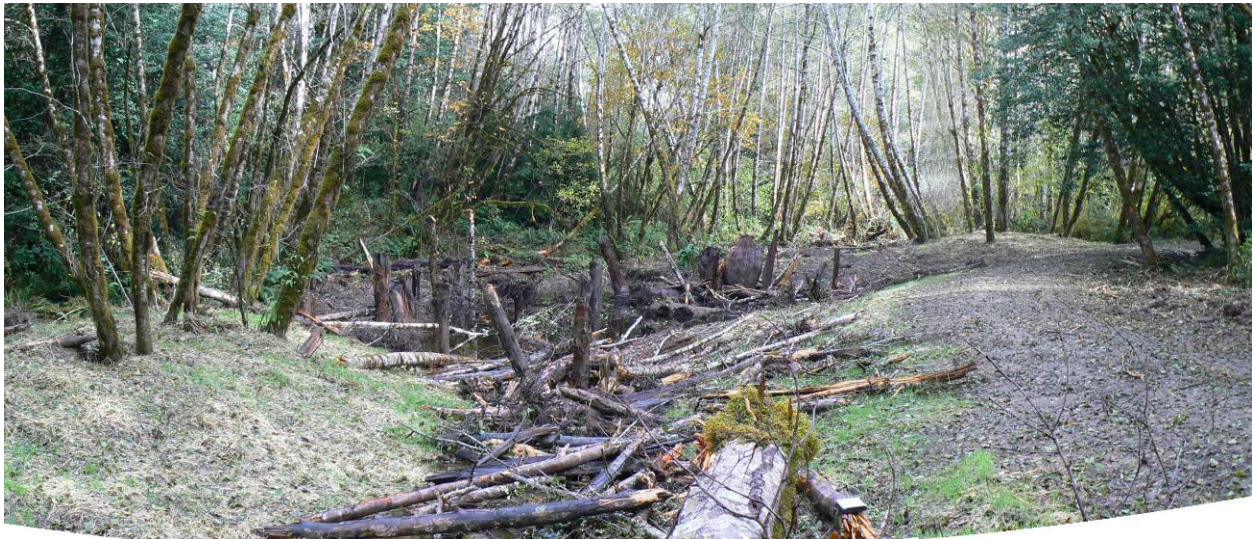
Photo-Site McGAlcoveIV_1: McGarvey Creek Alcove IV post-construction (10/31/2014).

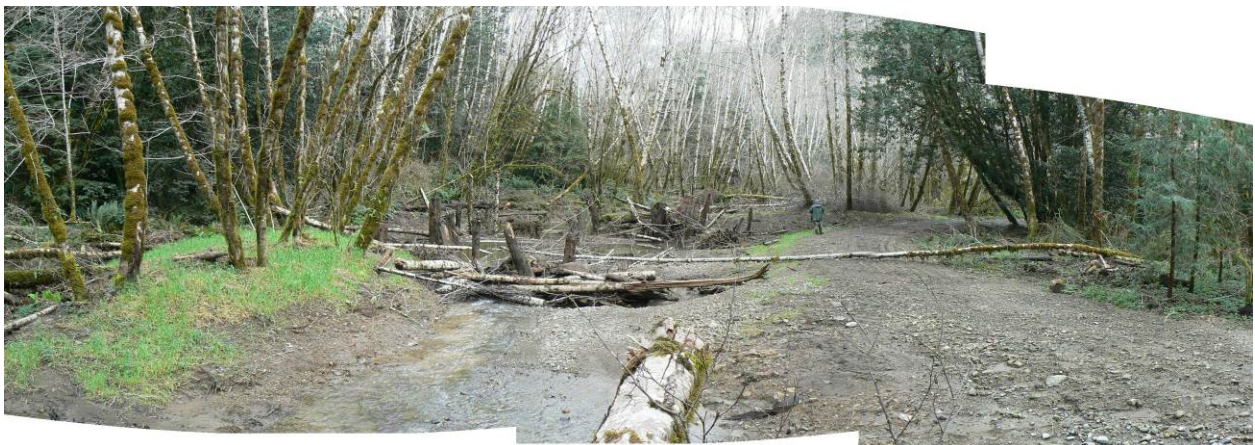
Photo-Site McGAlcoveIV_1: McGarvey Creek Alcove IV first winter post-construction (02/12/15).
