Age-0 Chinook and Coho Salmon Rearing Habitat Assessment: Sawmill Rehabilitation Site, Three Years after Construction at Winter Base Flow, Upper Trinity River

August 2014

De Julio, K., A. Martin, J. Alvarez, and D. H. Goodman. 2014. Age-0 Chinook and Coho salmon rearing habitat assessment: Sawmill rehabilitation site, three years after construction at winter base flow, upper Trinity River.. U.S. Fish and Wildlife Service. Arcata Fish and Wildlife Office, Arcata Fisheries Data Series Report Number DS 2014-37, Arcata, California.

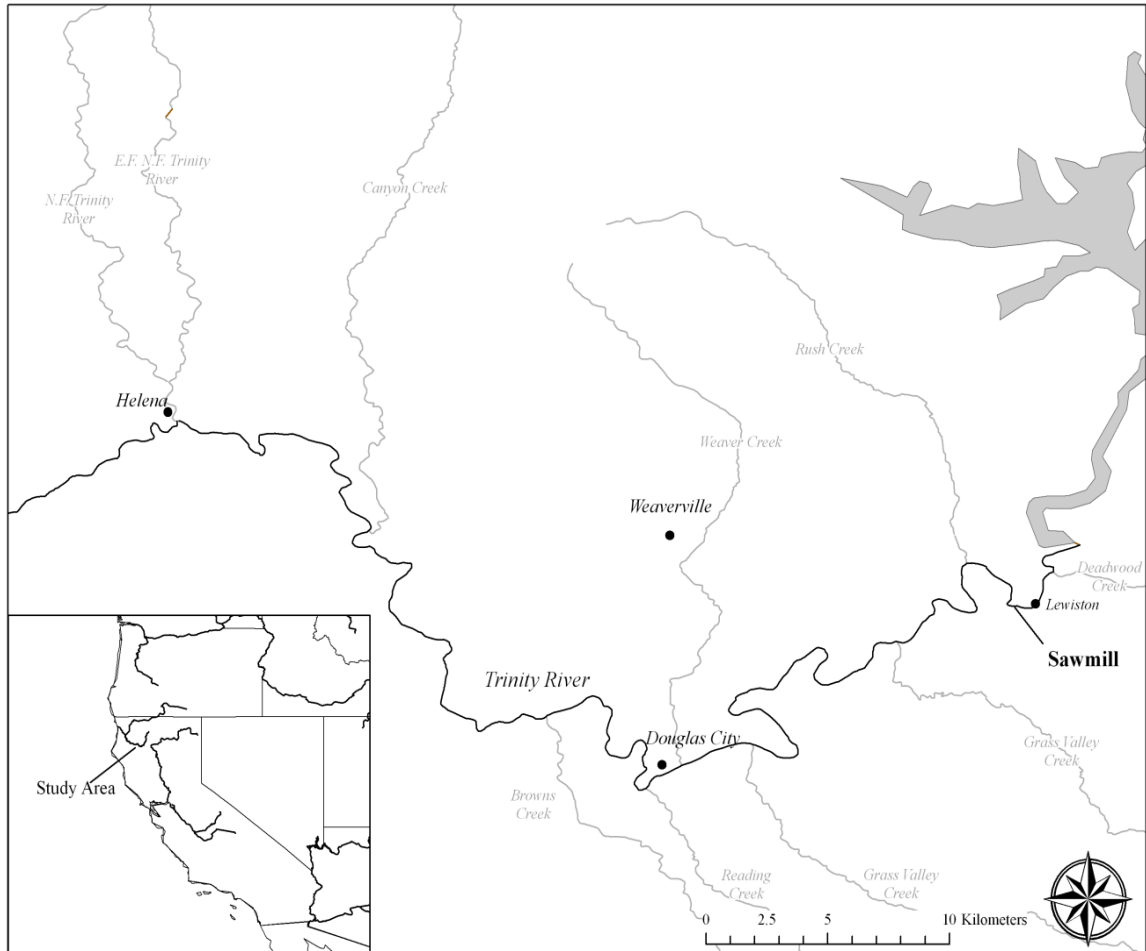
Figure 1. Location of Sawmill rehabilitation site within the 64 km upper Trinity River project reach. The primary restoration reach extends from Lewiston Dam near Lewiston to the confluence of the Trinity and North Fork Trinity Rivers at Helena.

The Trinity River is located in northwestern California within Humboldt and Trinity counties and the Hoopa Valley Indian Reservation. The watershed has a drainage area of 7,679 km², approximately one quarter of which is upstream of Lewiston Dam and inaccessible to anadromous fishes (USFWS 1989; USBOR 2009). The river's headwaters are in the Salmon-Trinity Mountains of northern California, from which it flows 274 km to its confluence with the Klamath River in Weitchpec, California. This monitoring effort focuses on the Sawmill rehabilitation site located in Lewiston, California approximately 4 river kilometers (rkm) downstream of the Lewiston Dam (Figure 1).

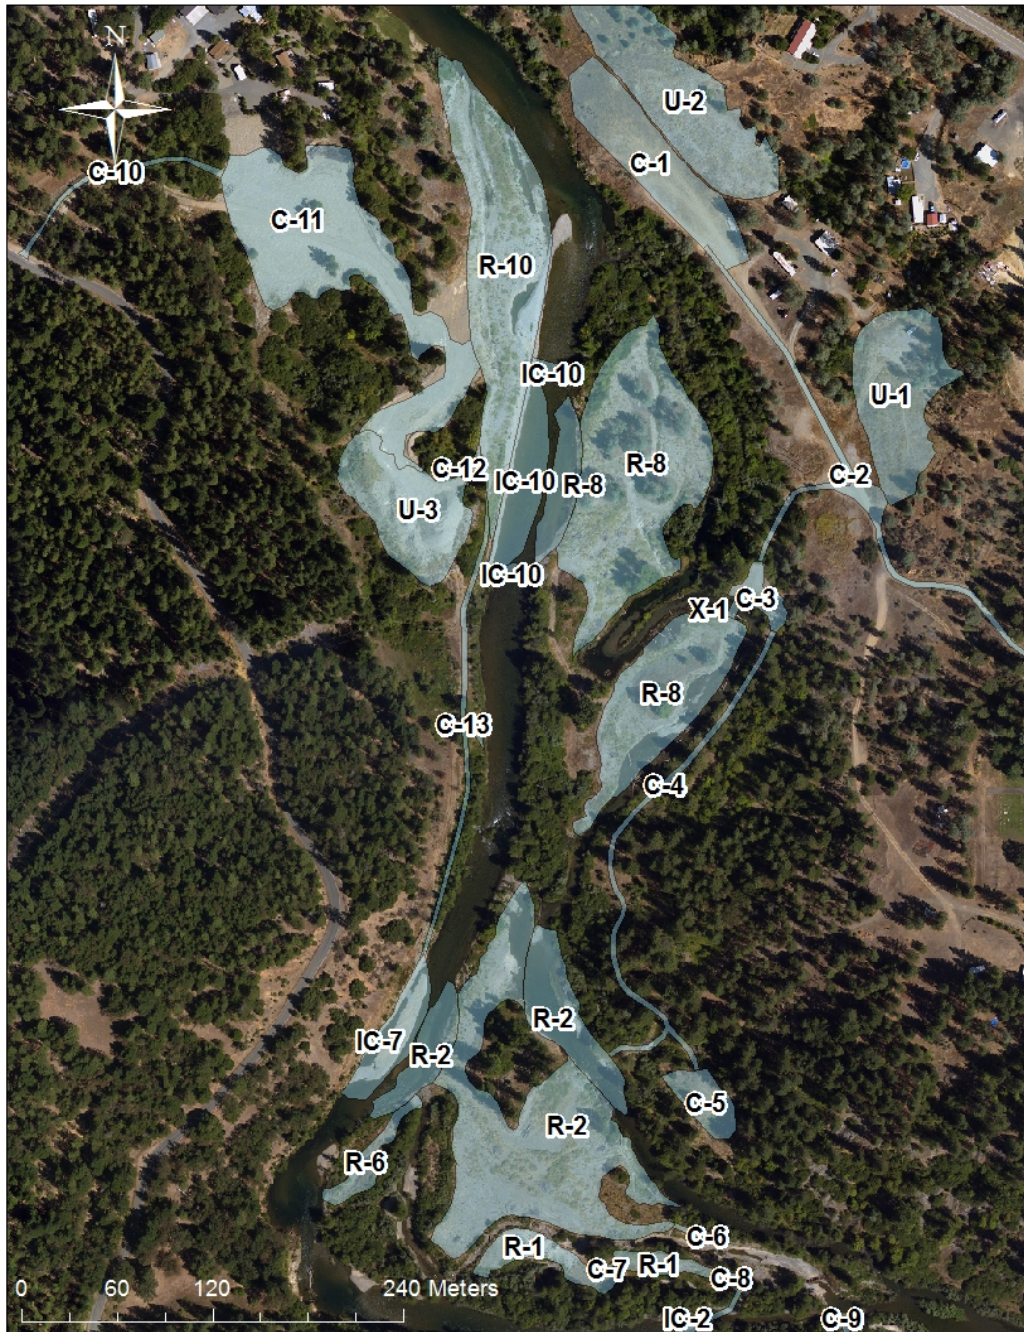
Figure 2. Aerial photos of Sawmill rehabilitation site design elements taken in 2011. Blue polygons indicate design rehabilitation site design elements (HVT and McBain and Trush 2009). 'IC' indicates an in-channel feature, 'R' is a riverine/floodplain feature, 'C' indicates contractor use areas, 'U' identifies spoil locations and 'X' is a construction crossing.

The Sawmill rehabilitation site encompasses 1,125 m of mainstem river channel. Mainstem rehabilitation actions involved the removal of 2 gabions and 4 rock weirs, addition of alluvial bars and excavation of vegetated banks to increase channel sinuosity (Figure 2; HVT and McBain and Trush 2009). Contained within the

A positive change took place in the upstream area of R8 (see Figure 2) where floodplain lowering was conducted. Although the area was constructed to be inundated at 42.5 cms (1500 cfs; HVT and McBain and Trush 2009) much of it is now engaged at 8.5 cms (300 cfs). Since the post-construction evaluation, the channel has spread out across this lowered surface creating a more complex channel that includes large wood components, shallow slow velocity rearing areas for fry and juvenile salmonids, as well as spawning habitat for adults.

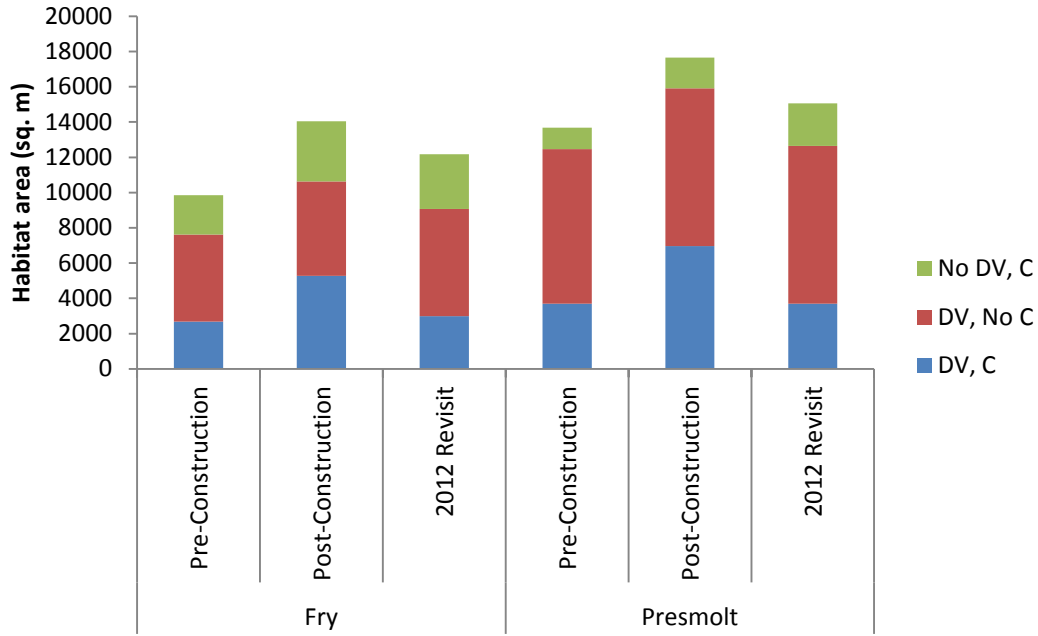
Figure 4. Area of rearing habitat types across the entire Sawmill rehabilitation site during pre-construction, post-construction and revisit surveys. All surveys were conducted at approximately 8.5 cms (300 cfs). Habitat categories correspond to combinations of depth/velocity (DV) and in-water escape cover (C) criteria.

Comparison of the post-construction site evaluation conducted in 2010 with the revisit survey conducted in 2012 showed a decrease in the total habitat area for fry and presmolt of 13% and 15%, respectively. Optimal habitat decreased 43% and 47% for fry and presmolt, respectively, since post-construction for the entire site (Table 3, Figure 4). However, in all cases habitat areas estimated from the 2012 site revisit survey remained above pre-construction levels. Total habitat area increased between 24% for fry and 10% for presmolt when compared to pre-construction conditions. Optimal habitat increased 11% for fry and remained stable (0.3% reduction) for presmolt compared with pre-construction estimates.

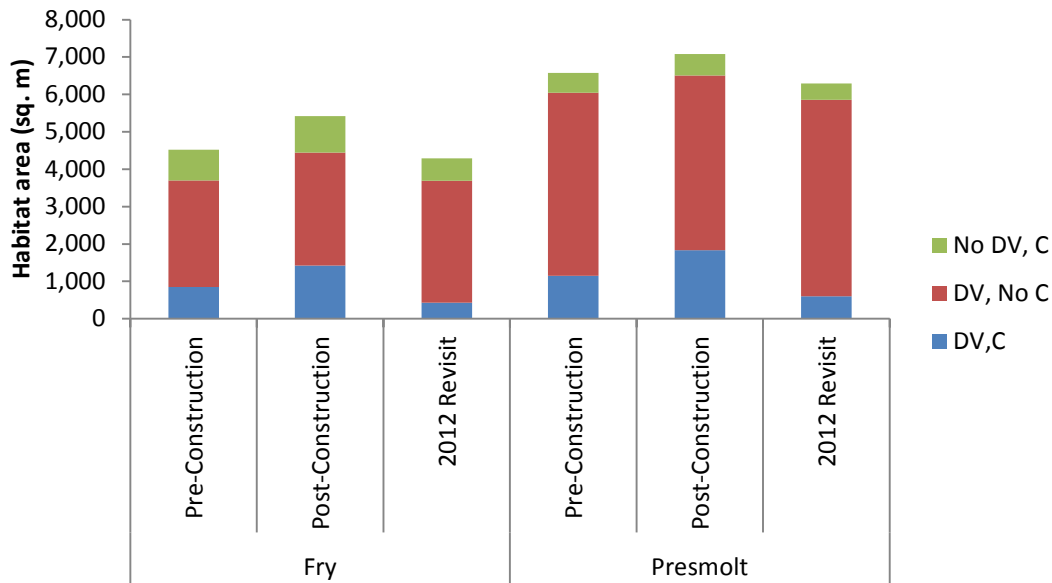
Figure 5. Area of rearing habitat types within the mainstem portion of the Sawmill rehabilitation site during pre-construction, post-construction and revisit surveys. All surveys were conducted at approximately 8.5 cms (300 cfs). Habitat categories correspond to combinations of depth/velocity (DV) and in-water escape cover (C) criteria.

Availability of total fry habitat in the mainstem during the revisit decreased 21% since post-construction. Total presmolt habitat availability decreased 11%. Optimal

habitat decreased by 70% and 67% for fry and presmolt respectively throughout the mainstem. Total habitat area was similar between pre-construction and revisit. However, the area of optimal habitat for fry and presmolt was lower during the revisit than what was observed pre-construction, by 49% and 48%, respectively (Figure 5).
