Estimation of Rearing Habitat Area for Age-0 Chinook and Coho Salmon during Winter Base Flows within the Sawmill Rehabilitation Site of the Upper Trinity River, 2010

Martin, A., D.H. Goodman and J. Alvarez. 2012. Estimation of rearing habitat area for age-0 Chinook and coho salmon during winter base flows within the Sawmill Rehabilitation Site of the Upper Trinity River, 2010. Yurok Tribal Fisheries Program, Willow Creek, CA. U.S. Fish and Wildlife Service Arcata Fisheries Data Series Report Number DS 2012-26.

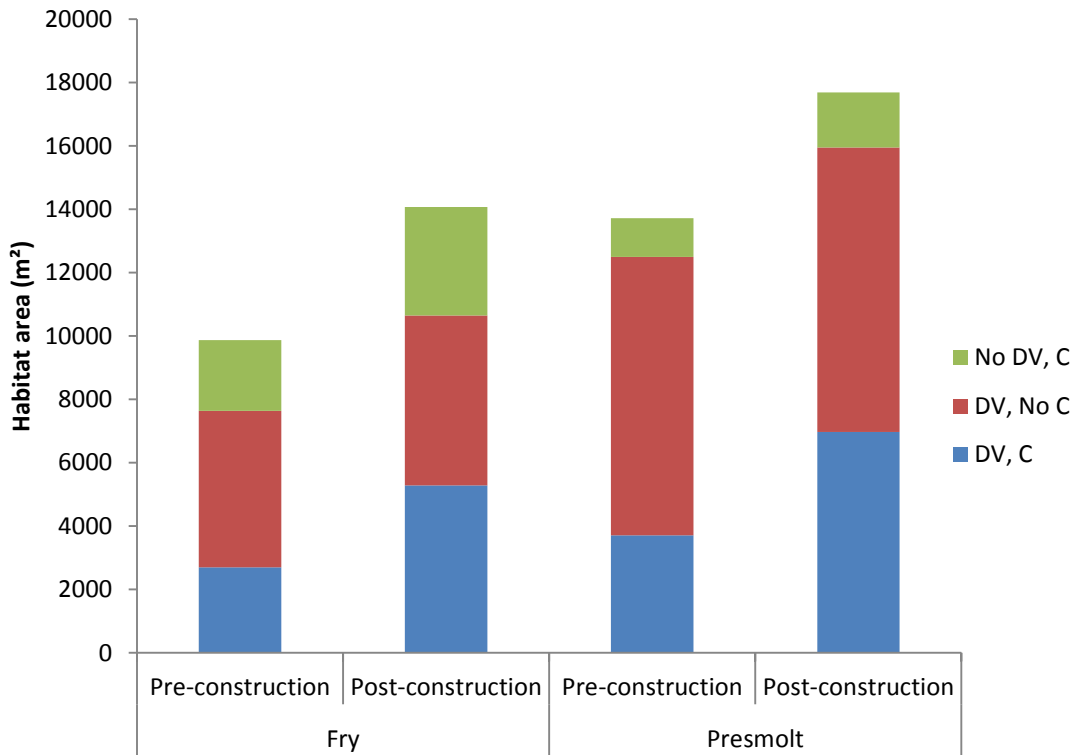
Figure 3. Chinook and coho Salmon rearing habitat quantities at the entire Sawmill rehabilitation site (rkm 176.5-175.4). Pre-construction estimates were conducted at 8.3cms (294 cfs) in 2009 and post-construction at 8.5 cms (306 cfs) in 2010. Habitat categories correspond to combinations of depth/velocity (DV) and in-water escape cover (C) criteria.

Habitat areas of like polygons, expressed as surface area (m²), were calculated and were compared between pre and post-construction surveys for the main channel, side channels (Cemetery and Sawmill), and sum of mainstem and side channels (combined total; Table 3). The combined total of fry and presmolt rearing habitat increased by approximately 4,196 m² and 3,967 m² or 42% and 29%, respectively following construction (Figure 3). Optimal habitat increased 2,588 m² or 96% for fry and 3,258 m² or 88% presmolt after construction. There was an 881 m² (20%) and 448 m² (7%) increase in total habitat for fry and presmolts within the mainstem channel (Figure 4) following construction.

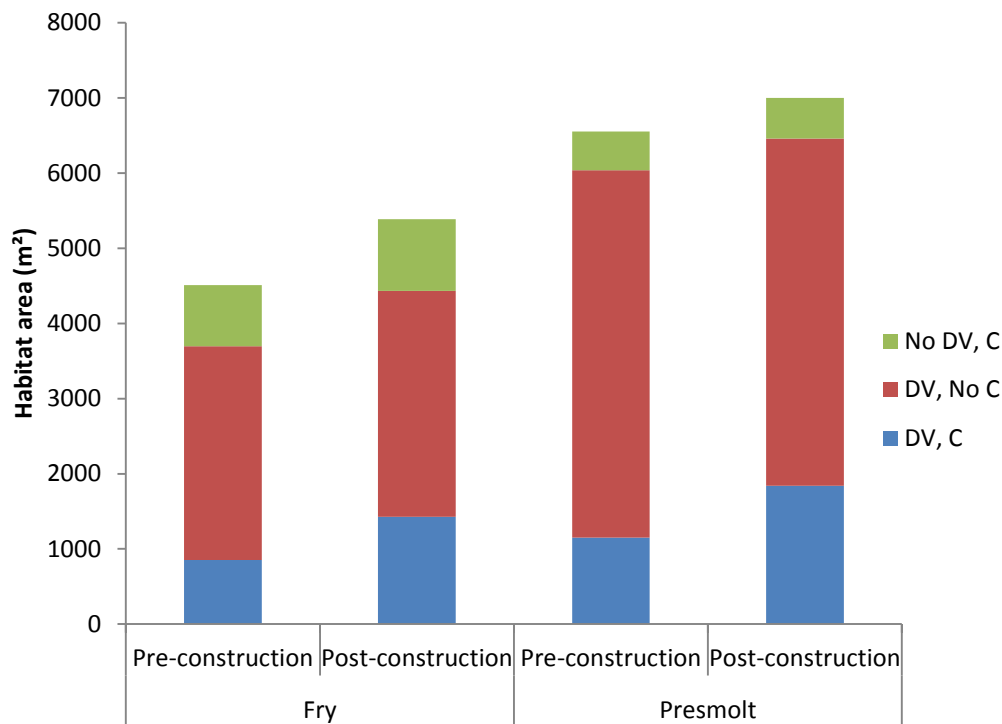
Figure 4. Chinook and coho salmon rearing habitat quantities throughout the mainstem portion of the Sawmill rehabilitation site (rkm 176.5-175.4). Pre-construction estimates were conducted at 8.3cms (294 cfs) in 2009 and post-construction at 8.5 cms (306 cfs) in 2010. Habitat categories correspond to combinations of depth/velocity (DV) and in-water escape cover (C) criteria.

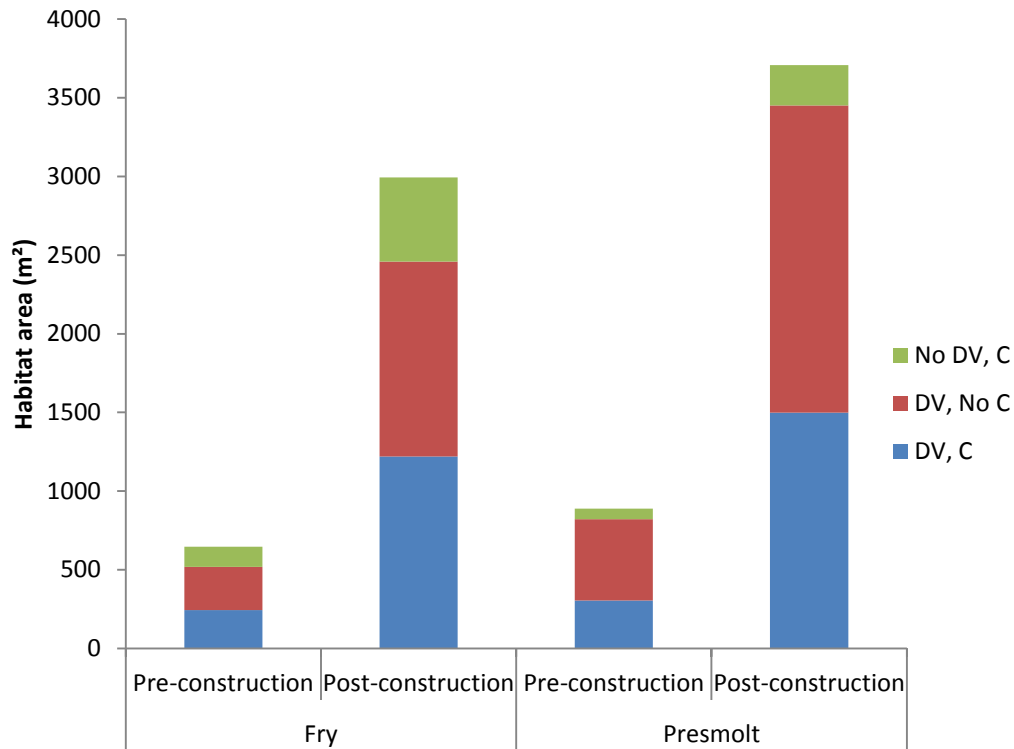
Figure 5. Chinook and coho salmon rearing habitat quantities within the Sawmill Side Channel portion of the Sawmill rehabilitation site (rkm 176.5-175.4). Pre-construction estimates were conducted at a mainstem discharge of 8.3 cms (294 cfs) in 2009 and post-construction at a mainstem discharge of 8.5 cms (306 cfs) in 2010. Habitat categories correspond to combinations of depth/velocity and in-water escape cover criteria.

The re-opening of the Sawmill Side Channel and addition of woody debris created a new low-flow channel that accounted for increases of 2,348 m² of fry and 2,821 m² of presmolt total habitat (Figure 5). These increases in habitat area accounted for 56 % of the fry and 71 % of the presmolt total habitat increases throughout the entire site.

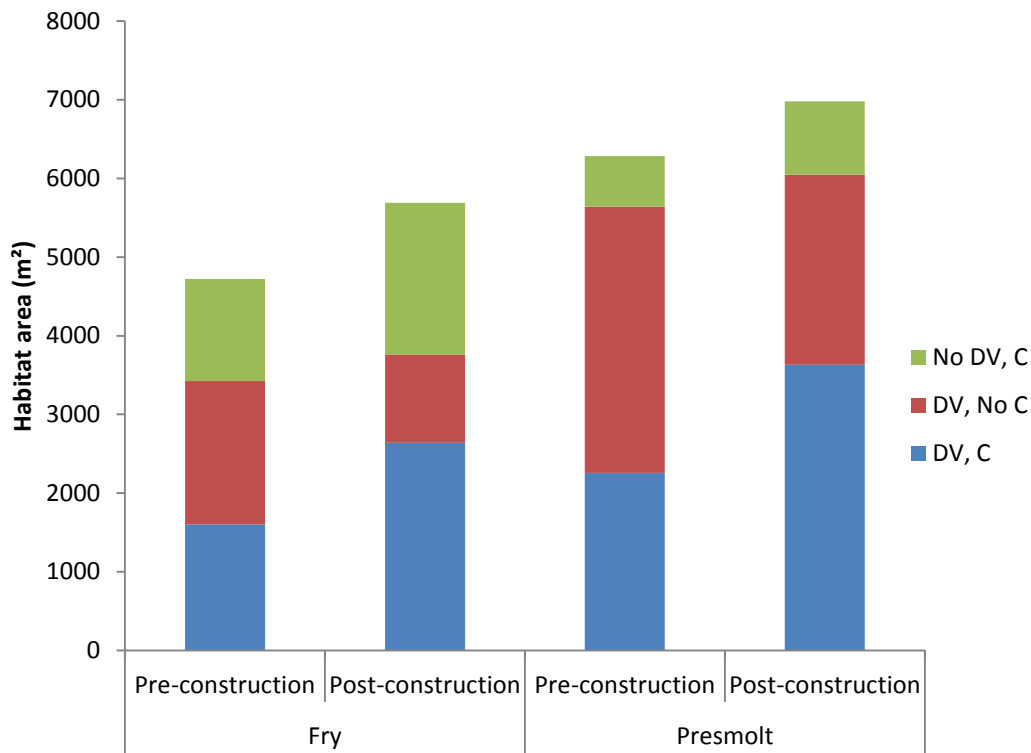
Figure 6. Chinook and coho salmon rearing habitat quantities within the Cemetery Side Channel portion of the Sawmill rehabilitation site (rkm 176.5-175.4). Pre-construction estimates were conducted at a mainstem discharge of 8.3cms (294 cfs) in 2009 and post-construction at a mainstem discharge of 8.5 cms (306 cfs) in 2010. Habitat categories correspond to combinations of depth/velocity (DV) and in-water escape cover (C) criteria.

Cemetery Side Channel, total rearing habitat increased by 967 m² and 698 m² or 20% and 11% for fry and presmolt, with an optimal habitat increase of 65% and 61% (Figure 6).

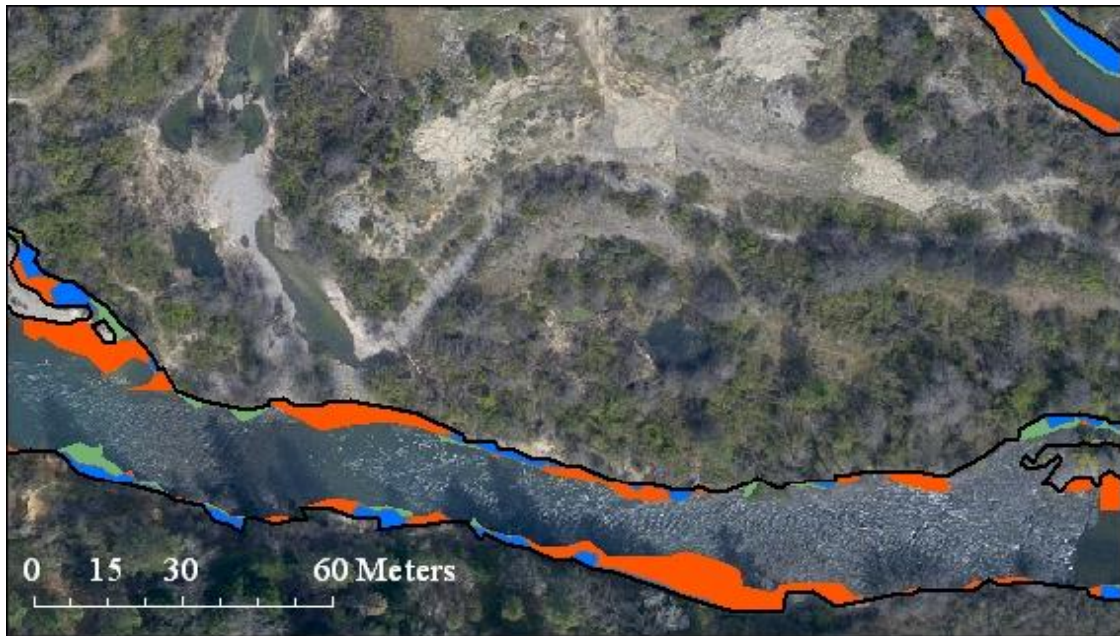
Figure 8. Aerial views of Sawmill Side Channel and mainstem prior to construction (upper photo), and the flowing side channel with newly formed backwater, post-construction (lower photo; rkm 176.2). Black lines indicate the wetted edge, blue areas indicate optimal presmolt habitat and red and green areas indicate suitable presmolt habitat.

A unique and highly valuable habitat feature developed upon activation of the Sawmill Side Channel. Water was able to flow sub-surface from the side channel and emerge approximately 20 m away as a seep forming a heavily vegetated backwater feature. The backwater is 60 m long and covers an area of 425 m². It connects back to the main Sawmill Side Channel and visual observations while mapping detected the presence of Chinook and coho salmon rearing within the feature.

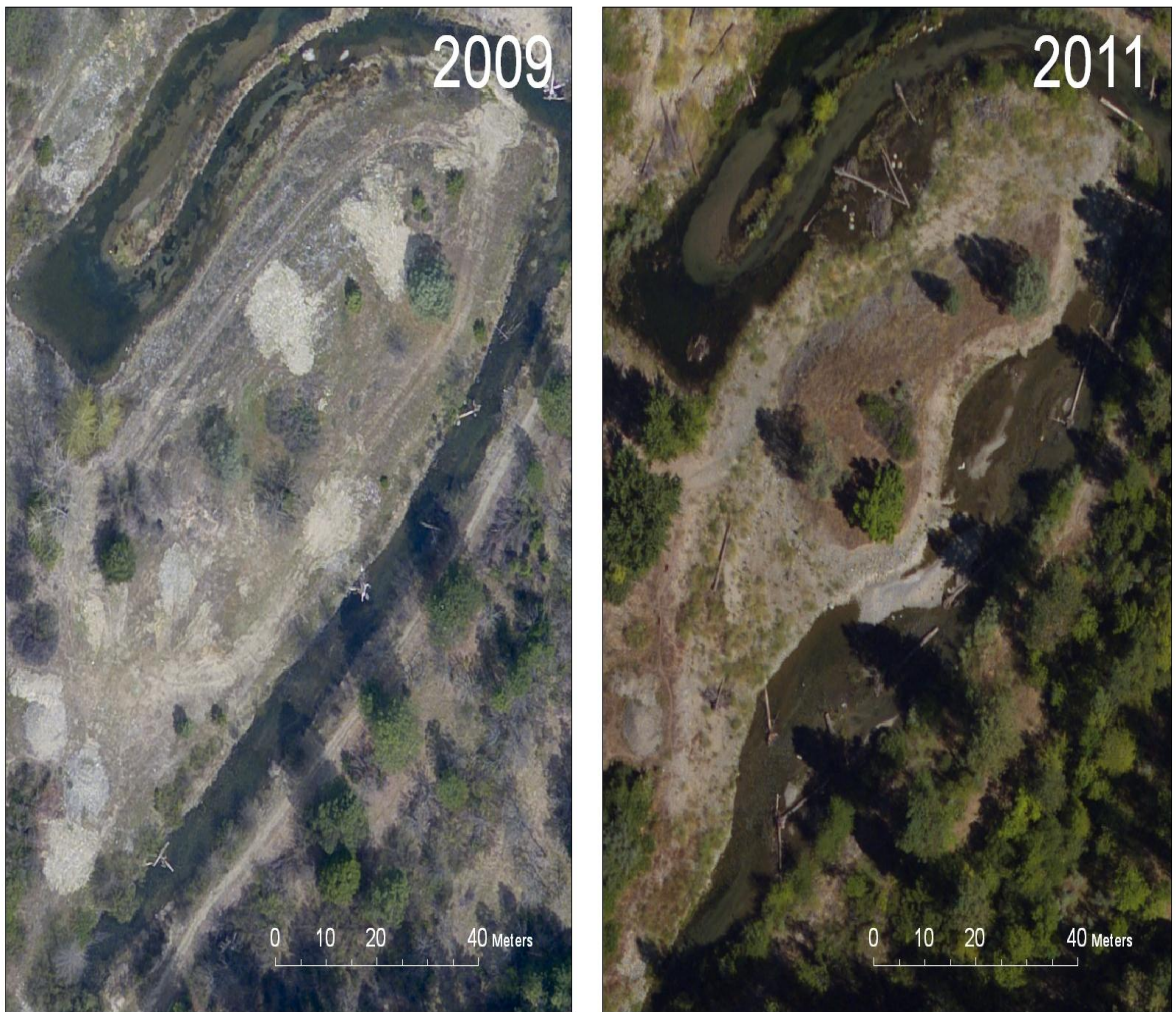
Figure 9. Aerial views of Cemetery Side Channel (rkm 175.75) prior to construction in 2009 (left photo) and post construction, post two high flows in 2011 (right photo). Both photos were taken at summer base flow ~12.7 cms (450 cfs).

The area that received floodplain lowering with the construction of a 42.5 cms (1500 cfs) inundation surface (HVT and McBain and Trush, 2009) and LWD augmentation has experienced significant positive changes. The re-constructed channel is more complex and sinuous and should provide valuable rearing and spawning habitat over a greater range of flows than prior to construction (Figure 9). The interaction of LWD and high flows over the past two seasons since construction have also played a major role contributing to the side channel's present state.

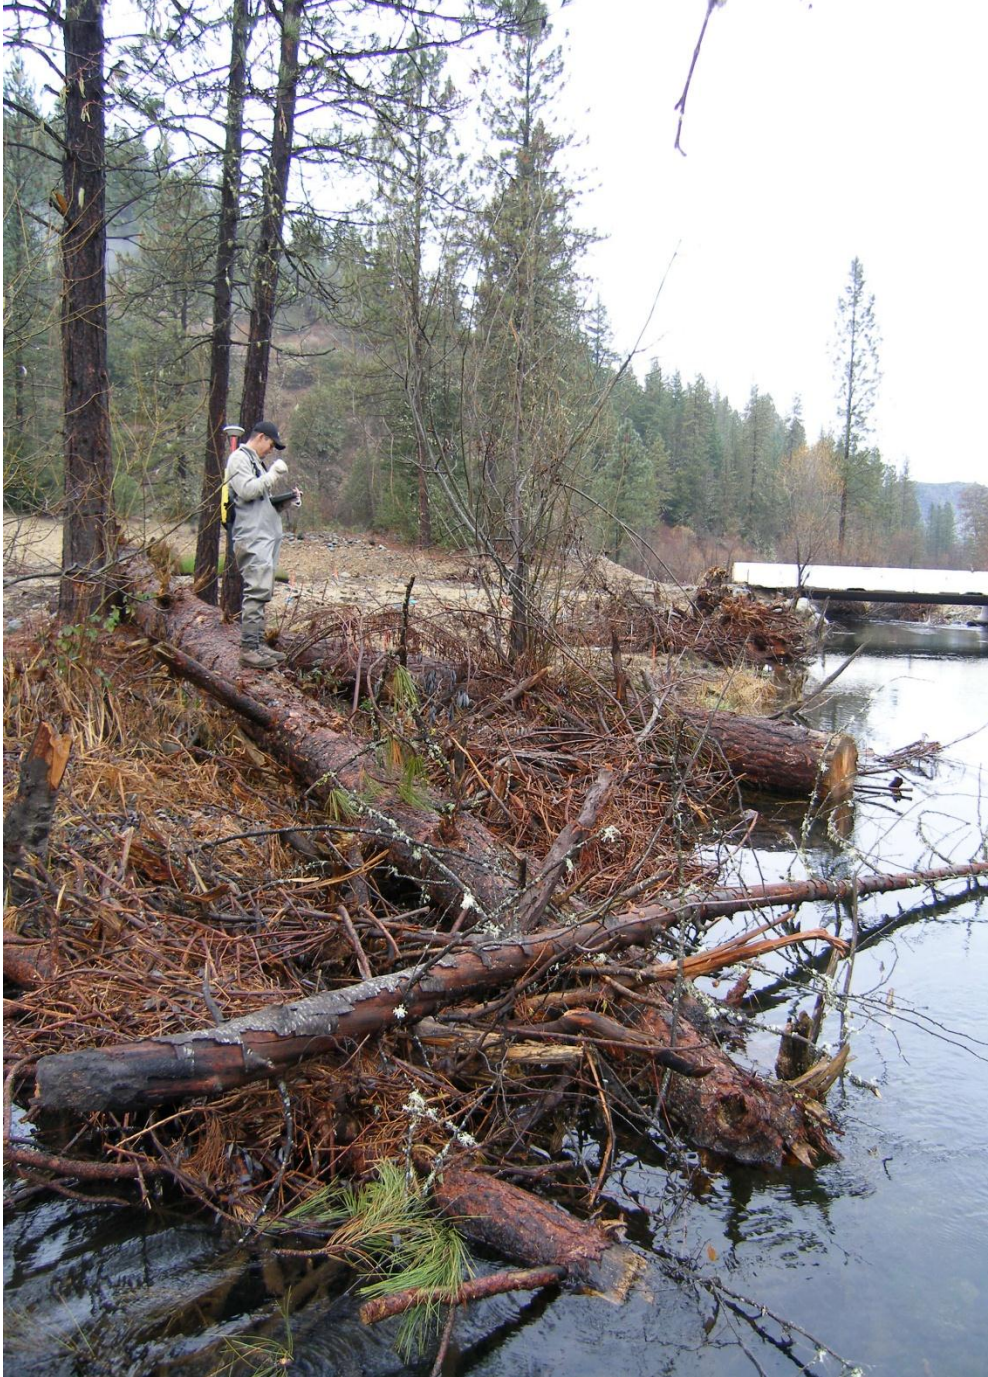
Figure 11. Slash incorporated into a large wood installation at Sawmill rehabilitation site. Large wood installations at previous sites did not incorporate slash, which increases the benefit of these installations to rearing salmonids. Slash increases the physical complexity of these features and therefore increases the quality of the escape-cover attributes for fish habitat.

Large woody debris and other vegetative cover also play a major part in the rehabilitation efforts contributing to the overall habitat gains. Vegetative slash was used at Sawmill in all LWD installations. The slash provides vital escape cover for fry and juvenile rearing immediately after construction when other types of vegetative cover have not yet established (Figure 11). The authors recommend that TRRP continue to incorporate cover components such as LWD, small wood, slash, as well as promote the growth of natural vegetation such as grasses along the wetted channel in all future restoration sites.
