# **LOWER TERWER CREEK OFF-CHANNEL WETLAND ENHANCEMENT**

**Sarah Beesley**  
**Yurok Tribal Fisheries Program**  
PO Box 1027 – Klamath, California 95548

**U.S. Fish & Wildlife Service**  
FY 2009 Partners for Fish & Wildlife Program Funding  
Agreement # 813319J192

**April 2012**

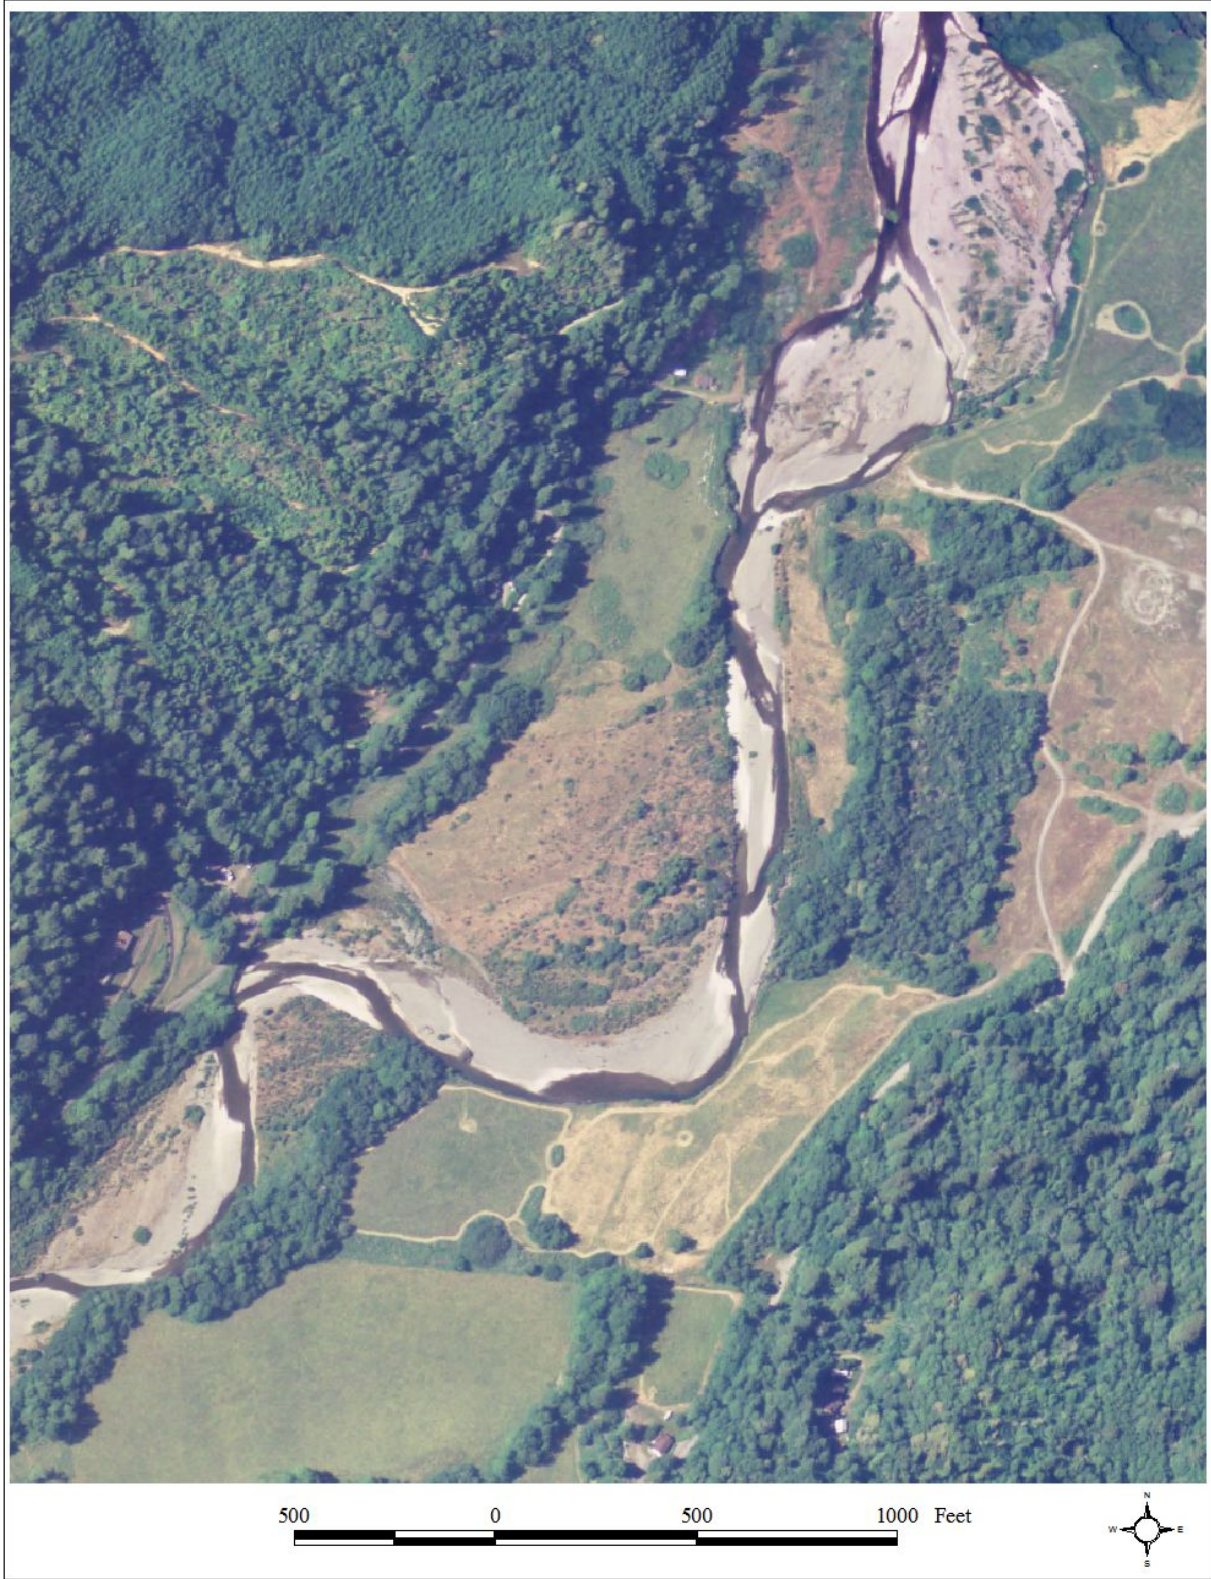
Figure 2. The Lower Arrow Mills Project Area in Terwer Creek, Lower Klamath River Sub-basin, California (Base image: 2005 NAIP Aerial Imagery).

In late summer 2010, YTFP and Rocco Fiori (Fiori GeoSciences – FGS) used heavy equipment to enhance two existing off-channel habitat features in the Lower Arrow Mills project area (Figures 2-5). The off-channel habitat feature located on the west side of Terwer Creek was named Pond A, while the off-channel habitat feature constructed on the east side of the creek was named Pond B (Figures 2-5). The ponds were excavated to increase the size and depth of the features using an excavator and dozer (Figure 6). Excavated materials were loaded into 20-yard dump trucks and transported off-site to an approved disposal area (Figure 6).

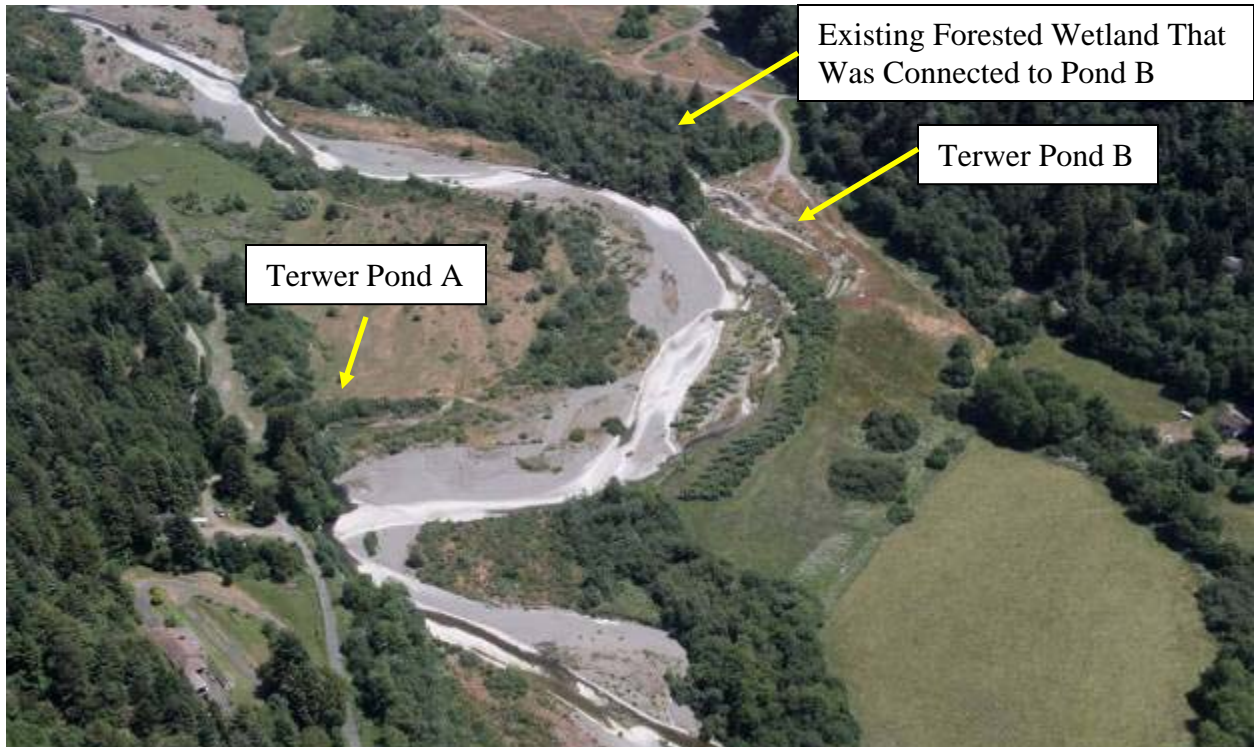
Figure 5. Aerial photograph of lower Terwer Creek depicting recently enhanced off-channel wetland habitats, Lower Klamath River (Summer 2011).

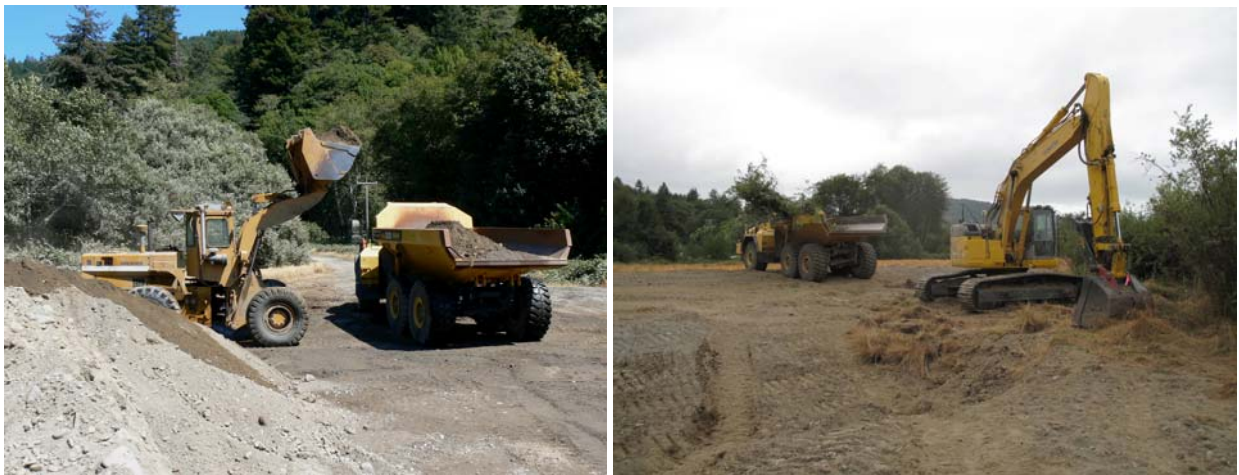
Figure 6. Yurok Tribal Fisheries Program staff using heavy equipment to enhance off-channel habitats in lower Terwer Creek, Lower Klamath River (Summer 2010).

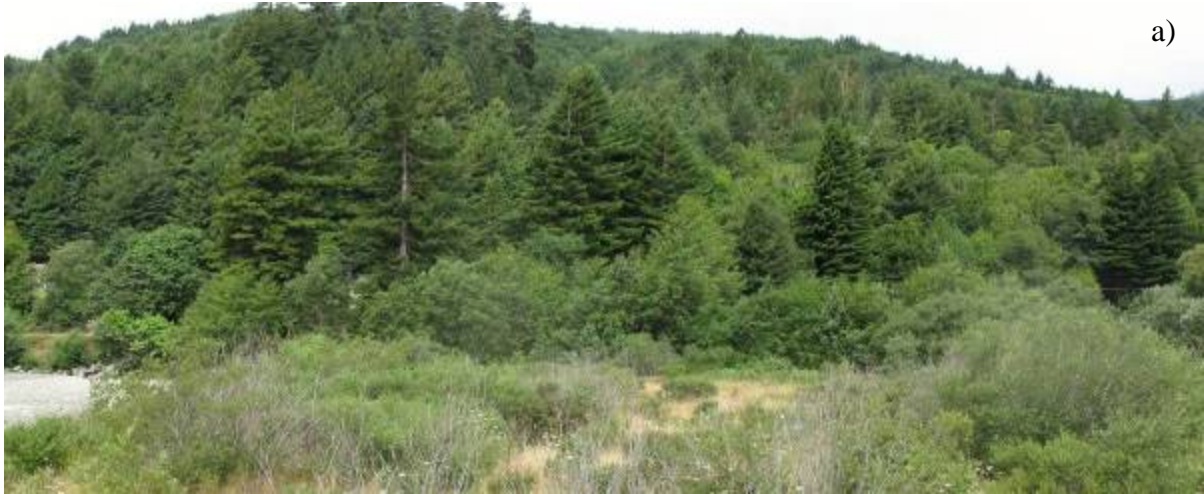
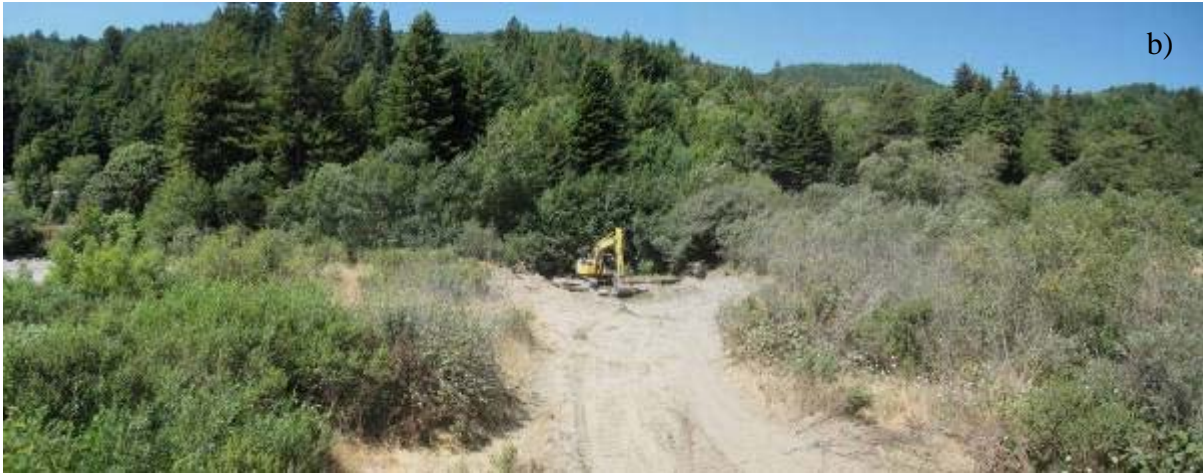
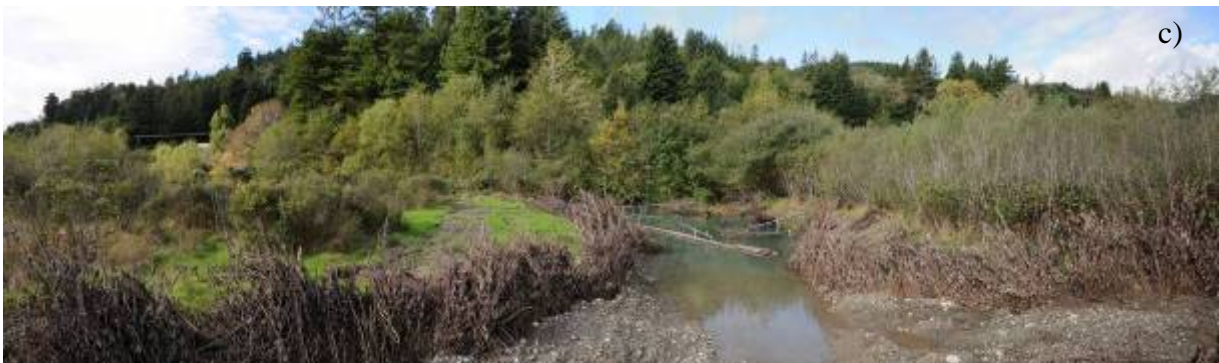
Figure 7. Photographs of Pond A constructed during 2010 in Terwer Creek, Lower Klamath River (Photo Site: TC Pond A-1; Dates: a) July 15, 2010, b) July 27, 2010, and c) 10/30/10).

Off-channel enhancement efforts of Pond A included enhancing the existing outlet channel, construction of a 700 ft side channel feature at the existing inlet, and adding large wood and vegetation (e.g. live willow) to increase habitat complexity (Figures 7-9). The volume excavated to form Pond A was approximately 1,200 cubic yards providing an inundated area of ~ 0.39 acres. The as-built design for Terwer Creek Pond A is presented as Appendix A.

nurse logs and/or viable redwood rootwads), live willow, and native trees (Figures 9-10). Planting islands were configured to provide increased habitat complexity in the newly constructed habitats. In addition to planting island construction, YTFP also installed willow mattresses along the edges of the newly enhanced portion of Pond A (Figure 7).

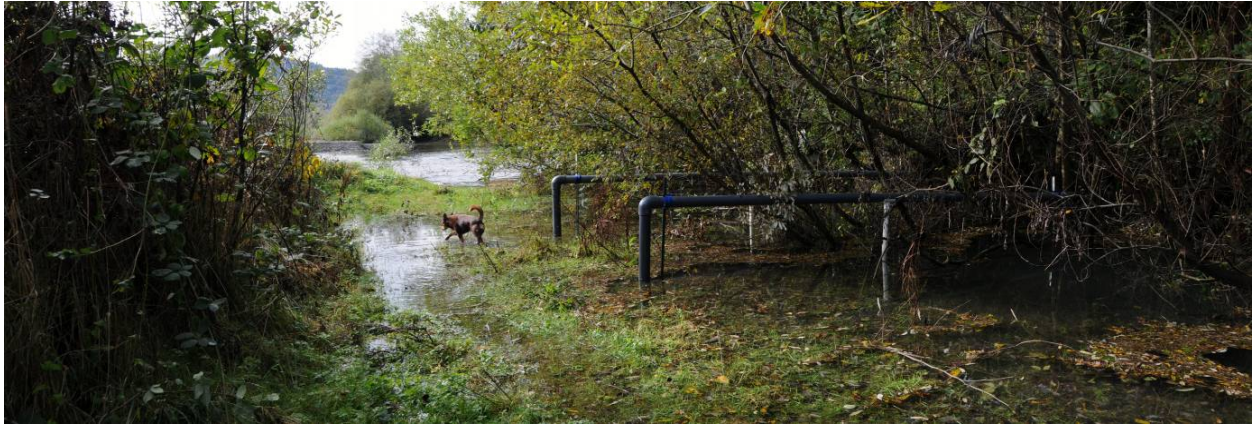
Figure 8. Photograph of the outlet channel and PIT tag antenna arrays of Terwer Creek Pond A.

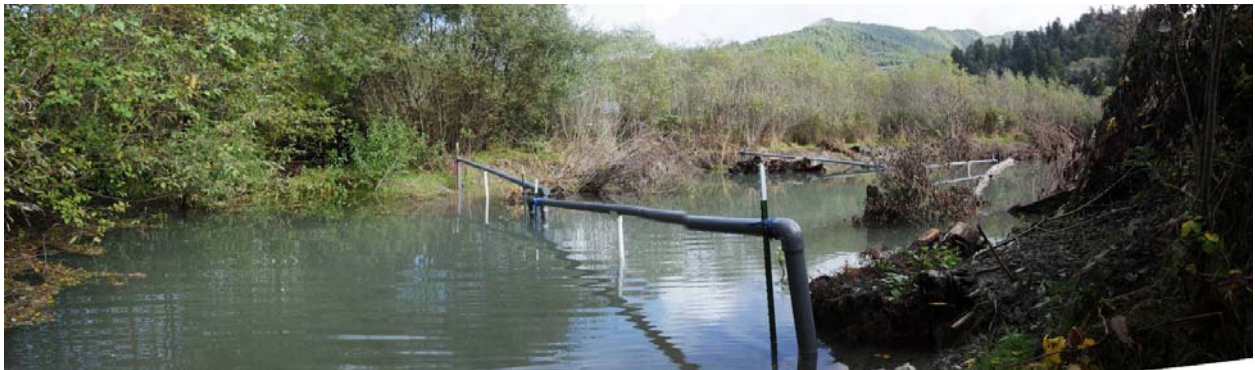
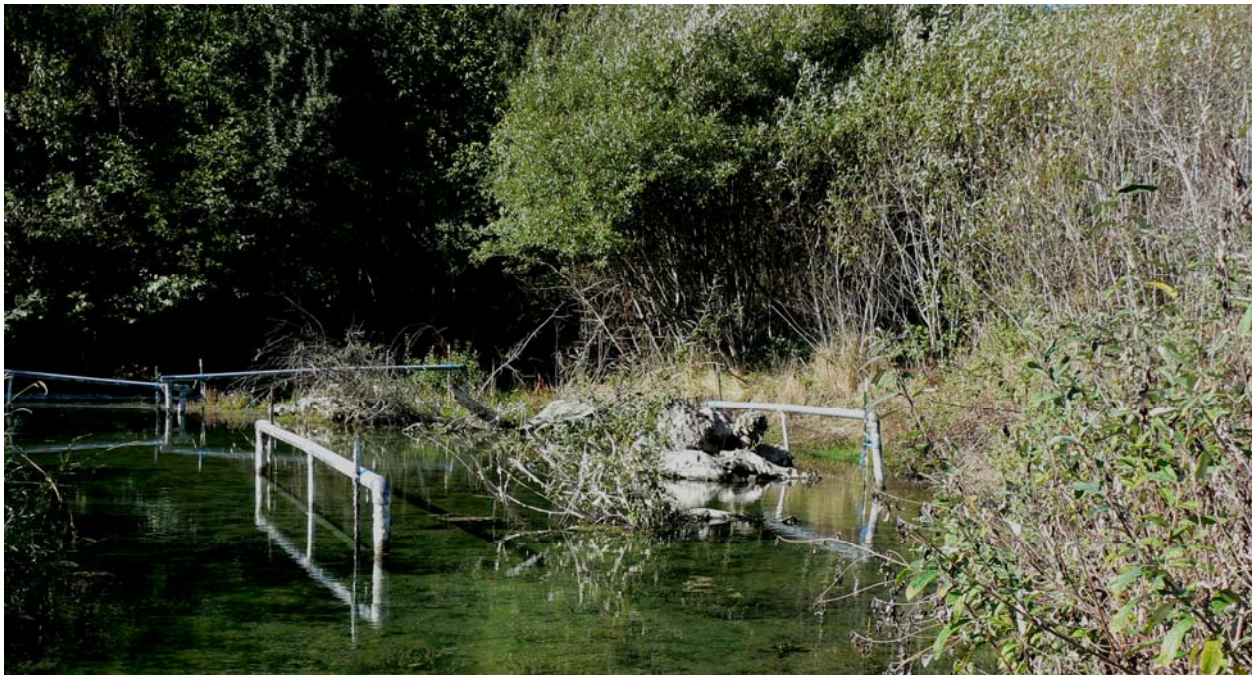
Figure 9. Photographs of the PIT tag antenna arrays and the fish habitat structures constructed in Terwer Creek Pond A (Winter 2011 – Top; Fall 2011 – Bottom).

A total of six planting islands (a.k.a. fish habitat structures) were constructed in Terwer Creek Pond A and five were installed in the constructed side channel using an excavator and hand crews (Figures 9-10). Planting islands consisted of a combination of large wood materials (e.g.

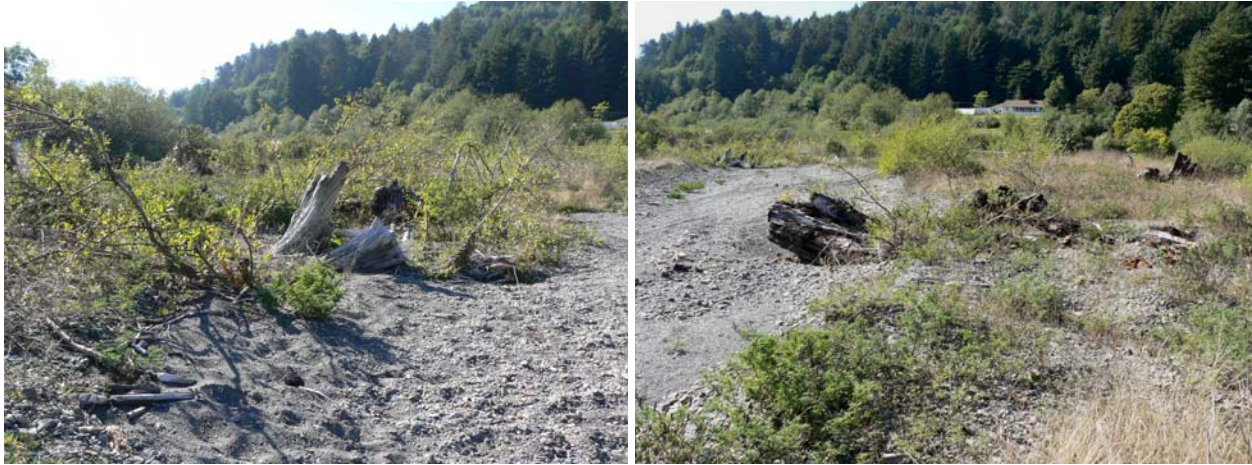
Figure 10. Photographs of large wood and willow planting islands installed in a constructed side channel feature of lower Terwer Creek.

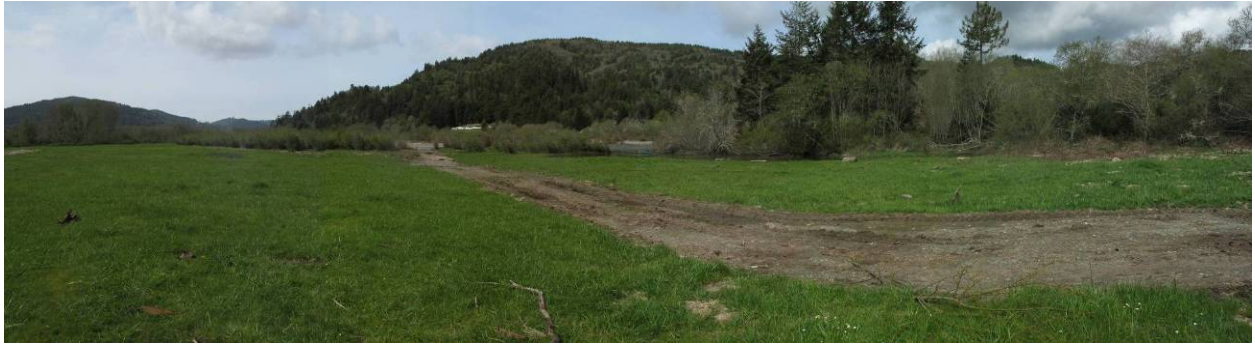
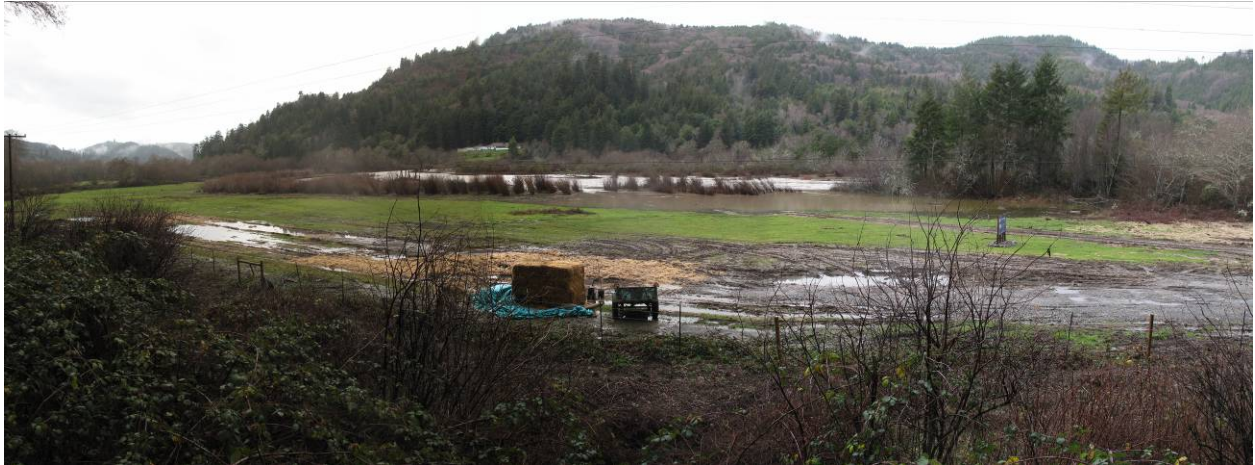
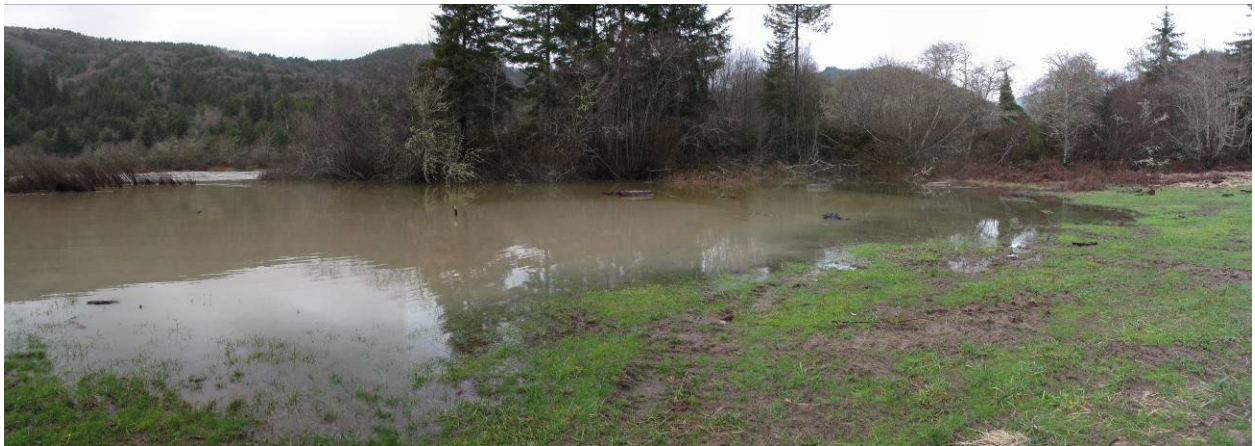
Figure 11. Photographs of Terwer Creek Pond B prior to enhancement efforts during summer (Top) and during winter flows (Middle and Bottom), Lower Klamath River (2009).

Off-channel enhancement efforts of Pond B included construction of a ~300 ft outlet channel, enhancing the existing inlet channel, removing a relic levee to connect Pond B to an existing ~3.5 acre wetland, and adding large wood and vegetation (e.g. live willow and wetland plants) to increase habitat complexity (Figures 11-13). The volume excavated to form Pond B was approximately 5,200 cubic yards providing an inundated area of ~ 1.1 acres. The as-built design for Terwer Creek Pond B is presented as Appendix B.

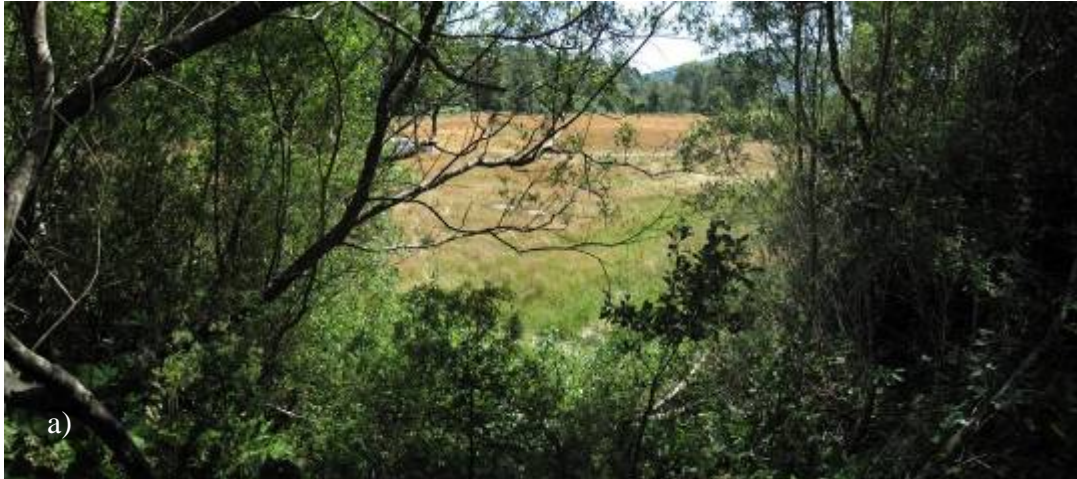
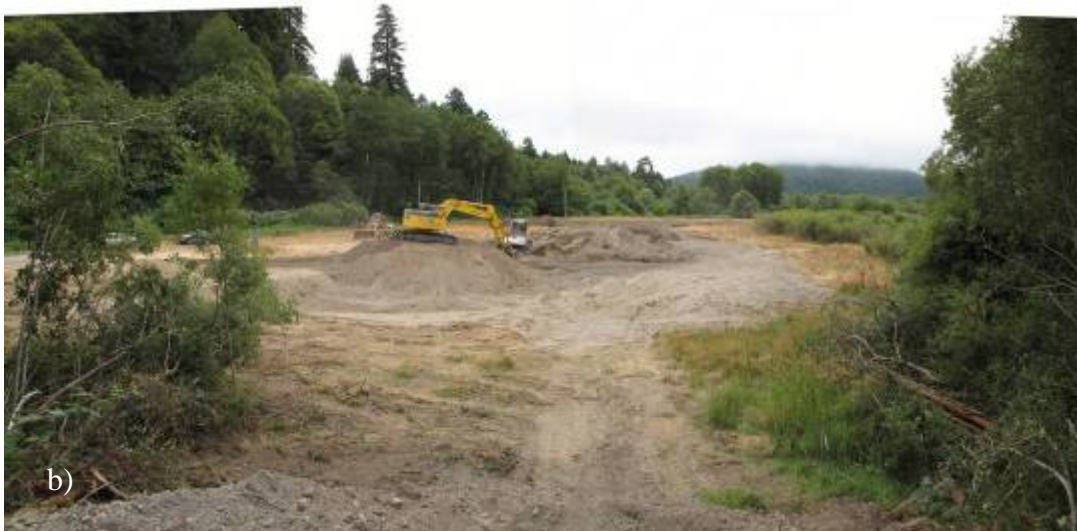
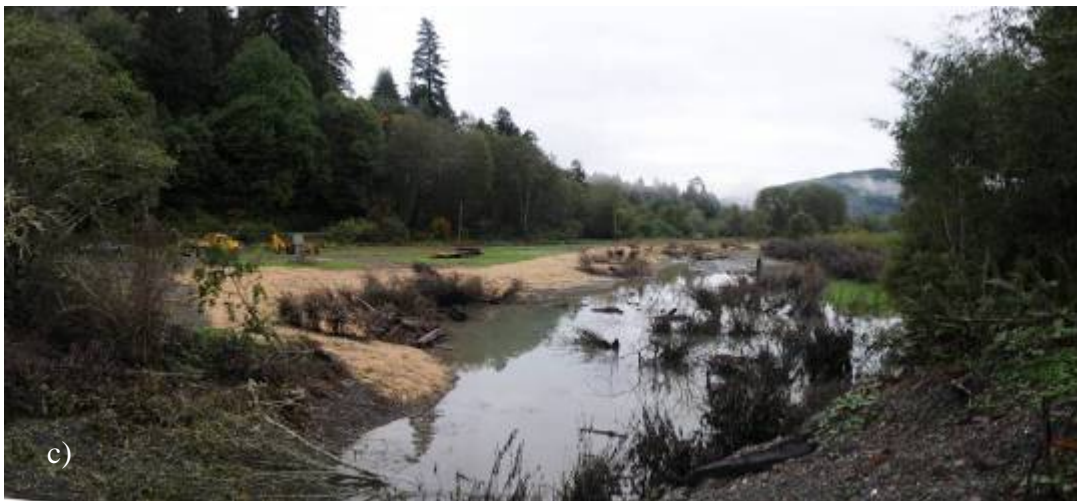
Figure 12. Photographs of Pond B constructed during 2010 in Terwer Creek, Lower Klamath River (Photo Site: TC Pond B-1; Dates: a) 7/15/10, b) 7/28/10, and c) 10/31/10).

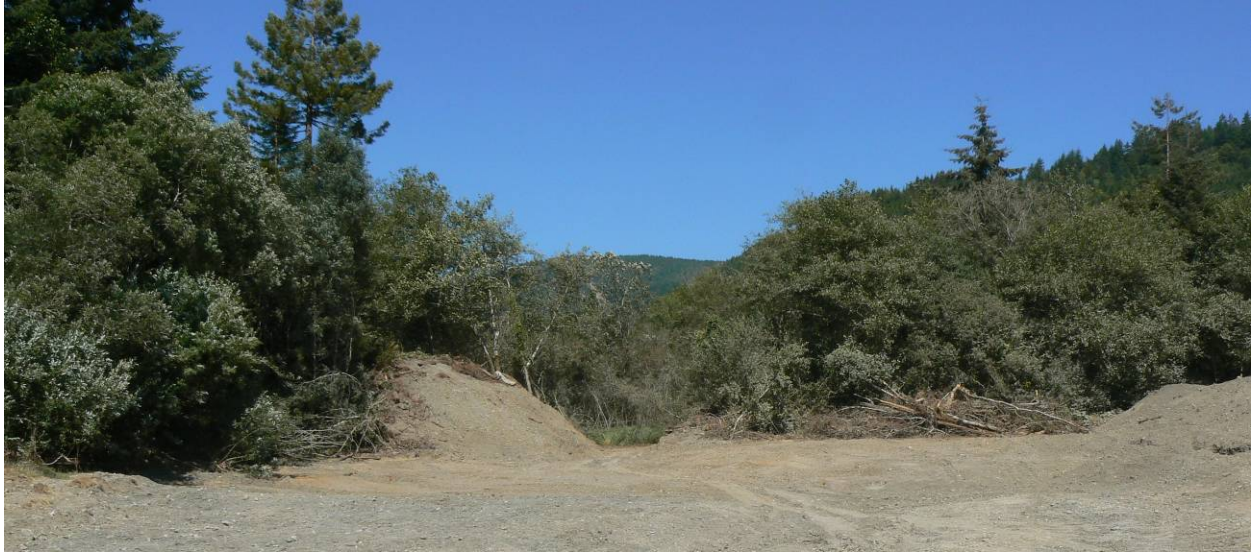
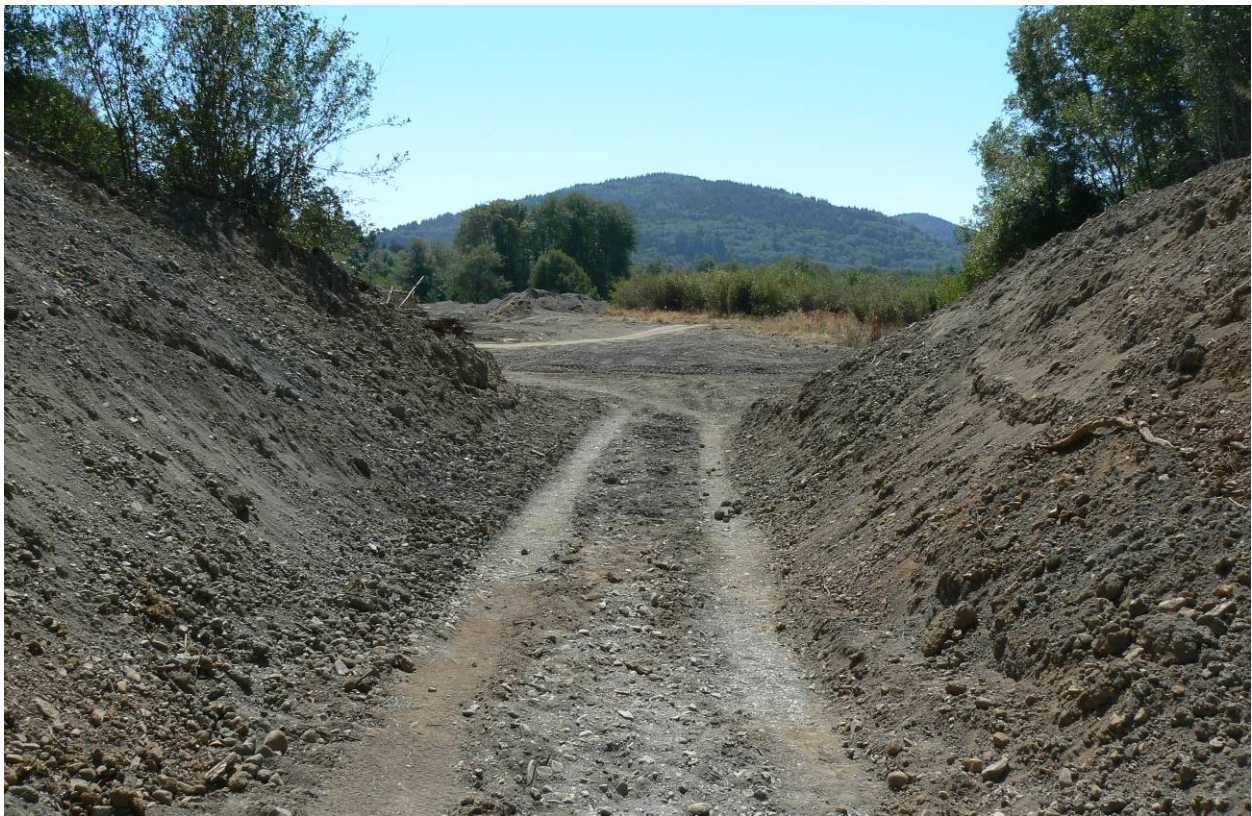
Figure 13. Photographs looking upstream at the breached levee and existing wetland habitats (Top) and looking downstream through the breached levee during off-channel habitat enhancement of Terwer Creek Pond B, Lower Klamath River (summer 2010).

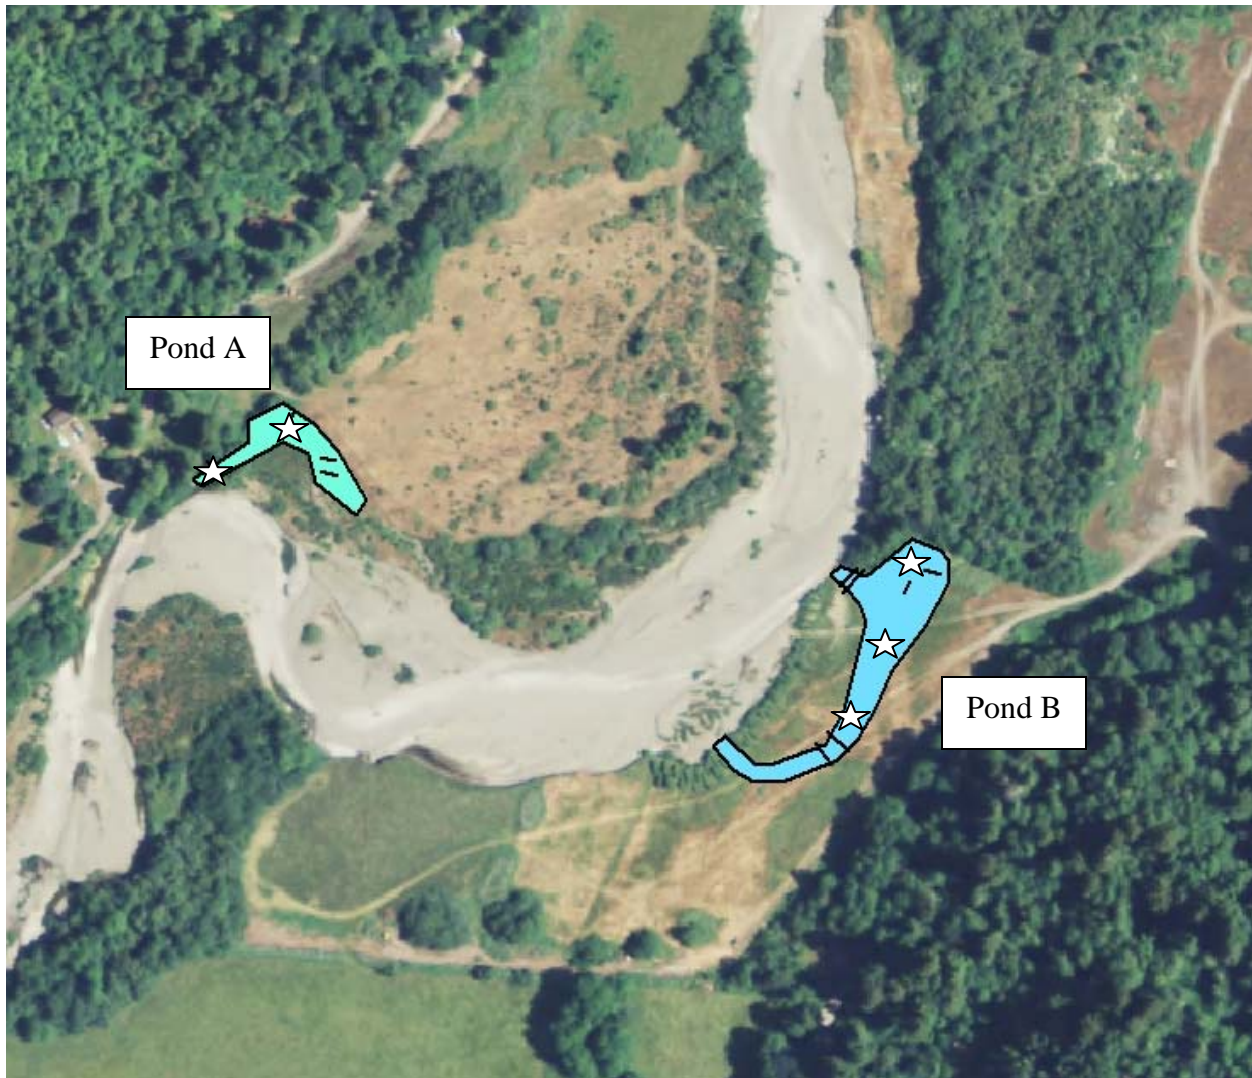
Figure 14. Map depicting water quality monitoring sites (stars) within two constructed off-channel wetlands of Terwer Creek, Lower Klamath River (Base Image: 2009 NAIP imagery).

In fall 2010, crews established two permanent water quality monitoring sites in Terwer Creek Pond A: Pond A\_Outlet, and Pond A\_Middle (Figure 14). YTFP deployed HydroLab Datasondes (datasonde) at these monitoring sites to document diurnal fluctuations in water

Crews established three permanent water quality monitoring sites in Terwer Creek Pond B: Pond B\_Upper, Pond B\_Middle, and Pond B\_Lower (Figure 14). These three sites were monitored during January 2011 to document diurnal fluctuations in water quality parameters (Figures 19-20). Dissolved oxygen values were the least variable at Pond B\_Upper with a range from 6.21 to 7.79 mg/L (Figure 19). Dissolved oxygen values recorded at the Pond B\_Middle and Pond B\_Lower sites were higher and more variable relative to values recorded at Pond B\_Upper (Figure 19). Dissolved oxygen values ranged from 7.62 to 11.39 mg/L at Pond B\_Middle and ranged from 7.49 to 12.86 mg/L at Pond B\_Lower (Figure 19). Water temperature during the January monitoring period ranged from 7.5 to 12.1 °C at the three monitoring sites (Figure 19).

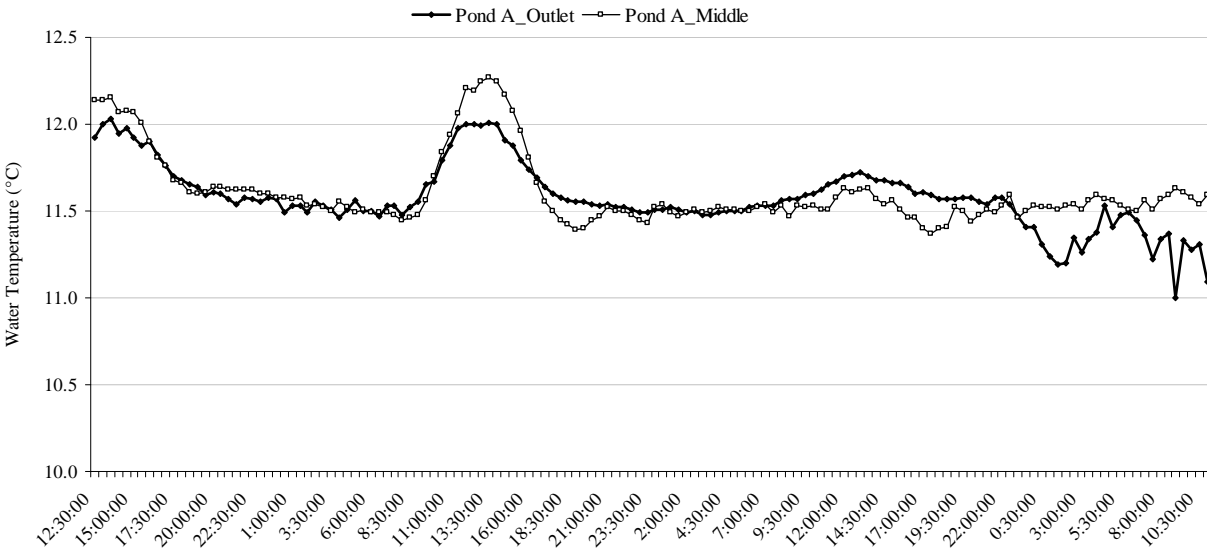
Figure 15. Water quality data (Dissolved Oxygen (DO), Water Temperature) collected from 11/24/10 (12:30 hours) to 11/27/10 (11:00 hours) at two monitoring sites located within Terwer Creek Pond A, Lower Klamath River.

Water quality was monitored at the Terwer Pond A sites during November 2010 (Figures 15-16) and during late February – early March 2011 (Figures 17-18). In fall 2010, water quality was more variable at the Terwer Pond A\_Outlet site compared to conditions recorded at Pond A\_Middle (Figures 15-16). Dissolved oxygen values ranged from 7.81 to 8.93 mg/L at

Pond A\_Outlet and ranged from 7.87 to 8.84 mg/L at the Pond A\_Middle site (Figure 15). Water temperature during the fall monitoring period ranged from 11.0 to 12.3 °C at the two monitoring sites (Figure 15). Specific conductance values recorded during November were similar for the two sites for most of the sampling period (Figure 16). Specific conductance values ranged from 75.4 to 88.7  $\mu\text{S}/\text{cm}$  at Pond A\_Outlet and ranged from 82.9 to 89.7  $\mu\text{S}/\text{cm}$  at the Pond A\_Middle site (Figure 16). Recorded values for pH ranged from 6.28 to 6.64 during November for the two sites (Figure 16).

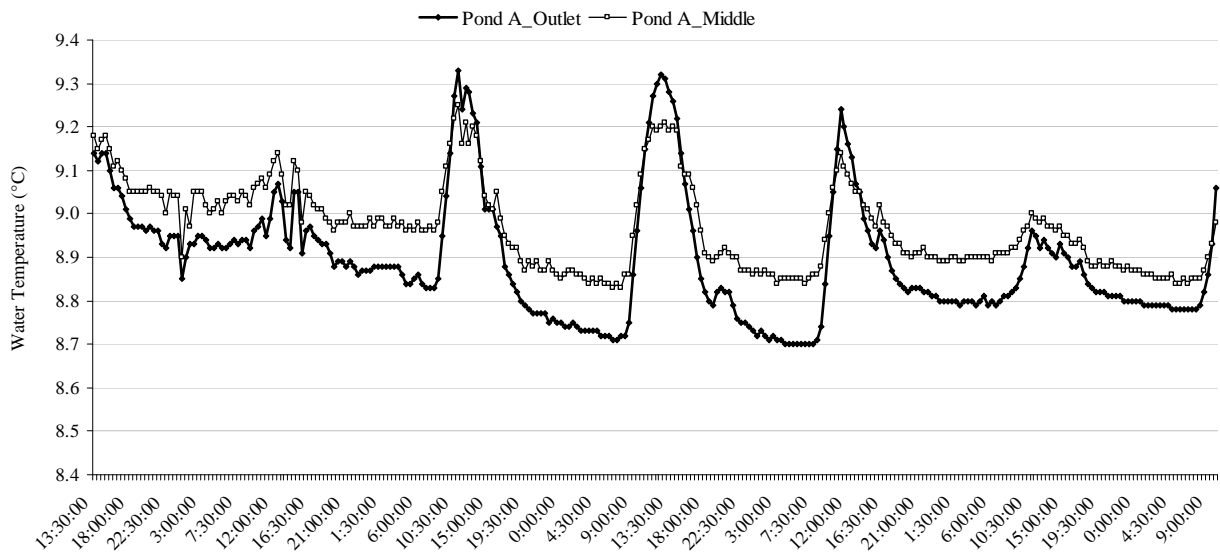
Figure 17. Water quality data (Dissolved Oxygen (DO), Water Temperature) collected from 02/23/11 (13:30 hours) to 03/01/11 (10:00 hours) at two monitoring sites located within Terwer Creek Pond A, Lower Klamath River.

Water quality patterns were similar for the two sites during the winter 2011 monitoring period; however, dissolved oxygen values recorded at Pond A\_Outlet were on average 0.43 mg/L higher than values recorded at Pond A\_Middle (Figure 17). Dissolved oxygen values ranged from 8.42 to 9.35 mg/L at Pond A\_Outlet and from 7.99 to 8.85 mg/L at Pond A\_Middle (Figure 17). Water temperature during the winter monitoring period ranged from 8.7 to 9.3 °C at Pond A\_Outlet and from 8.8 to 9.3 °C (Figure 17). Water temperatures were slightly higher (Average of 0.07 °C higher) at Pond A\_Middle relative to temperatures recorded at Pond A\_Outlet (Figure 17). During this monitoring period, specific conductance values ranged from 66.7 to 68.1  $\mu\text{S}/\text{cm}$  at Pond A\_Outlet and from 66.9 to 68.5  $\mu\text{S}/\text{cm}$  at the Pond A\_Middle site (Figure 18). Recorded values for pH ranged from 6.17 to 6.66 during winter for the two sites (Figure 18).

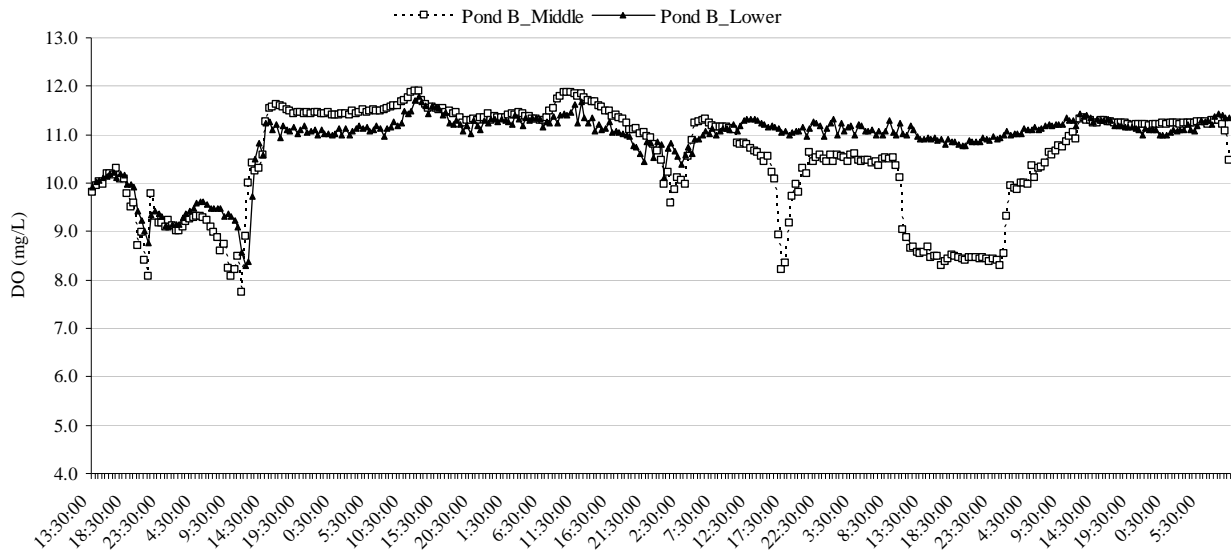
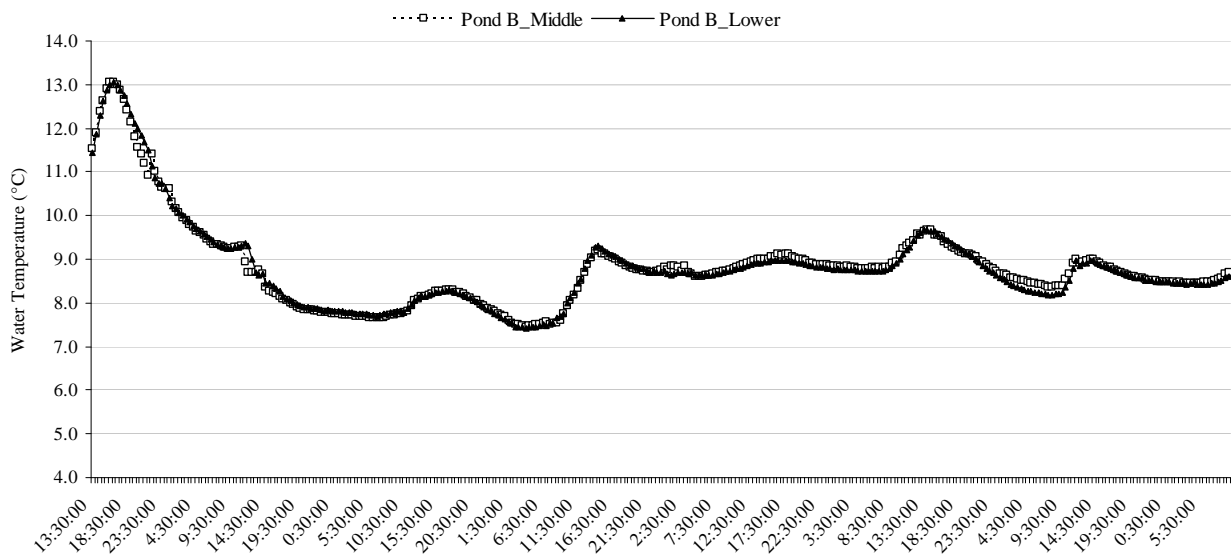
Figure 21. Water quality data (Dissolved Oxygen (DO), Water Temperature) collected from 03/01/11 (13:30 hours) to 03/08/11 (09:30 hours) at two monitoring sites located within Terwer Creek Pond B, Lower Klamath River.

Water quality was also monitored in Terwer Creek Pond B during early March 2011. Unfortunately only two datasondes were available so only Pond B\_Middle and Pond B\_Lower were monitored during this period. Water quality conditions were very similar for these two sites during the March monitoring period (Figures 21-22). Dissolved oxygen values ranged from 7.74 to 11.90 mg/L and water temperatures were from 7.4 to 13.0 °C at these two sites during this monitoring period (Figure 21). Specific conductance ranged from 52.9 to 73.4  $\mu\text{S}/\text{cm}$  and pH values ranged from 6.42 to 7.68 at these two sites (Figure 22).

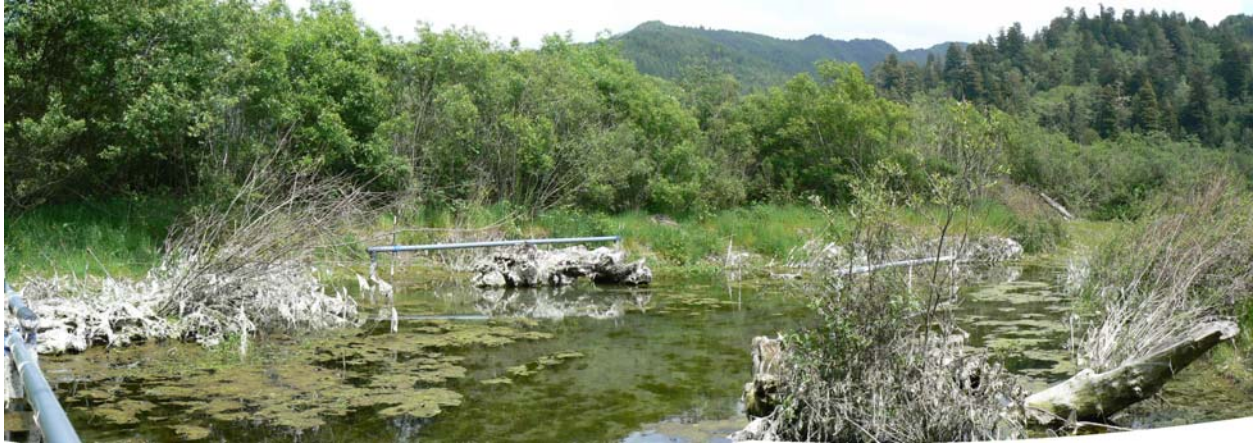
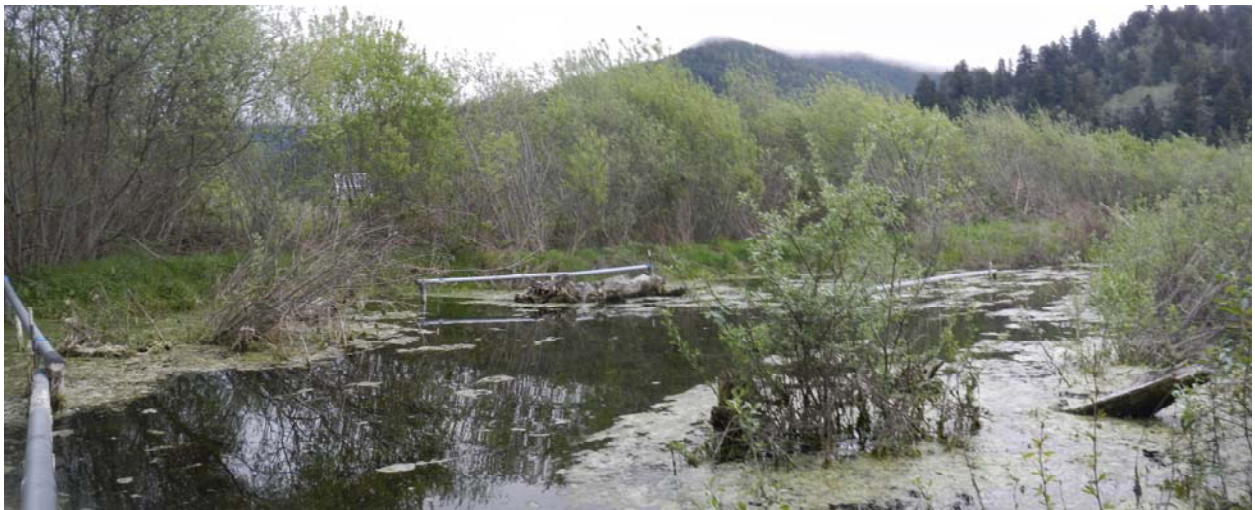
Figure 24. Photographs taken from a permanent photo-monitoring site in Terwer Creek, Lower Klamath River (Site: TC Pond A-3: Top-May 2011, Bottom-April 2012).

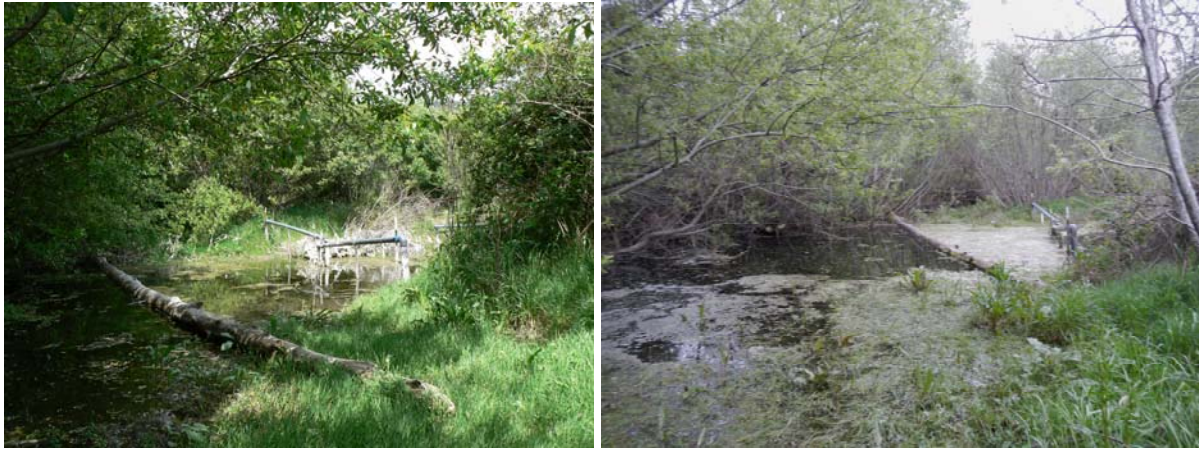
Figure 24. Photographs taken from a permanent photo-monitoring site in Terwer Creek, Lower Klamath River (Site: TC Pond A-2: Top-May 2011, Bottom-April 2012).

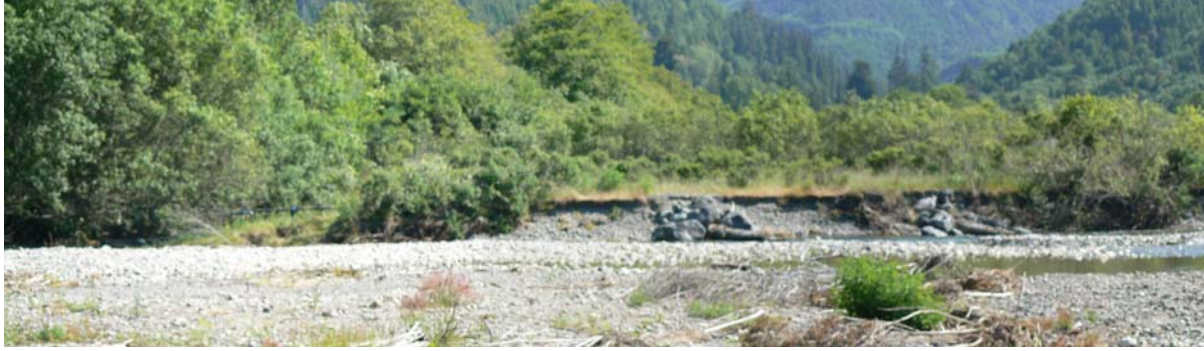
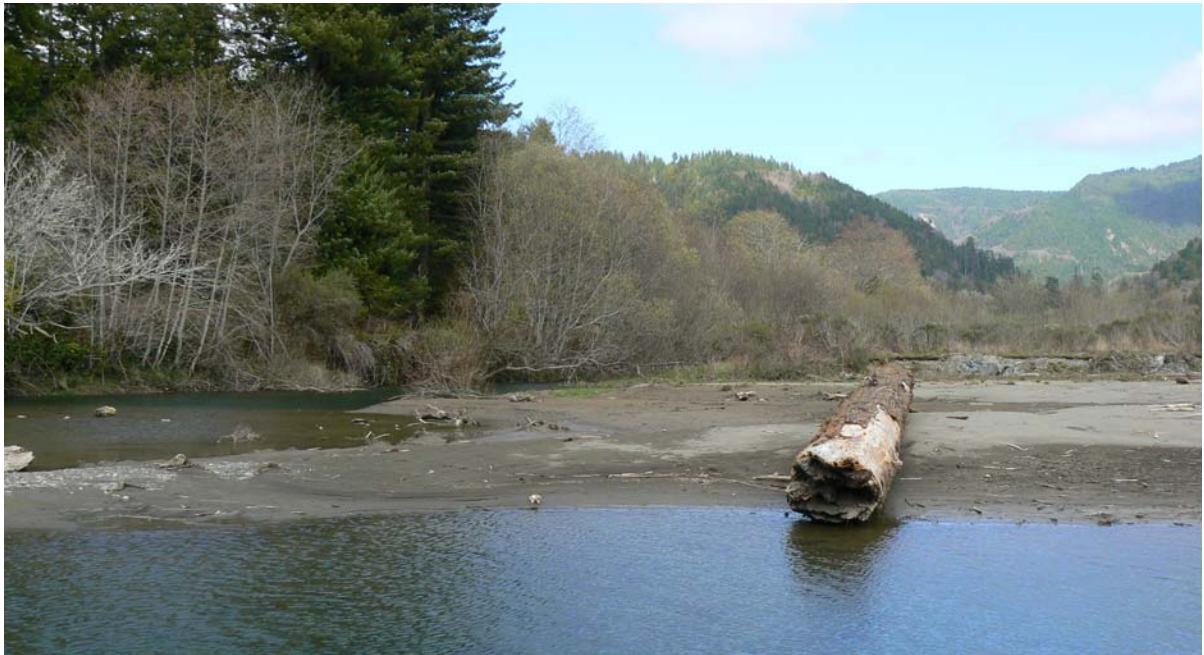
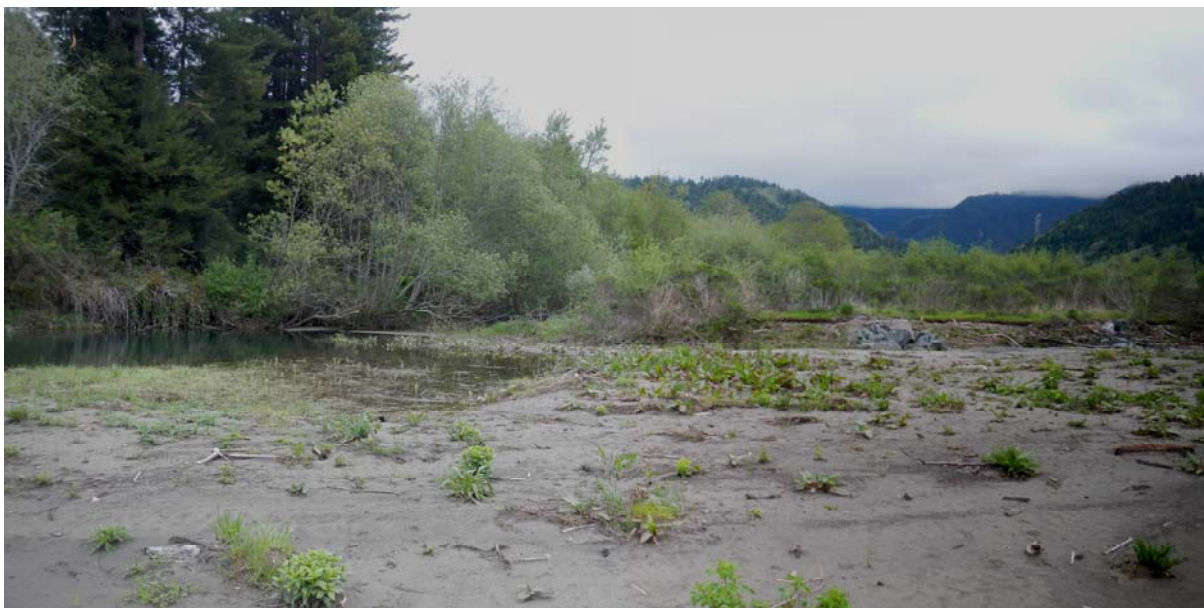
Figure 25. Photographs taken from a permanent photo-monitoring site in Terwer Creek, Lower Klamath River (Site: TC Pond A-Outlet: Top 6/17/10, Middle 5/25/11, Bottom 4/24/12).
