# Terwer Creek Riparian Restoration Project

Klamath River Basin Fisheries Task Force  
Project # 2004-HR-04/2005-HR-02  
FY 2004 Agreement #113334J005  
FY 2005 Agreement #813335J003

January 23, 2007

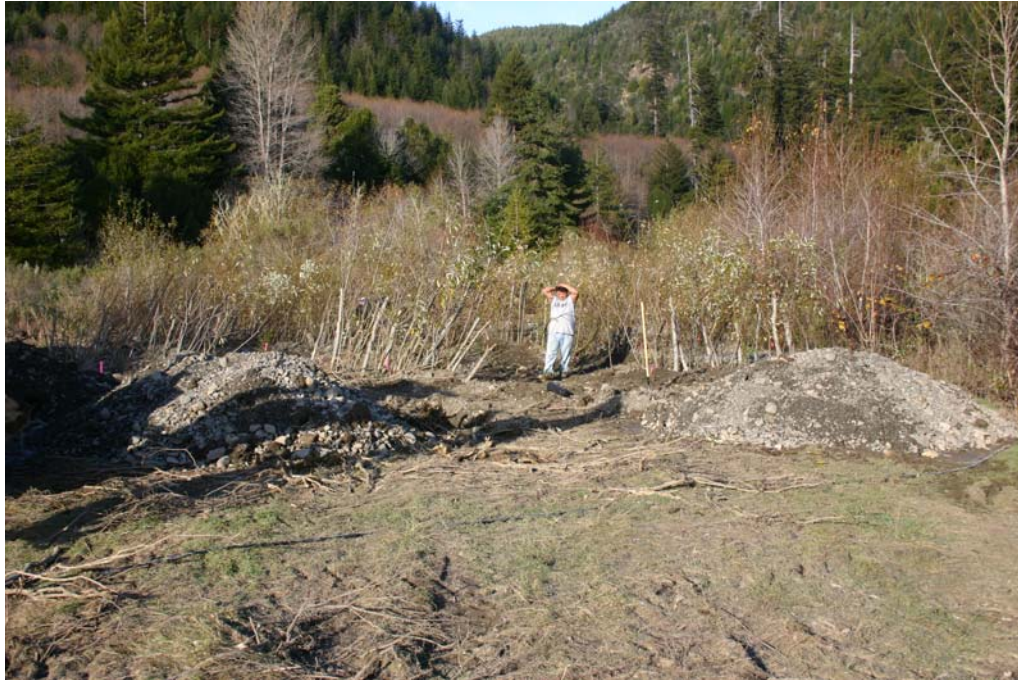
Following the onset of fall rain and resumption of streamflow in the project reach, the crew moved away from the active channel and began work on constructing willow baffles on the adjoining flood terrace (Figure 50). These baffles were constructed

Figure 50. YTFP staff installing willow baffles on adjoining flood terrace, Lower Terwer Creek, Lower Klamath River, 2005.
