## **Terwer Creek**

## **Terwer Creek Restoration Background**

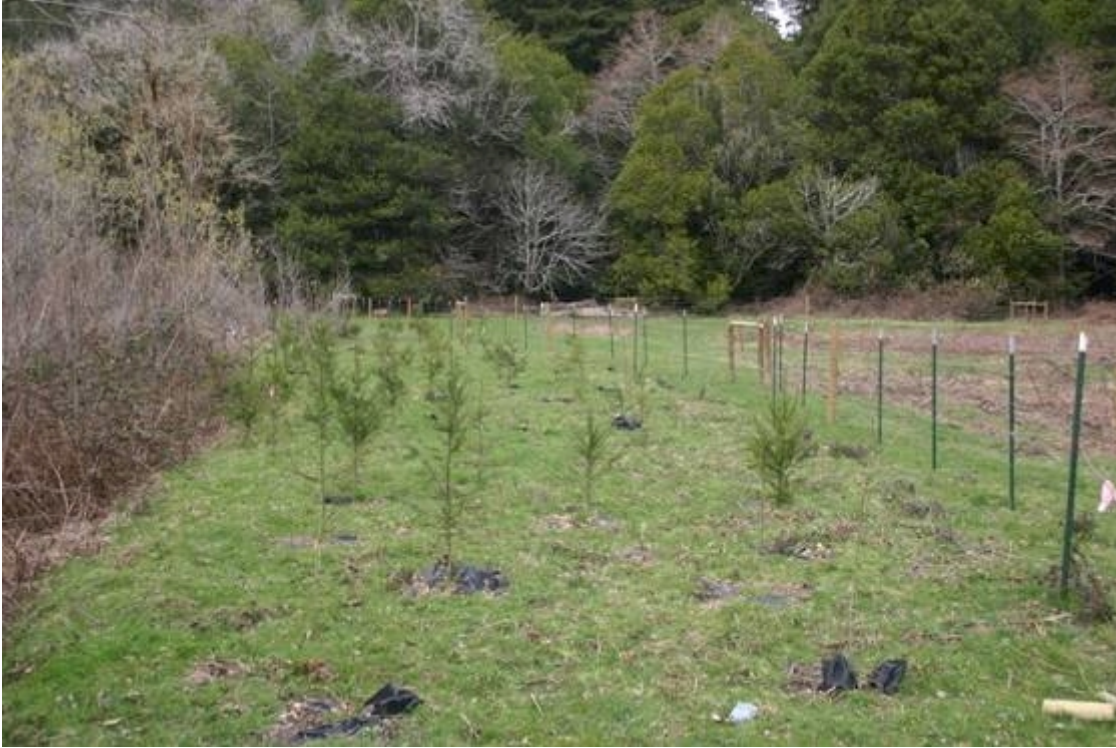
Figure 41. Riparian area in lower Terwer Creek following planting efforts by Yurok Tribal Fisheries Program staff, Lower Klamath River Sub-basin, California (2007).

banks using willow revetment techniques (i.e. siltation baffles and sprigs) (Figure 39) and large wood structures (Figure 40); and 3) planting floodprone surfaces and terraces with native willow, maple, cottonwood, and conifers (Figure 41).

leaf maple, 160 black cottonwood, 41 red alder, and 200 bare-root Douglas fir (Figure 41). The deciduous trees were started from seed (maples and alders) or cuttings (cottonwood) and were grown out for over a year at the YTFP native tree nursery.

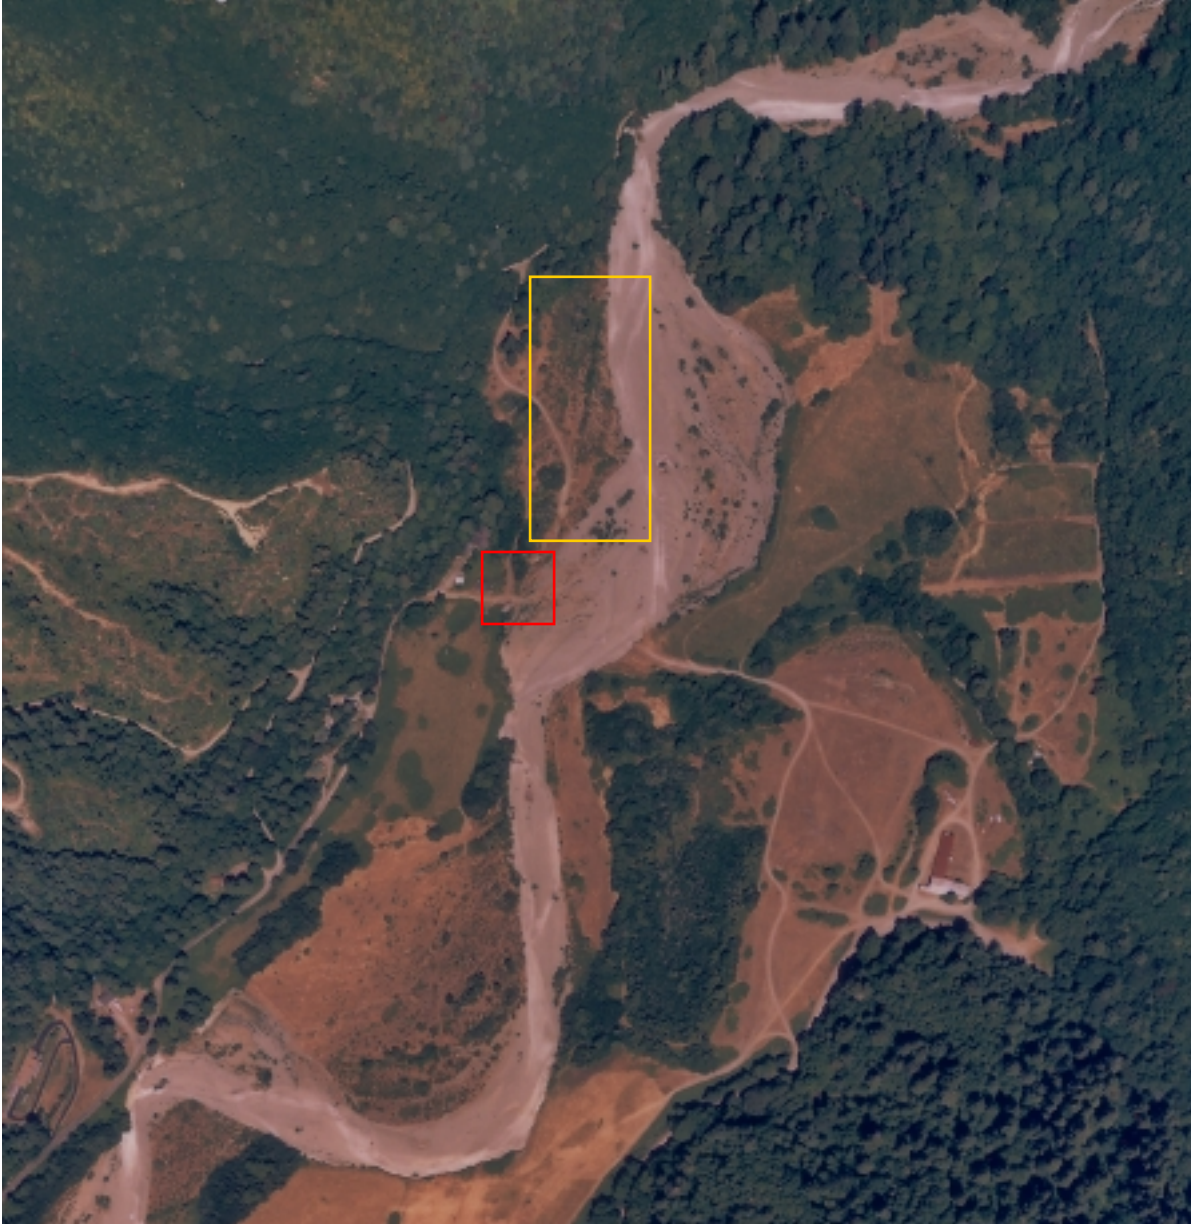
In February 2005, YTFP conducted an emergency repair of a rapidly eroding bank located on the west side of Terwer Creek across from Arrow Mills (Figure 44) (Gale 2006a). Channel instability related to excessive sedimentation of fluvial habitats, large-scale riparian dysfunction, and a severe lack of instream wood accumulations resulted in over ten feet of lateral bank erosion during winter 2004-2005 and threatened valuable infrastructure such as private roads, pastures, and a domestic water supply well. YTFP used 200 tons of quarry boulders to stabilize ~100 feet of eroding bank with the intention of removing the material when alternative measures could be employed to ensure local channel stability and long-term infrastructure protection. Boulders were placed along the eroding bank up to the level of the adjoining road to minimize any additional erosion or lateral channel migration. The treatment resulted in the prevention of an estimated 600 cubic yards of sediment delivered to the stream had the erosion continued. An additional 275 tons of quarry rock was stockpiled at the site for rapid treatment of additional erosion problems should they arise. The surplus quarry rock was used to treat other priority sites in lower Terwer Creek during summer 2006.

Figure 44. Map of the Lower Terwer Creek Emergency Bank Protection Project (outlined in red), and the Farley Restoration Project (outlined in gold), Lower Klamath River Sub-basin, California (2004 Air Photo).

YTFP continued working with GDRC and Mr. Farley to implement stream and riparian enhancement on the west bank of Terwer Creek just upstream of the emergency repair site (Figure 44). Activities conducted in this area were similar to those implemented at the Arrow Mills site located directly across the creek (Figure 37) (Gale 2006b). The main objective was to address 1,250 feet of highly erodable banks and reduce impacts to infrastructure and pastures located downstream. In the past, heavy equipment was used to excavate channels through lower Terwer Creek with the intent of controlling the channel to reduce the loss of infrastructure during flood events. Channel materials were often excavated and stockpiled along the existing bank as makeshift levees. Therefore, a majority of the active surfaces located in lower Terwer Creek consist of loosely consolidated gravels and repeated disturbance of the area has greatly impacted native plant recruitment and survival.

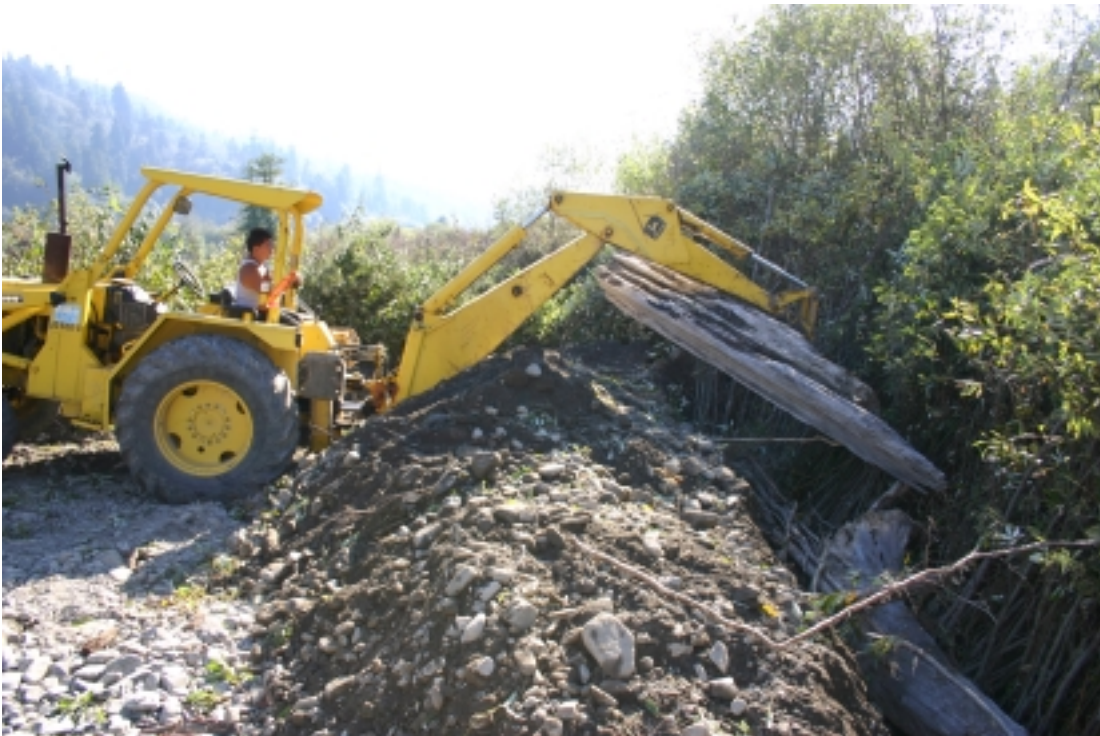
Figure 47. Placement of large wood at the base of a willow mattress constructed in lower Terwer Creek, Lower Klamath River Sub-basin, California (2005).

YTFP constructed 14 willow siltation baffles along the bank using a combination of heavy equipment and hand-crews (Figure 45). The baffles were comprised of willow brush and the bases were lined with ¼ ton quarry rock in an effort to reduce localized scour (Figure 46). Fifteen willow mattresses were constructed parallel with the channel along the bank between the baffles. Mattress bases were lined with small and large wood to improve growing conditions (Figure 47). YTFP crews also constructed a series of large wood-boulder structures upstream of Mr. Farley's well to deflect stream flows away from his property and reduce near-bank shear stress (Figure ). Live willow was incorporated in all of the structures and willow mattresses were constructed between the structures to promote long-term bank stability (Figure 48). Crews also constructed 41 willow brush and post baffles on the adjacent floodprone surface; and planted 500 willow sprigs, 30 big-leaf maple, 65 black cottonwood, 41 red alder, and 350 bareroot Douglas fir trees. The deciduous trees were started from seed (maples and alders) or cuttings (cottonwood) and grown out for over a year at the YTFP native tree nursery. These measures were implemented to immediately enhance existing riparian habitats; reduce stream velocities on floodprone surfaces; and promote conditions that maintain complex, native riparian forests and large wood recruitment to Terwer Creek.

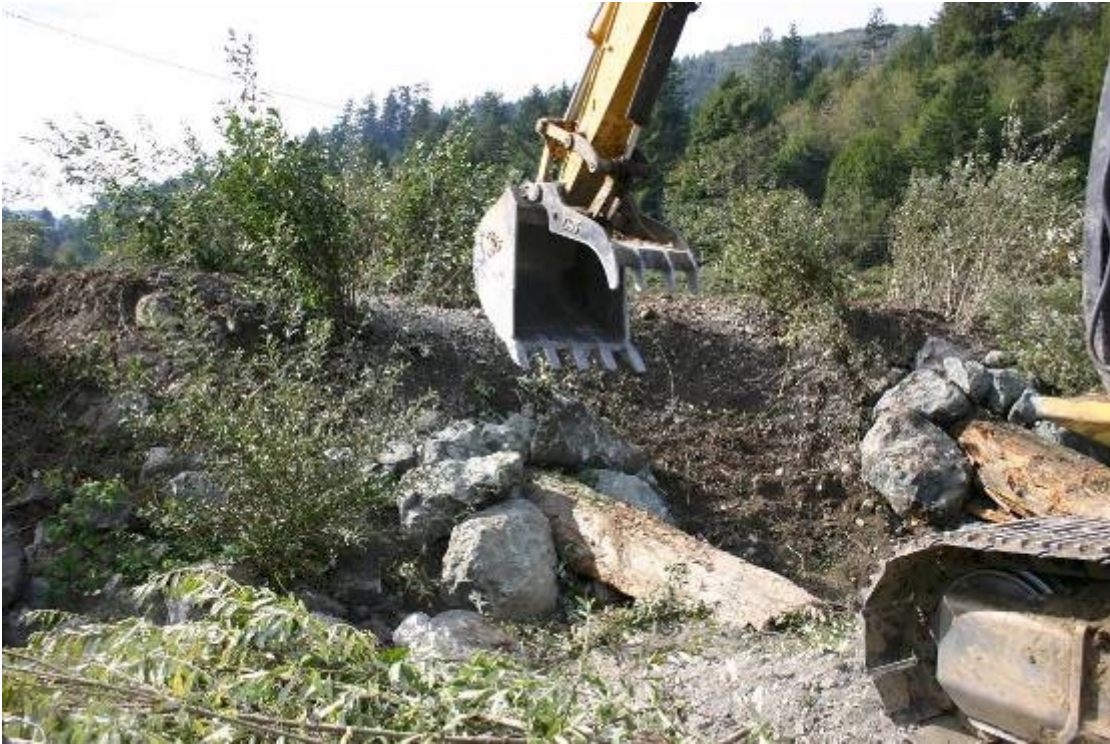
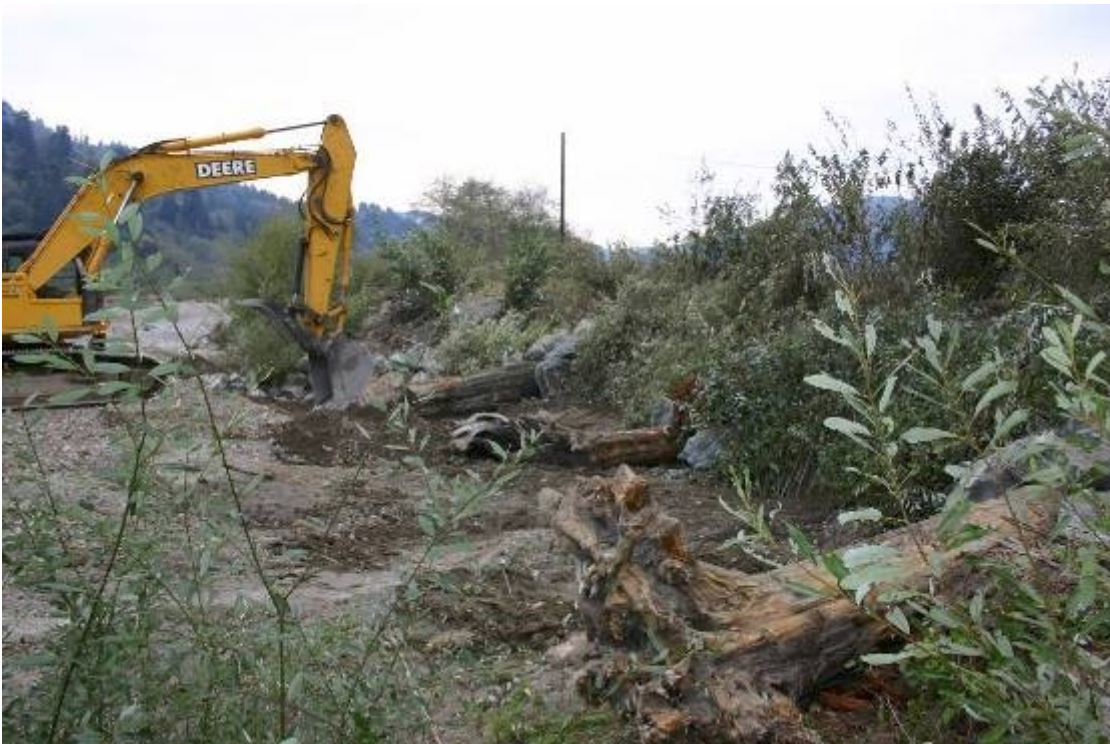
Figure 48. Construction of large wood-boulder structures in lower Terwer Creek, Lower Klamath River Sub-basin, California (2005).

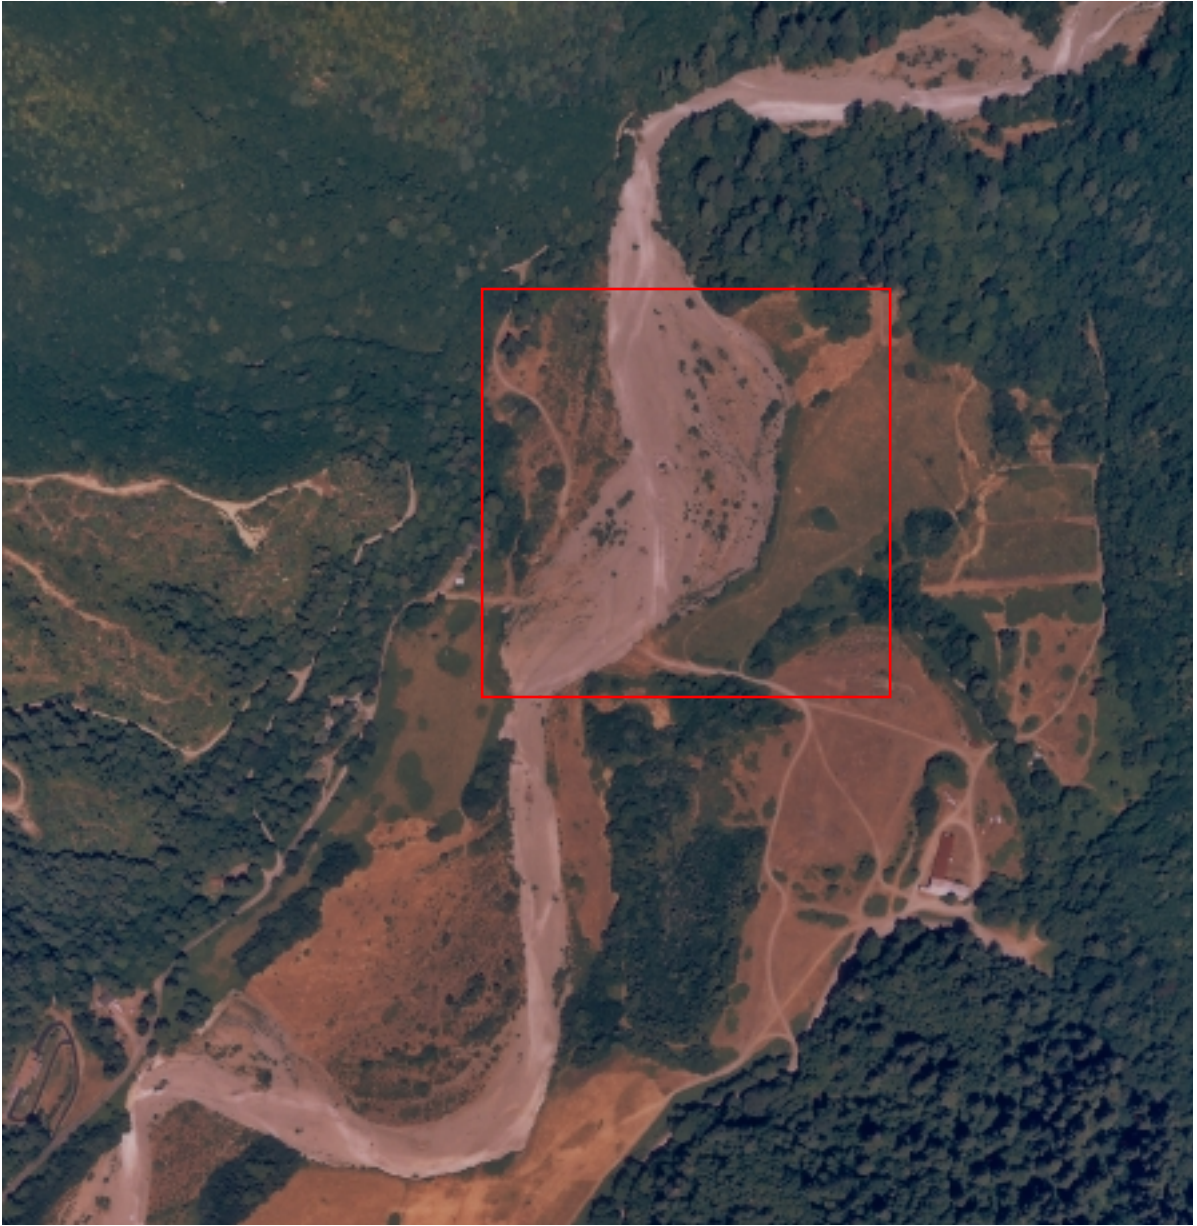
Figure 49. Map of the Lower Terwer Creek Restoration Phases I and II Project Area (outlined in red), Lower Klamath River Sub-basin, California (2004 Air Photo).

YTFP continued addressing riparian dysfunction and channel instability on both the west and east banks of Terwer Creek in the vicinity of Mr. Farley's property from July – November 2006 (Figure 49) (Gale 2007a). Project objectives were similar to those of Phase I with a focus on stabilizing erosive banks and planting riparian habitats with native trees. Crews constructed 11 willow siltation baffles and 10 willow mattresses along the west bank of the channel upstream of Mr. Farley's well (Figure 50). The baffles were comprised of willow brush and the bases were lined with ¼ ton quarry rock in an effort to reduce localized scour. Mattress bases were lined with small and large wood to improve growing conditions. Crews also removed the quarry rock that was placed in February 2005 as an emergency treatment of an eroding bank. Five large wood-boulder structures with live willow incorporated were constructed at this location to ensure long-term bank stability.

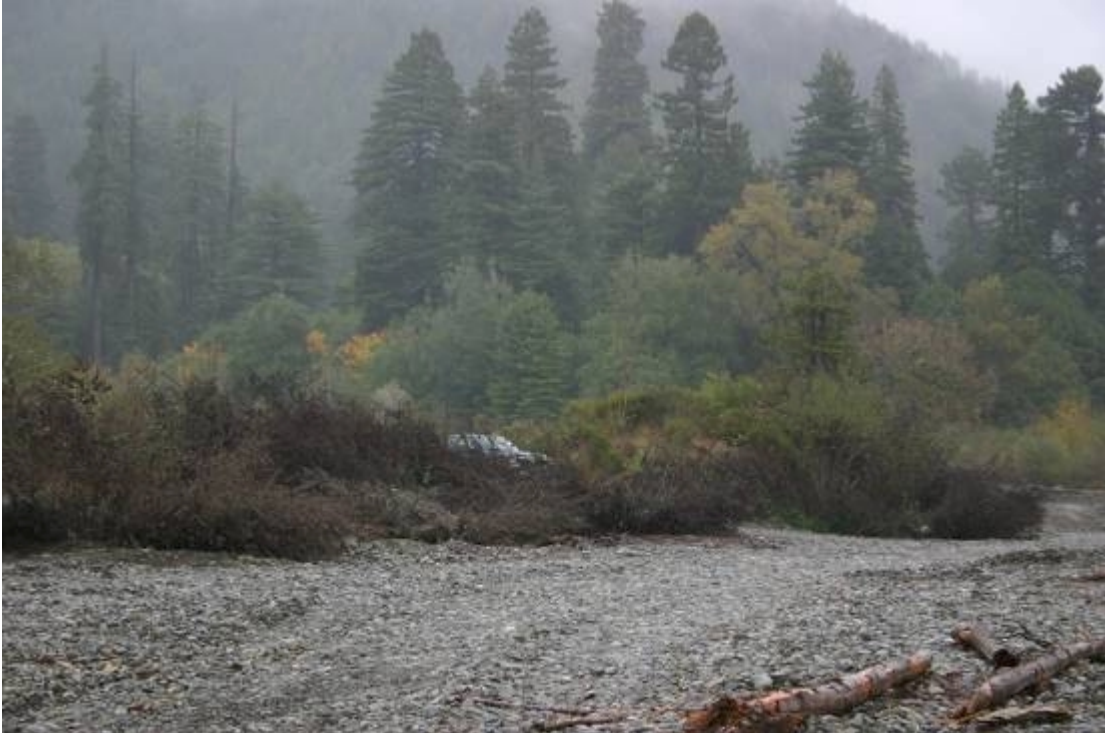
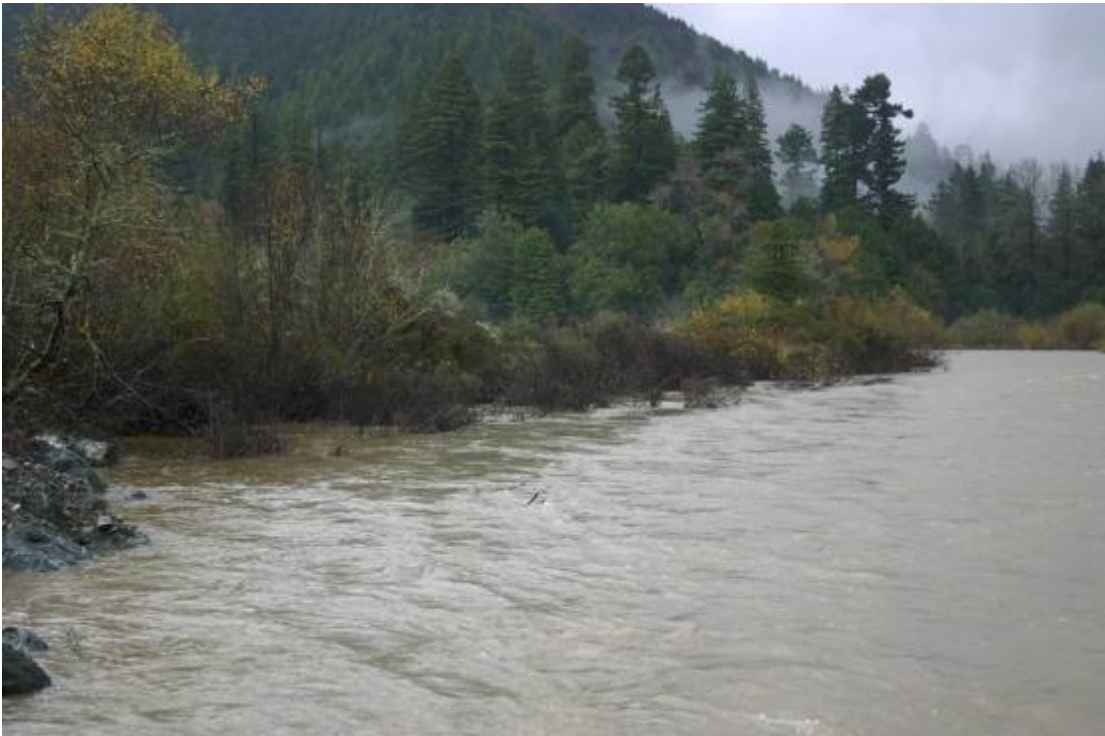
Figure 50. Willow siltation baffles and mattresses constructed along the west bank of lower Terwer Creek, Lower Klamath River Sub-basin, California (YTFP 2006).

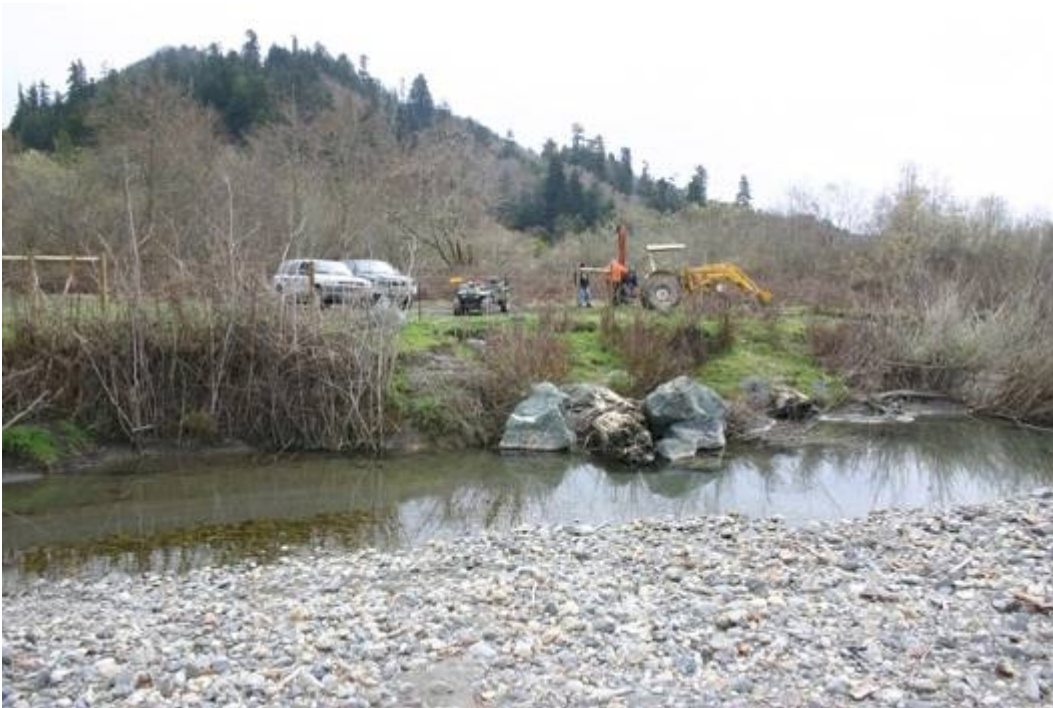
Figure 53. Large wood-boulder structure constructed along the east bank of lower Terwer Creek, Lower Klamath River Sub-basin, California (2008).

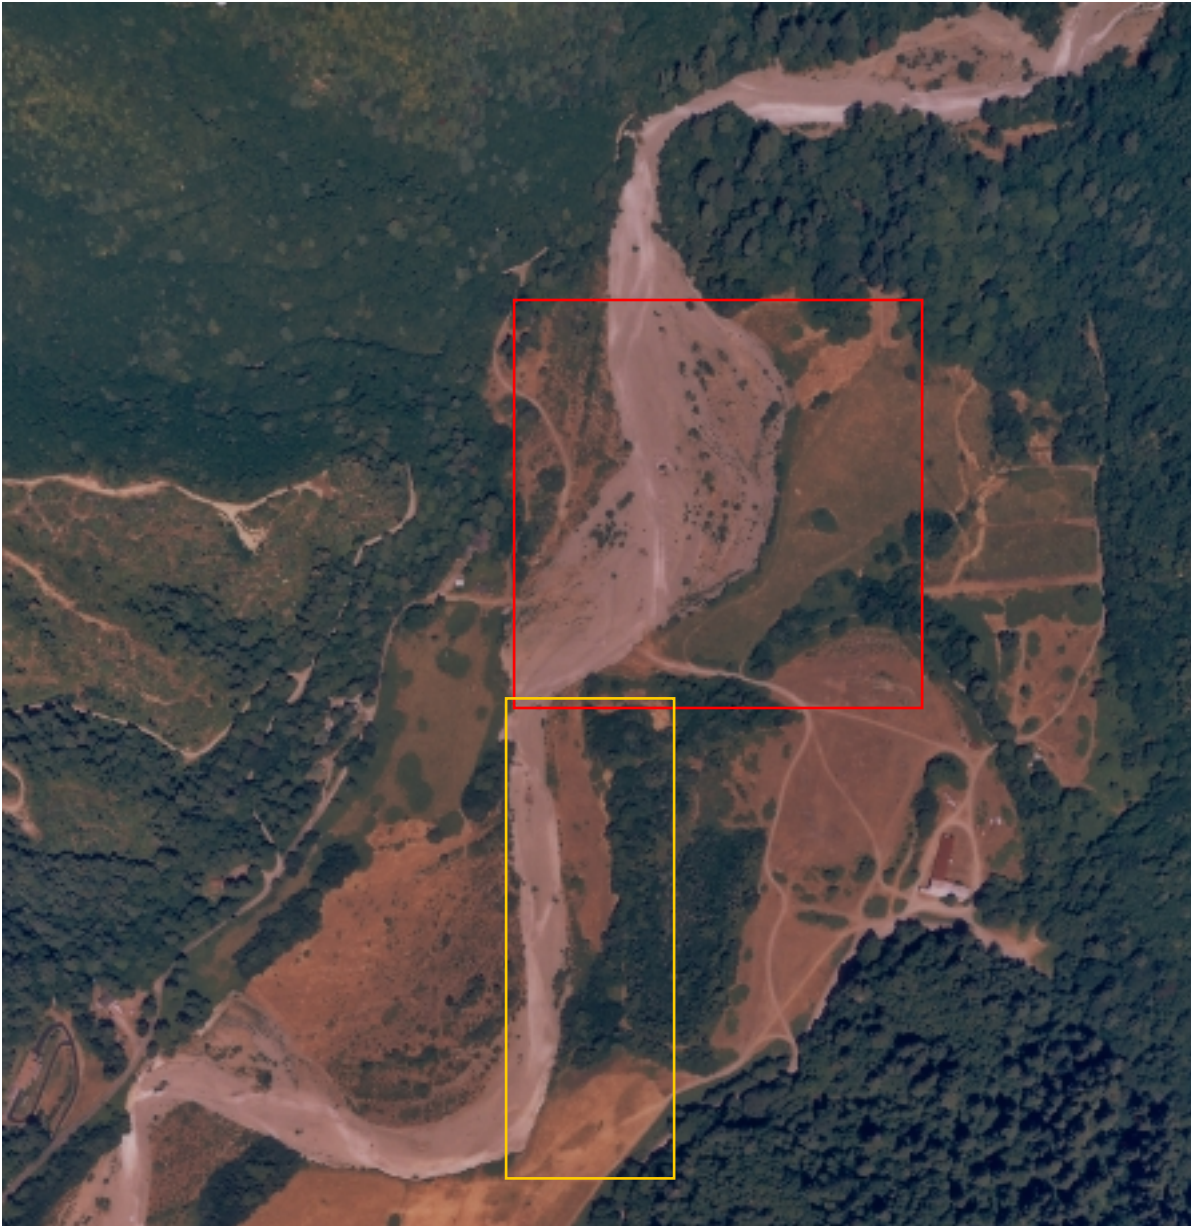
Figure 54. Map of the Lower Terwer Creek Restoration Phases I and II Project Area (outlined in red) and Phase III Project Area (outlined in gold), Lower Klamath River Sub-basin, California (2004 Air Photo).

The most recent restoration program activities were implemented in lower Terwer Creek from July 2007 – spring 2008 (Figure 54) (Gale 2007b). The objectives were to supplement previous restorative efforts by increasing the number of willow siltation baffles and large wood-boulder structures to increase bank stability; and planting more native conifers and deciduous trees within riparian habitats. Other project objectives included monitoring the survival of previously constructed willow baffles and planted trees as well as continual removal of invasive, non-native plants in the project area. As in Phase II, crews addressed both banks of Terwer Creek at Arrow Mills and Mr. Farley's property. Crews constructed 28 willow baffles on Mr. Farley's property adjacent to his well to ensure long-term protection of his infrastructure and pastures (Figure 55). These "terrace" baffles were planted without quarry rock just behind the large wood-boulder structures and willow mattresses that were constructed along this bank in 2005. Another 17 willow siltation baffles were also constructed ~ 400 feet downstream of Mr. Farley's well. These baffles were constructed with ¼ ton quarry rock at the bases in an effort to reduce localized scour.

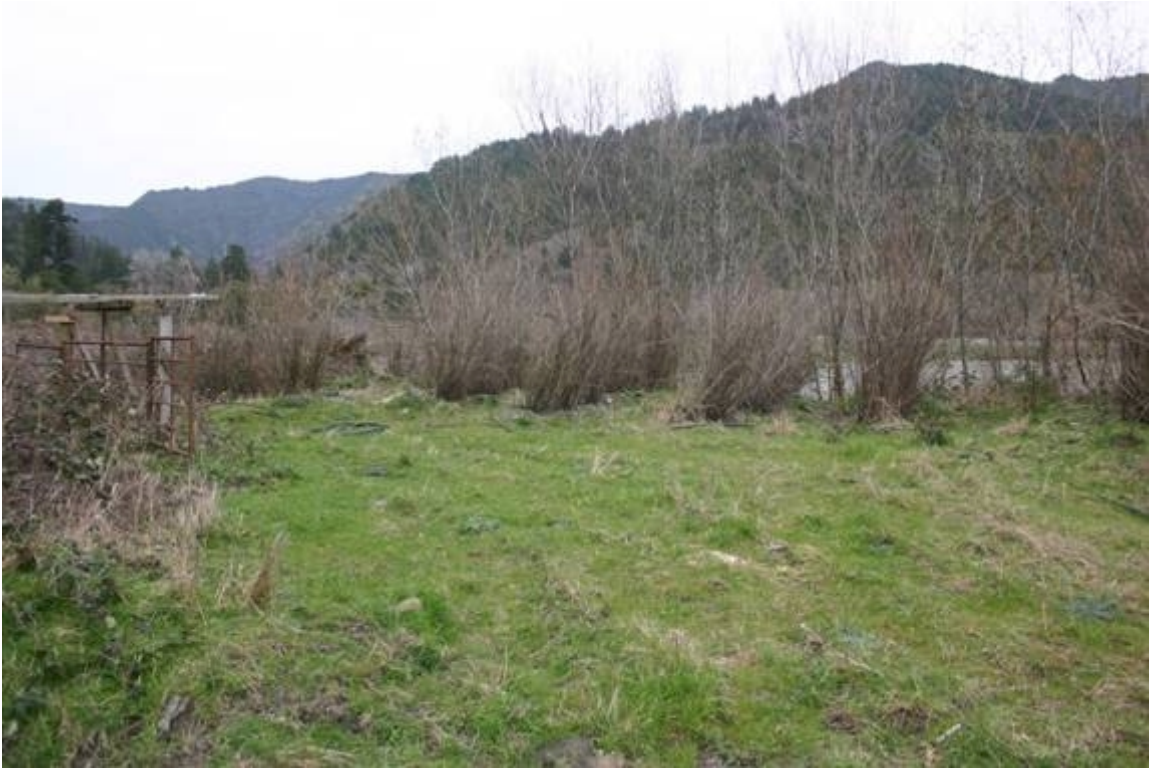
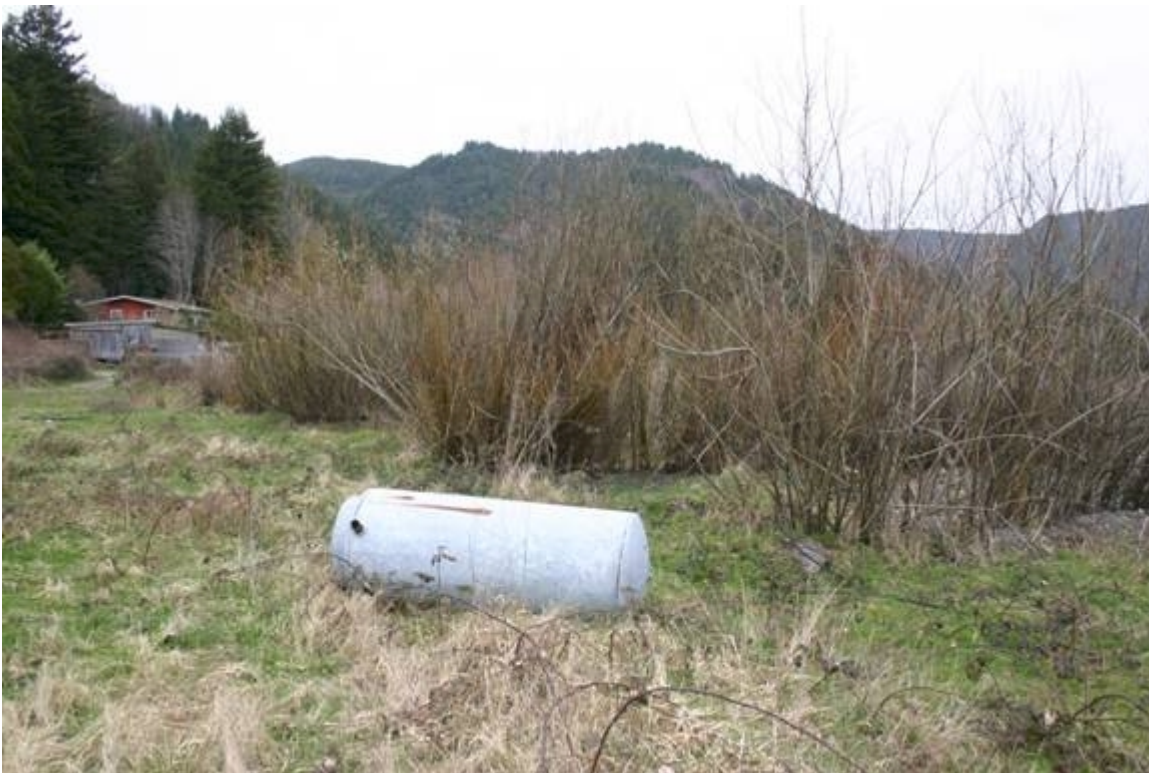
Figure 55. Willow terrace baffles constructed to protect private infrastructures and pastures in lower Terwer Creek, Lower Klamath River Sub-basin, California (2008).

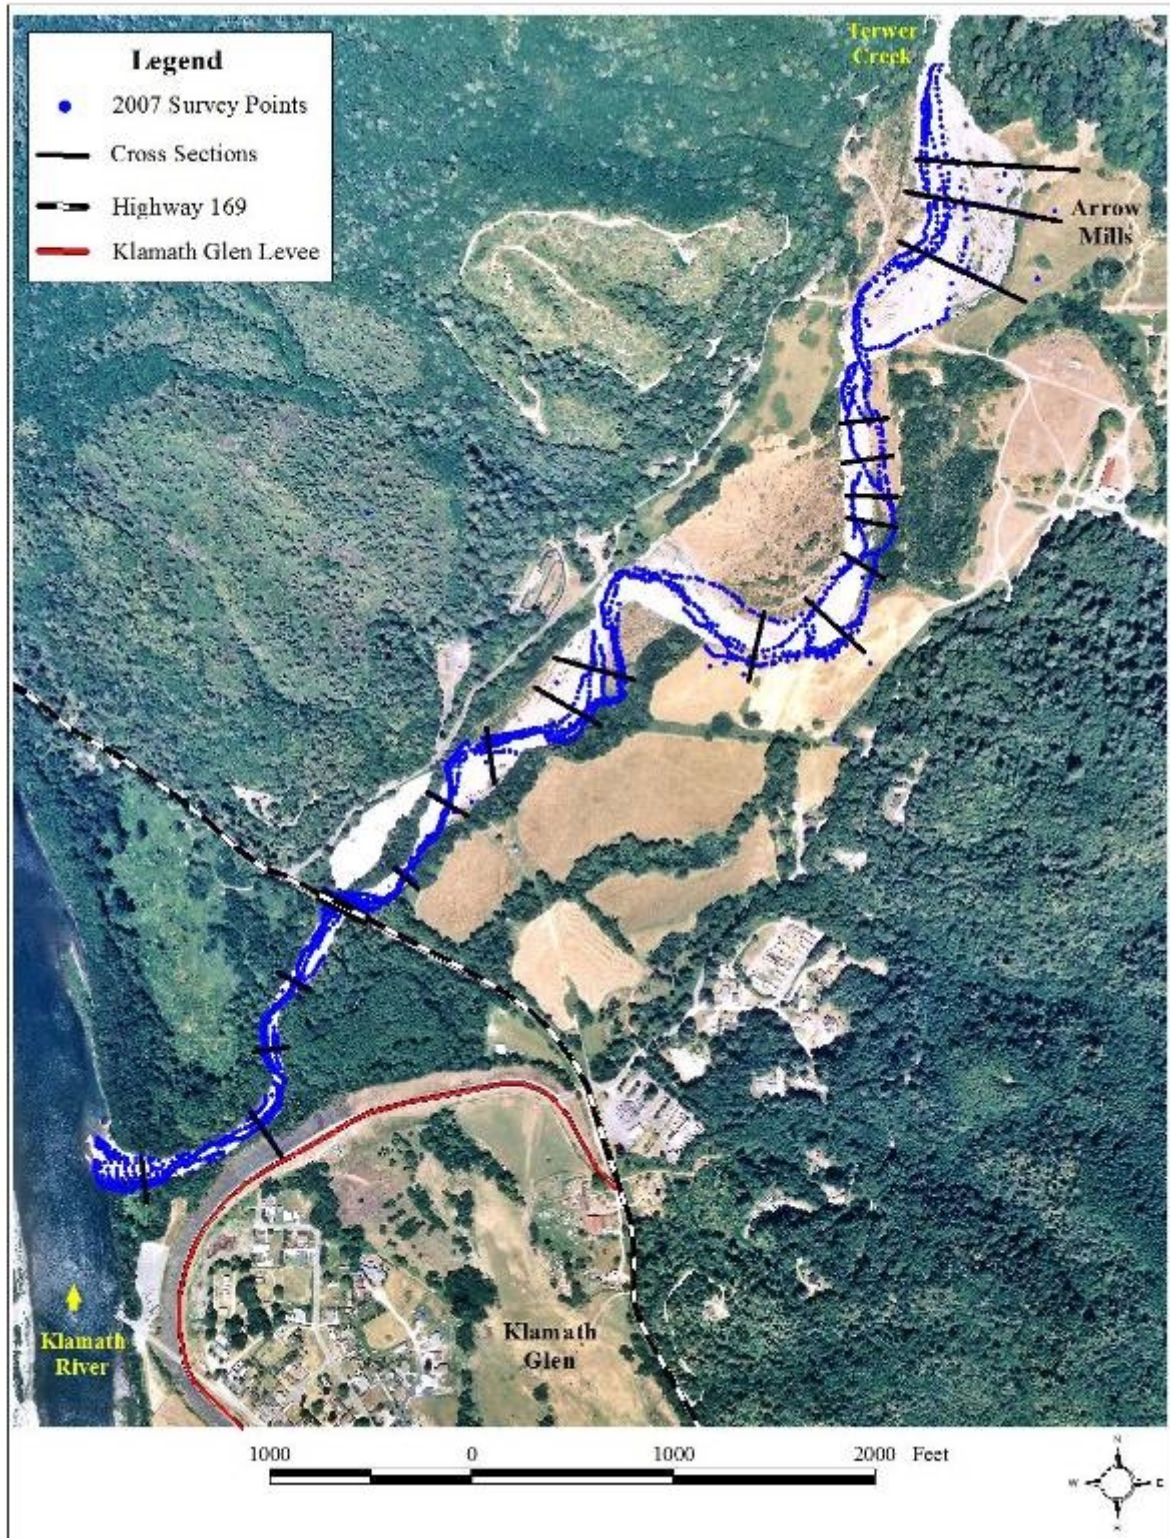
Figure 61. Map depicting the 2007 topographic survey of lower Terwer Creek, Lower Klamath River Sub-basin, California (2004 Air Photo).

Lower Terwer Creek still contains fairly extensive backwater formed terraces in the vicinity of Arrow Mills (Figure 61). Excessive sedimentation of channel and floodplain habitats is the primary cause of terrace erosion and conversion of floodprone surfaces from those dominated by fine-grained materials to surfaces dominated by gravel and cobble (Figure 57). Major channel reconstruction may be a potential strategy for reducing bank erosion rates and increasing channel stability. However, a comprehensive sediment budget for the watershed and more detailed channel surveys will need to be conducted to determine if channel manipulation would result in long-term benefits including improved sediment routing capacity and increased channel stability. In the meantime, YTFP is planting these surfaces with native conifers and deciduous trees and protecting them from cattle to begin restoring riparian function in the lower valley. These forests will require several decades to mature and will be dependent on our ability to increase channel stability in lower Terwer Creek.

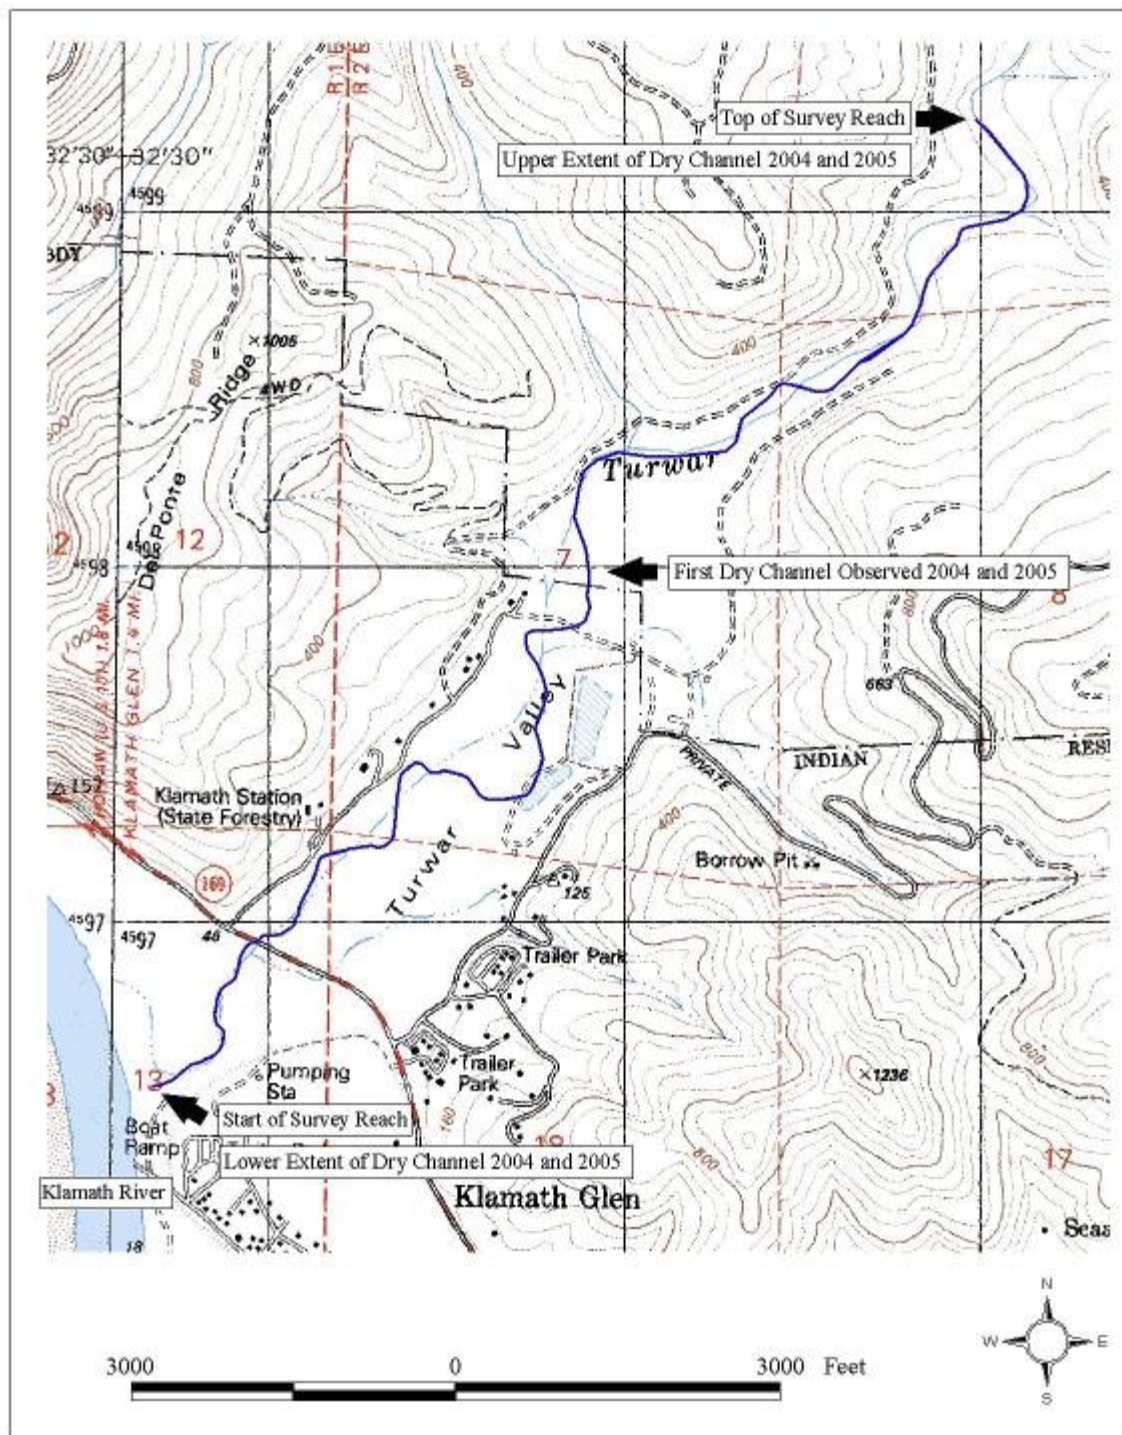
A critical factor inhibiting salmonid productivity and native plant survival in lower Terwer Creek is the depth to the water table from late spring through fall. Lower Terwer Creek consistently experiences subsurface flows from May – October (Figure 62). Subsurface tributary flows interrupt juvenile outmigration in the spring and adult immigration in the fall; limit the quality and quantity of salmonid rearing habitat; reduce available cool water refuge; increase competition and predation; thereby reducing overall survival from spawning to emigration. As part of a larger assessment of LKRSB tributaries, YTFP documented the timing and aerial extent of subsurface flows (2004-2005); and monitored water table elevations at several wells (2005 – 2008) (Figure 63) in lower Terwer Creek (Beesley and Fiori 2007b). The main objective of that study was to examine the interaction of rainfall and Klamath River flow levels with local tributary water tables and surface flows. The data indicated that without sufficient precipitation, water tables and surface flows receded rapidly due to the coarse alluvium comprising the fluvial corridor of lower Terwer Creek.

Figure 62. Map depicting the Terwer Creek channel and the reach surveyed for subsurface flow for the period 1 April 2004 – 31 December 2005, Lower Klamath River Sub-basin, California.

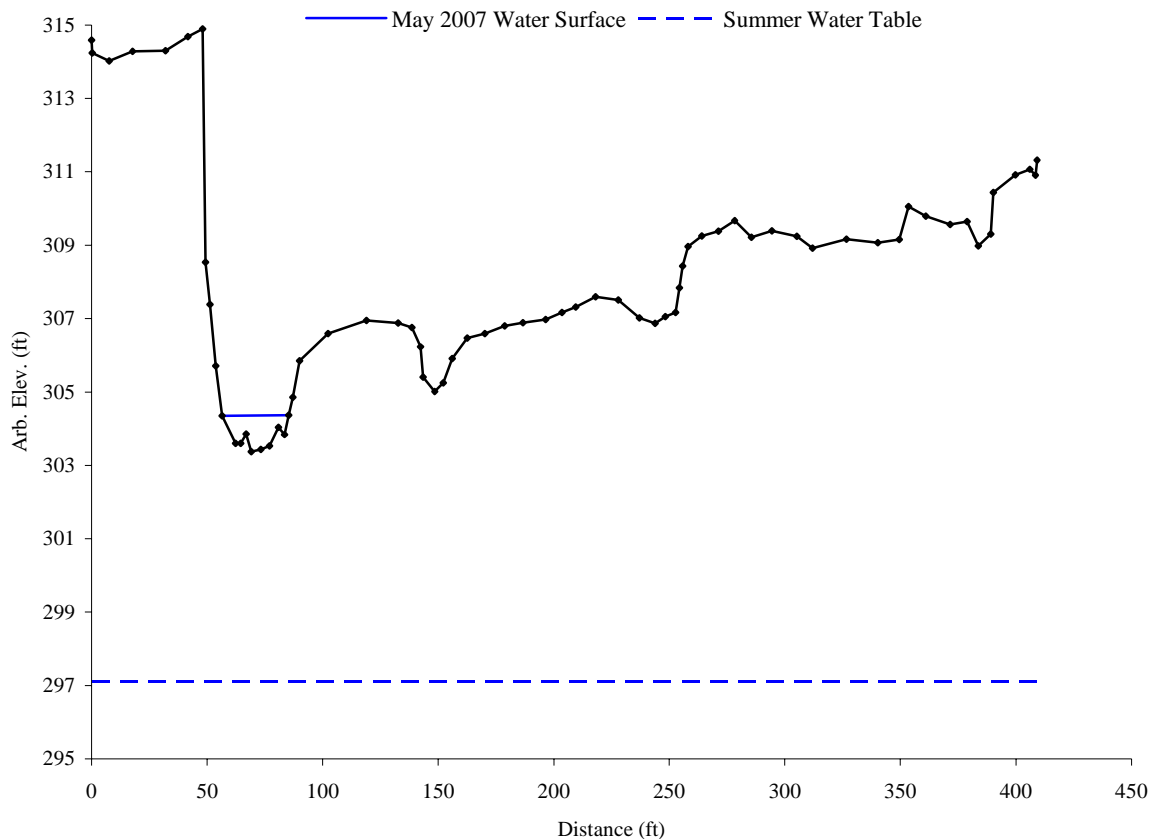
Groundwater monitoring and topographic survey data collected at the Arrow Mills site indicated that the water table during late summer – fall was 25 – 30 feet below the active channel and floodplain surfaces (Figure 64). The summer water table was closer to channel and floodplain surfaces at monitoring stations located ~ 4,000 feet downstream of the Arrow Mills site (Figure 65). Water tables located near the mouth of Terwer Creek appeared to be

Figure 65. Cross section plot depicting elevations of channel and floodprone surfaces relative to base flow and water table elevations located downstream of Arrow Mills, Terwer Creek, Lower Klamath River Sub-basin, California (2007).
