# Instream Restoration of Lower West Fork McGarvey Creek

Prepared by:

Daniel B. Gale  
Yurok Tribal Fisheries Program  
P.O. Box 339  
Klamath, CA 95548

March 28, 2008

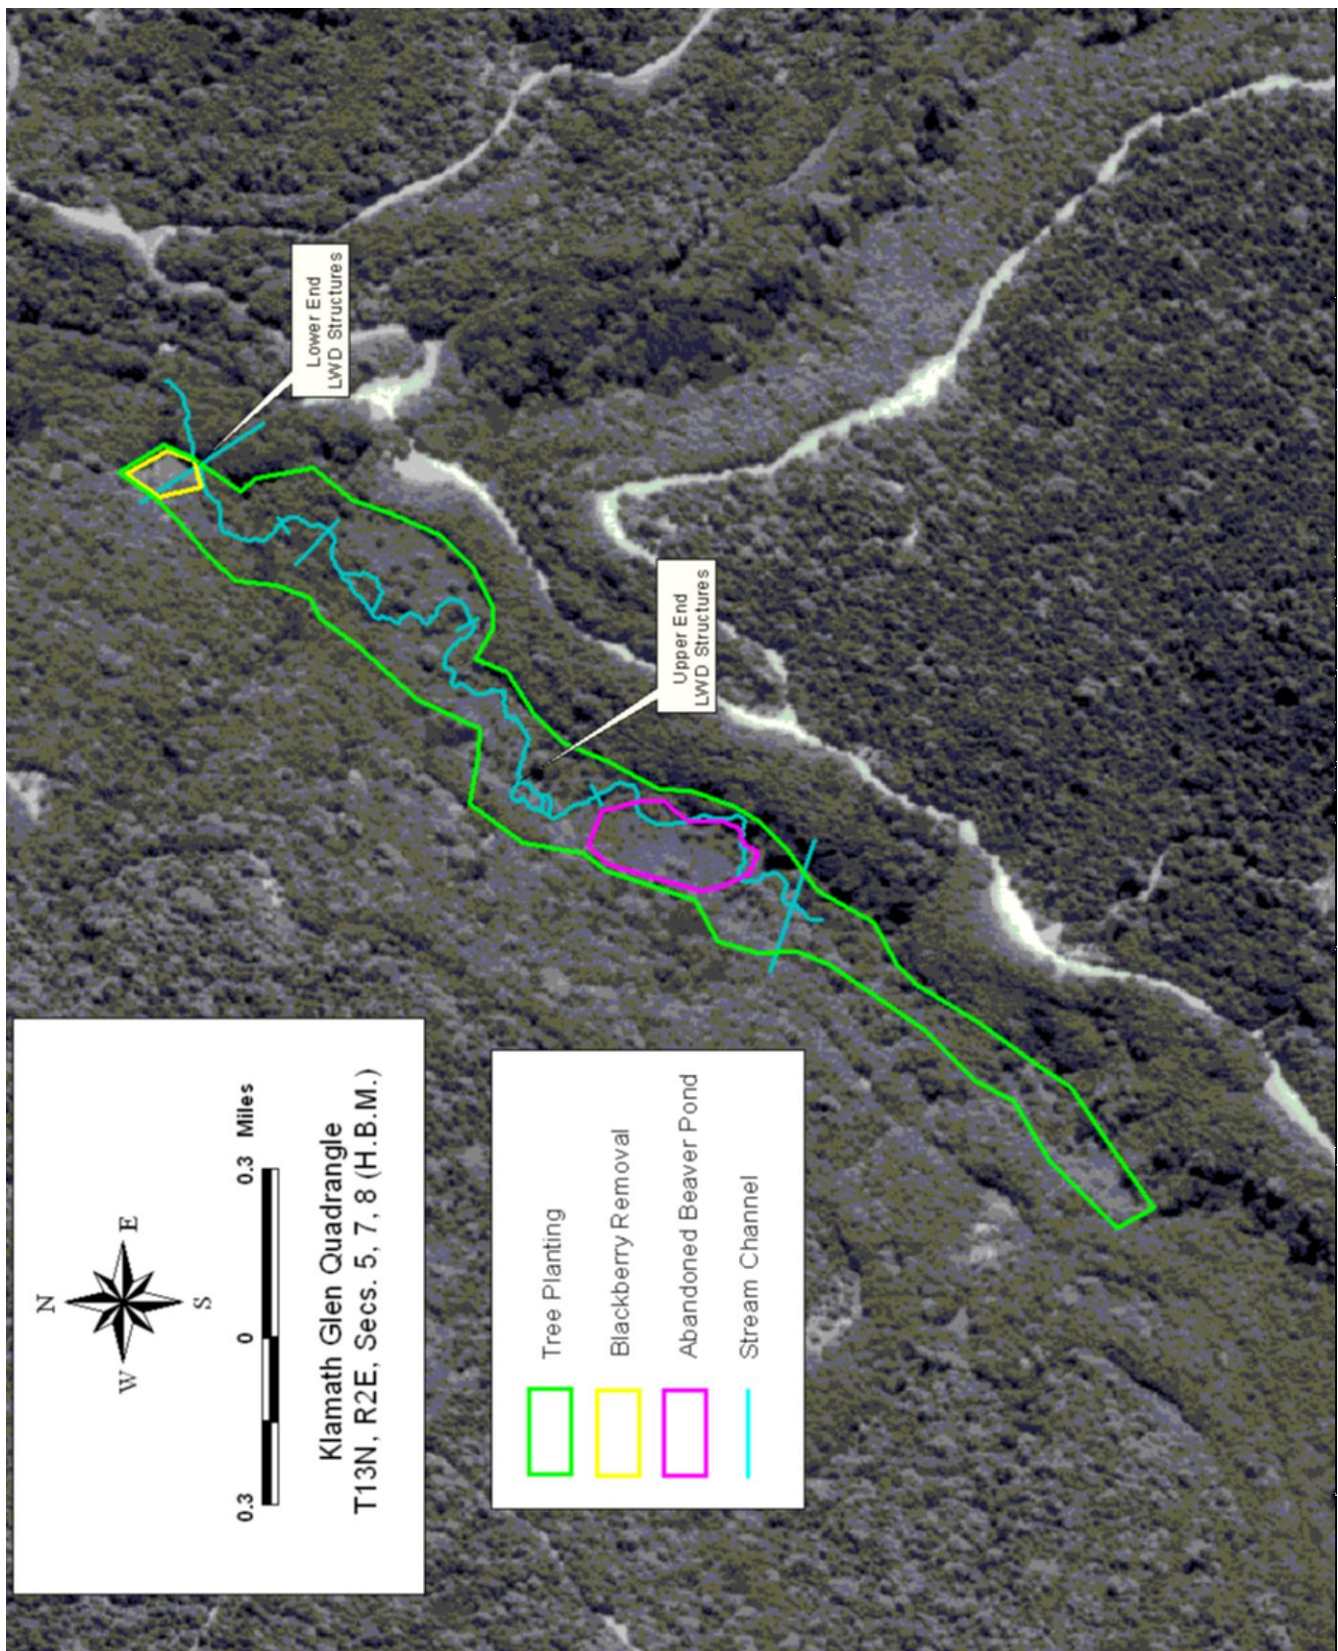
Figure 5. Riparian tree planting and exotic vegetation removal sites, West Fork McGarvey Creek, Lower Klamath River, California, 2007.

- Crews planted a total of 2,100 bareroot coastal redwood and 1,900 bareoot Sitka spruce throughout lower West Fork McGarvey Creek (Figure 5). This included 700 redwood and 900 spruce planted within the project area and an additional 1,400 redwood and 1,000 spruce planted upstream of the project area to a large redwood LWD jam believed to be the coho anadromous barrier. All bareroot trees were stock purchased from Hastings Tree Nursery in Smith River California.

- 249 five-gallon potted coastal redwood trees, 133 five-gallon potted western red cedar trees, and 23 five-gallon big-leaf maple trees were planted throughout the project area (Figure 5). The potted trees, donated by YTFP from our native tree nursery in Klamath, were planted along the areas adjacent to the stream channel that were disturbed by the excavator. The conifer trees averaged 24"-36" tall and the maple trees averaged 48"-72" tall. They were utilized to accelerate revegetation in the disturbed areas due to their larger size and more developed root systems.

- YTFP planted a total of 630 willow sprigs throughout the abandoned beaver pond just upstream of the project reach (Figure 5). The beaver dam that held back this pond was washed away in high flows approximately 4-5 years ago and no beaver have been observed in the area since prior to this event. The old pond site is one of the few large areas in McGarvey Creek with a wide open tree canopy and adequate direct solar input to support willows. As a result we planted the willow sprigs in addition to the conifer bareroot trees planted in the area to facilitate reestablishment of a diverse native riparian canopy. It is YTFP's hope that a reestablished willow canopy will eventually attract beaver back to the area.

- YTFP removed a large Himalayan blackberry patch from the old landing and quarry site adjacent to the confluence of Mainstem and West Fork McGarvey Creeks (Figure 5). Upon removing this berry patch, a large earthen berm was discovered that had been constructed perpendicular and adjacent to the stream channel out of tailings from the quarry site. Our consulting geologist/Geomorphologist (Rocco Fiori) determined that this berm was creating an undesirable floodplain restriction and would impair flood flows. As a result, the berm was removed with the excavator and the material used to recontour the floodplain prior to being revegetated with native conifers.

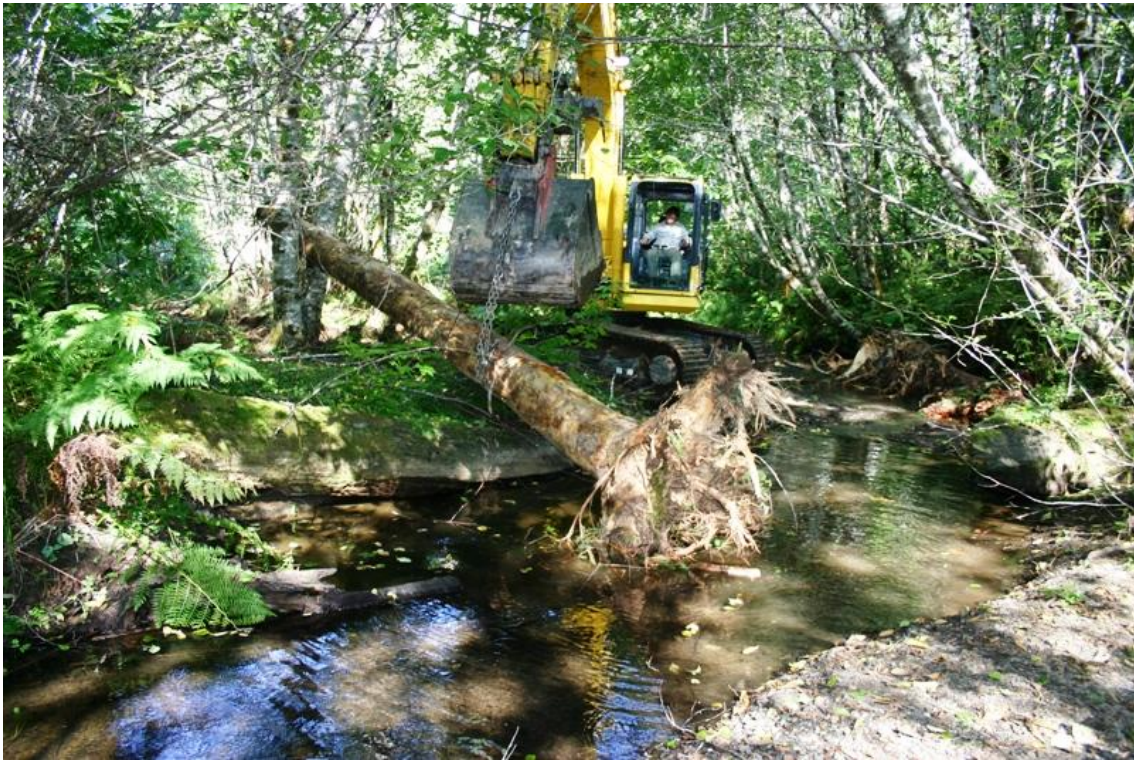
Figure 29. Shallow pool near top end of project reach during installation of LWD pieces #2-4, West Fork McGarvey Creek, Lower Klamath River, California, 2007.

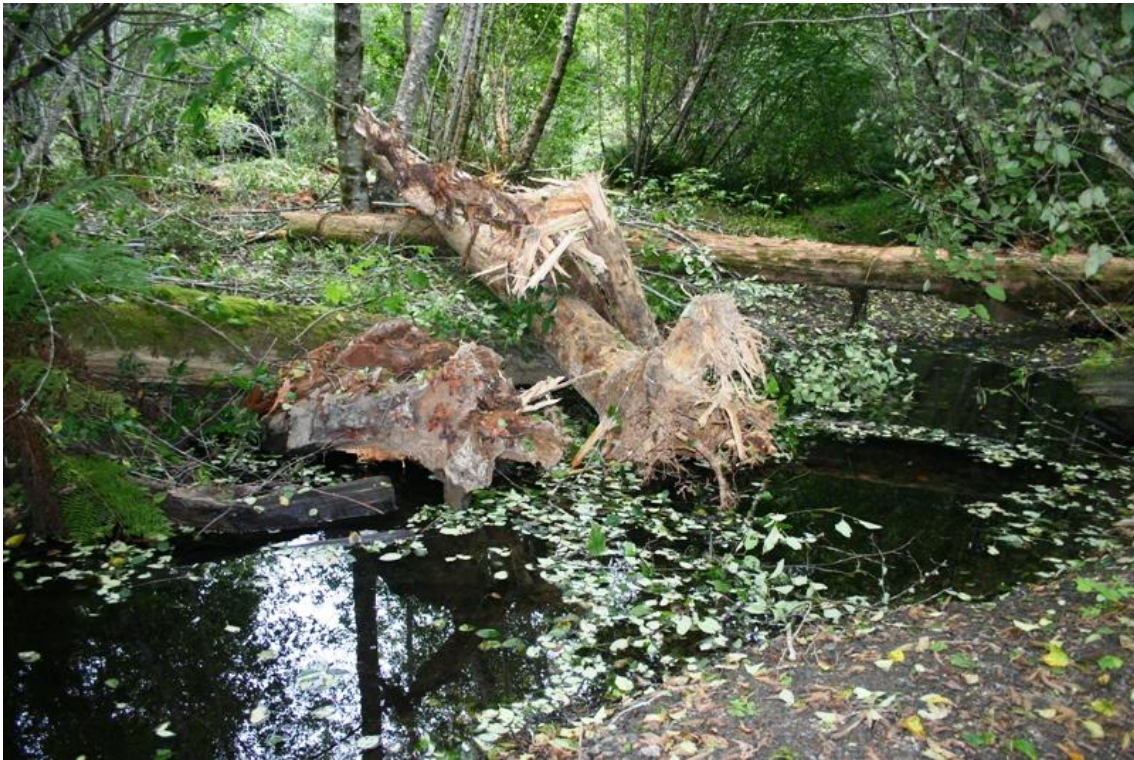
Figure 30. Shallow pool near top end of project reach during installation of LWD pieces #2-4, West Fork McGarvey Creek, Lower Klamath River, California, 2007.

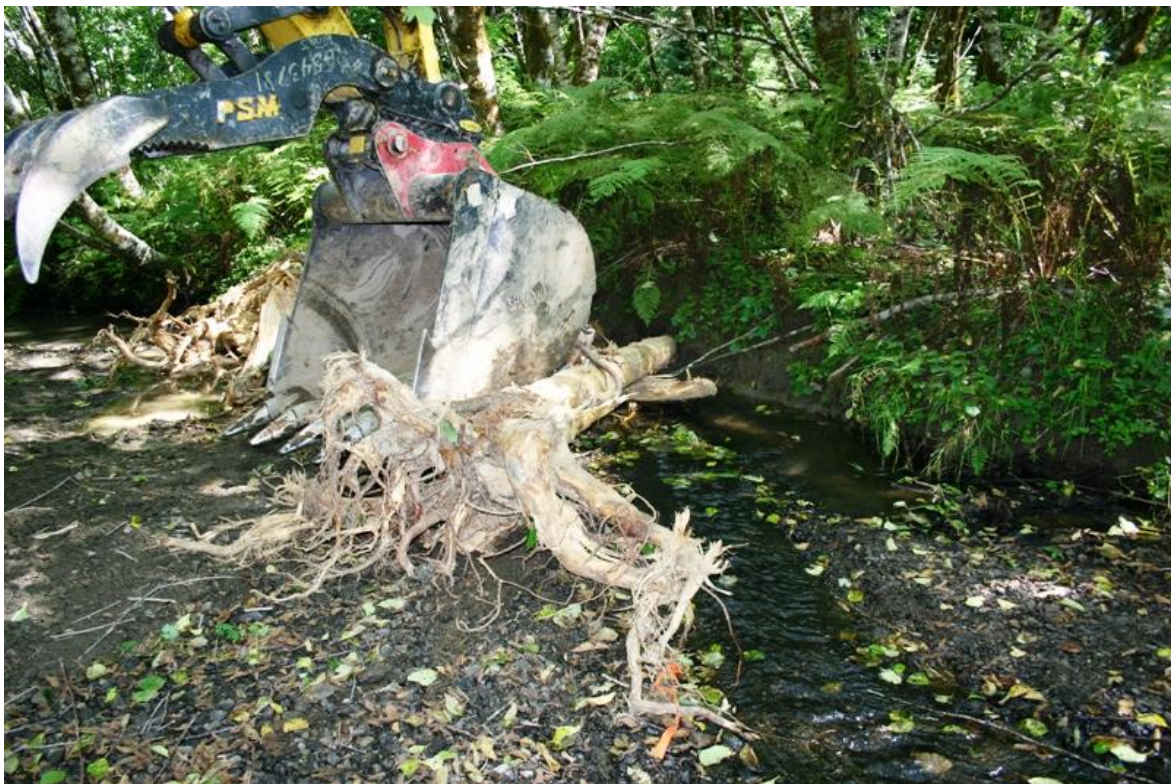
Figure 34. Shallow pool near top of project reach during installation of LWD pieces #5-10, West Fork McGarvey Creek, Lower Klamath River, California, 2007.

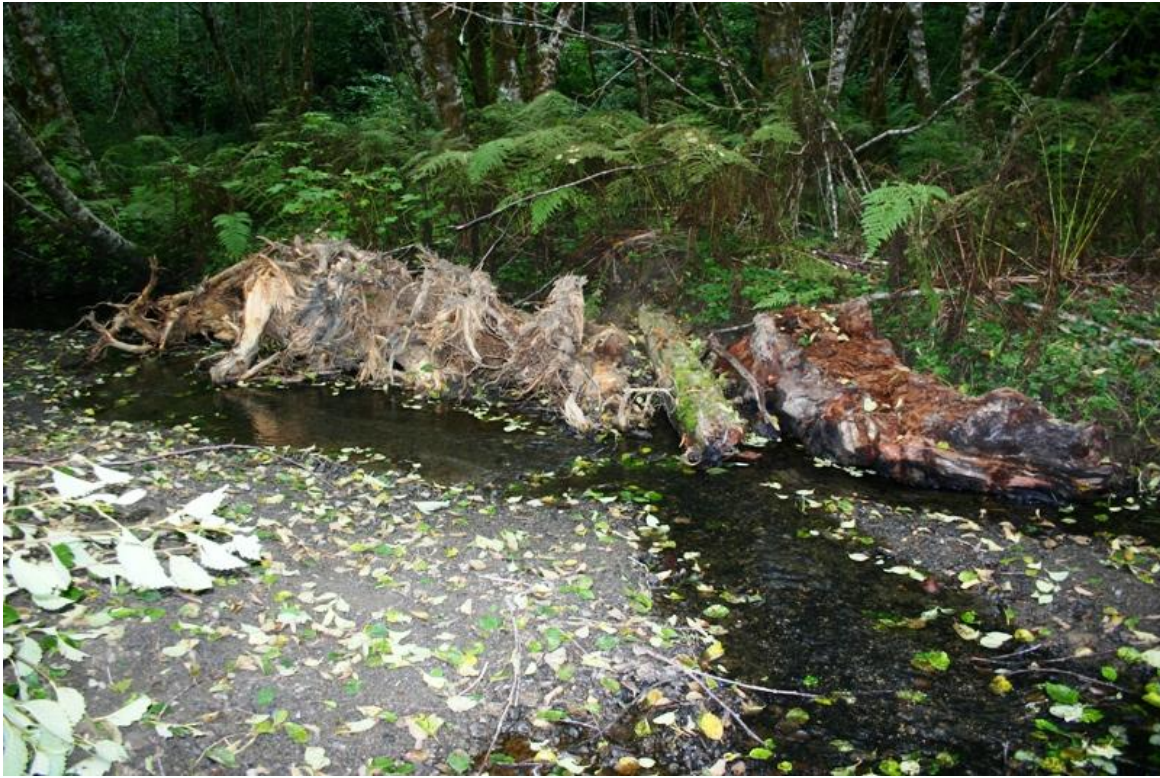
Figure 35. Shallow pool near top of project reach following installation of LWD pieces #5-10, West Fork McGarvey Creek, Lower Klamath River, California, 2007.

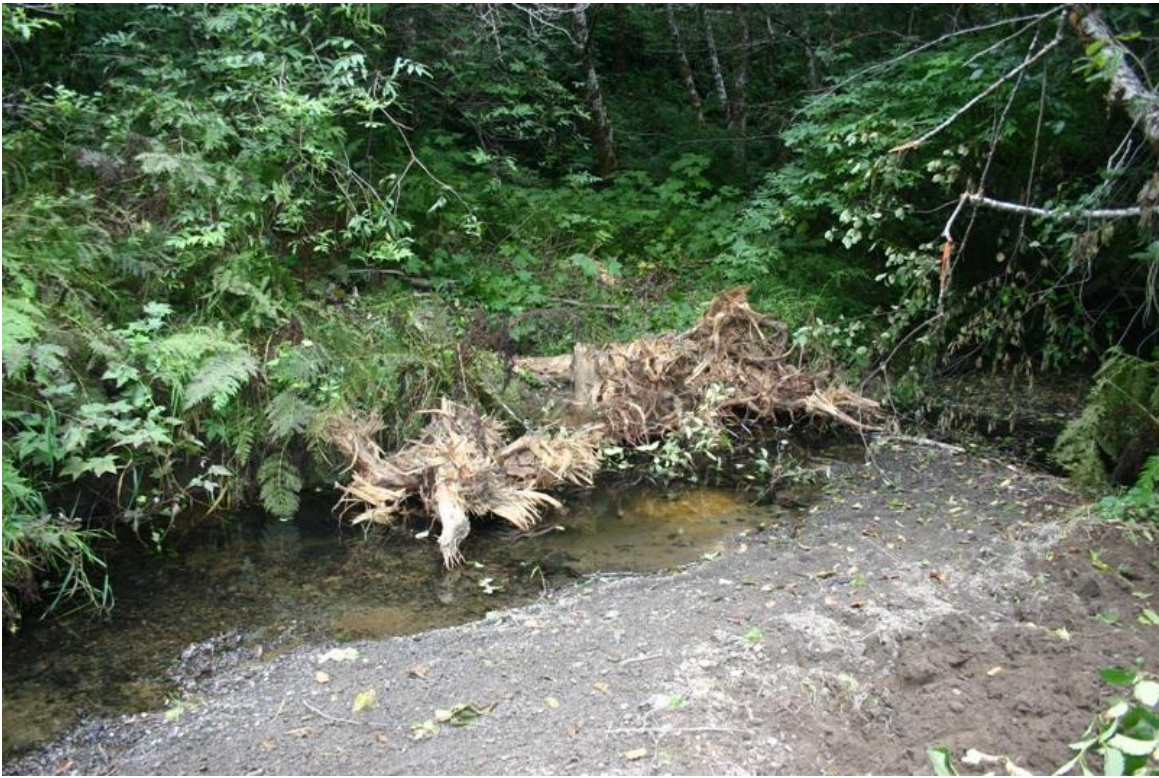
Figure 37. Shallow pool near top of project reach following installation of LWD pieces #11-15, West Fork McGarvey Creek, Lower Klamath River, California, 2007.

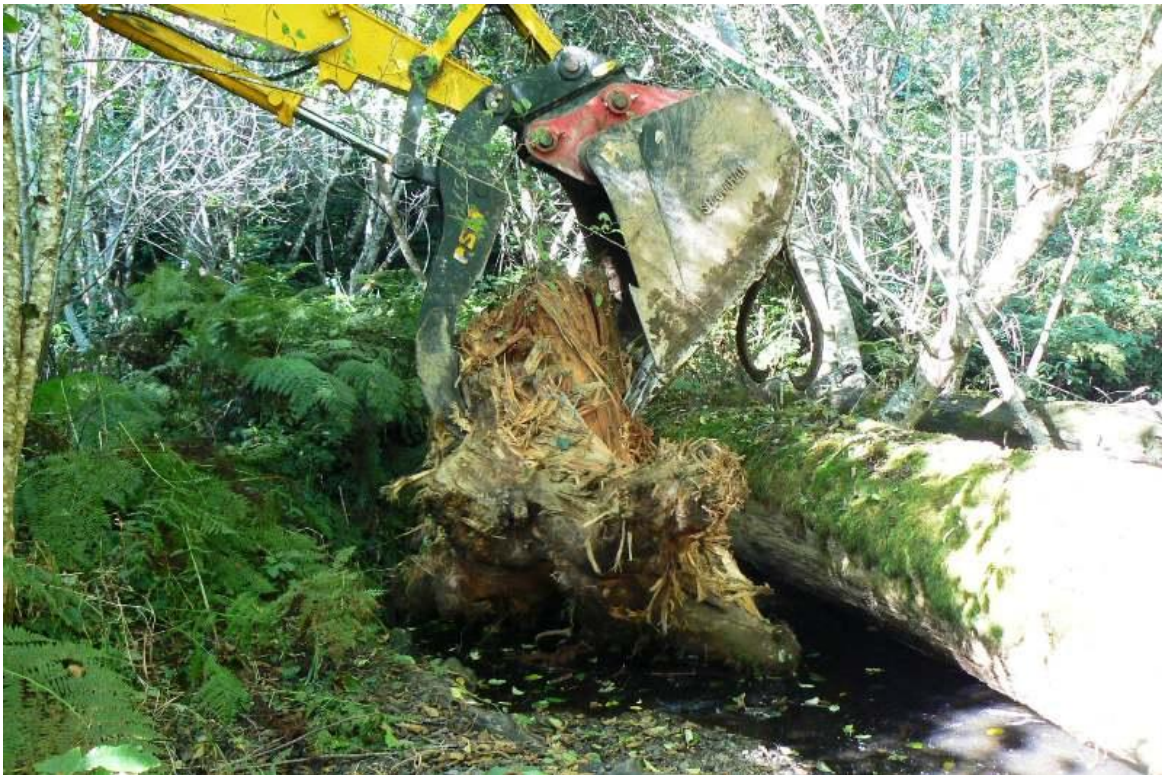
Figure 42. Rootwad (LWD piece #17) being placed in backwater pool, West Fork McGarvey Creek, Lower Klamath River, California, 2007.

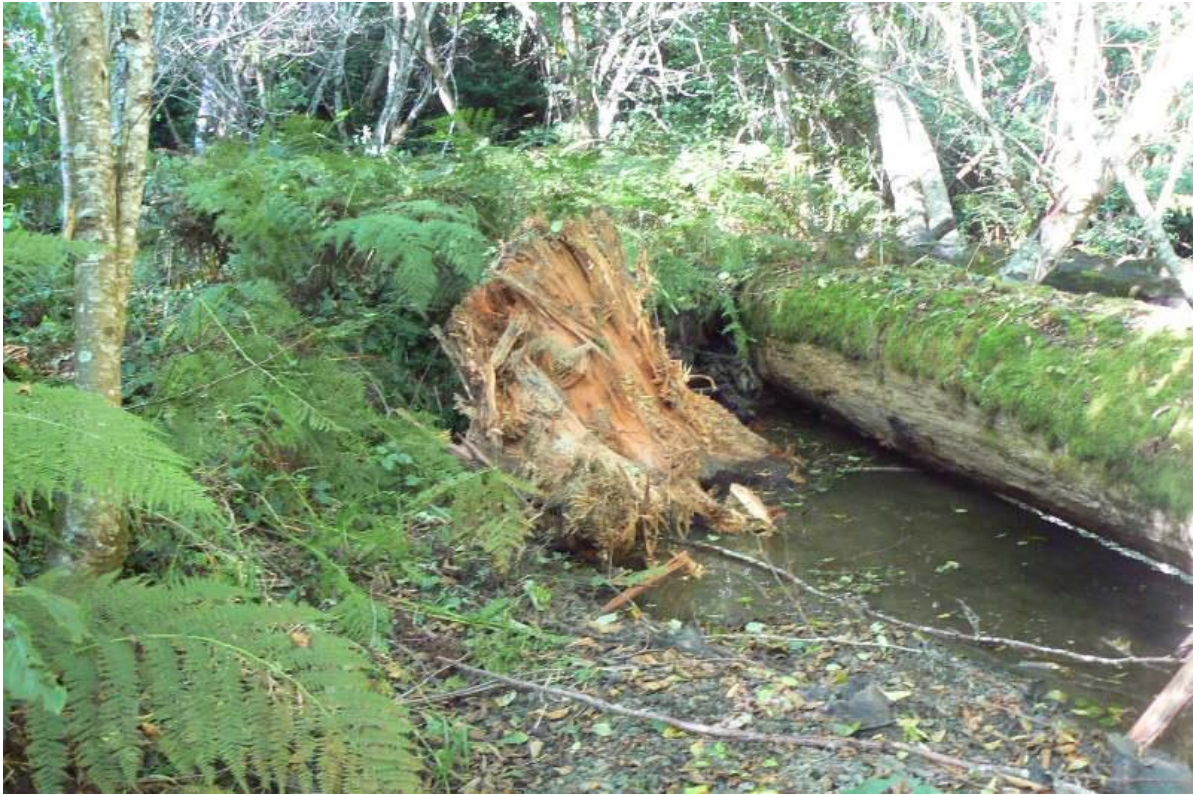
Figure 43. Rootwad (LWD piece #17) following placement in backwater pool, West Fork McGarvey Creek, Lower Klamath River, California, 2007.

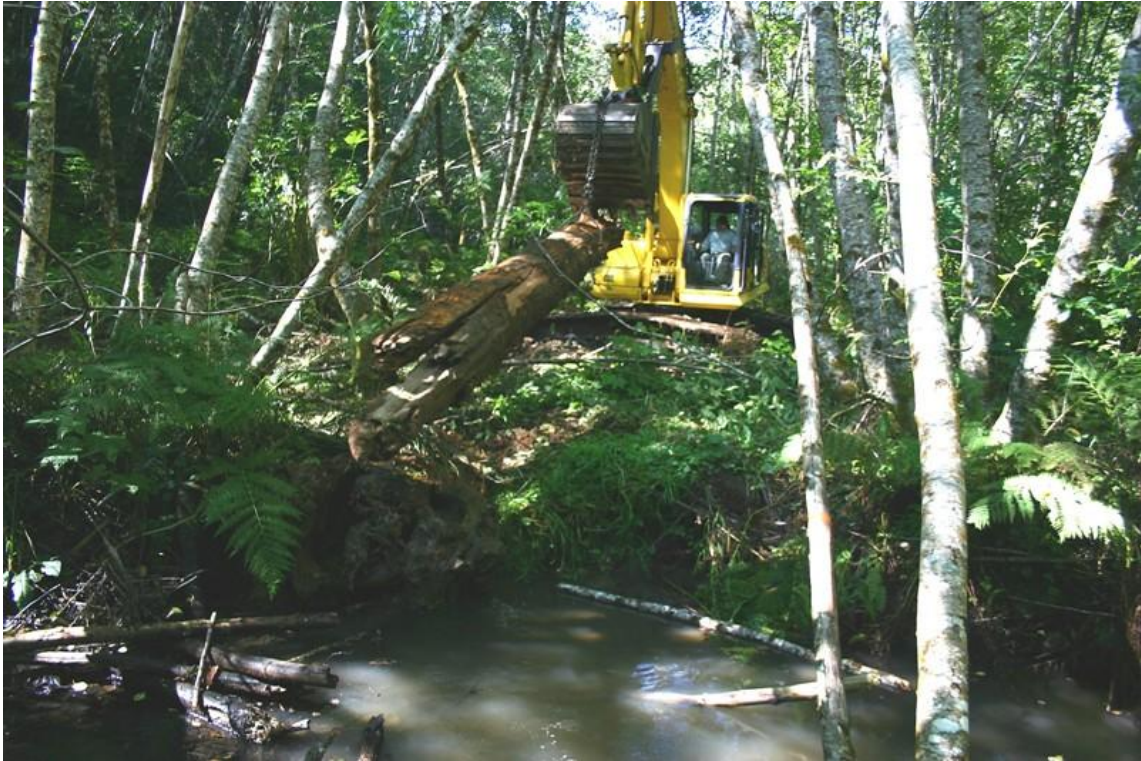
Figure 47. Shallow pool during installation of LWD pieces #18-21, West Fork McGarvey Creek, Lower Klamath River, California, 2007.

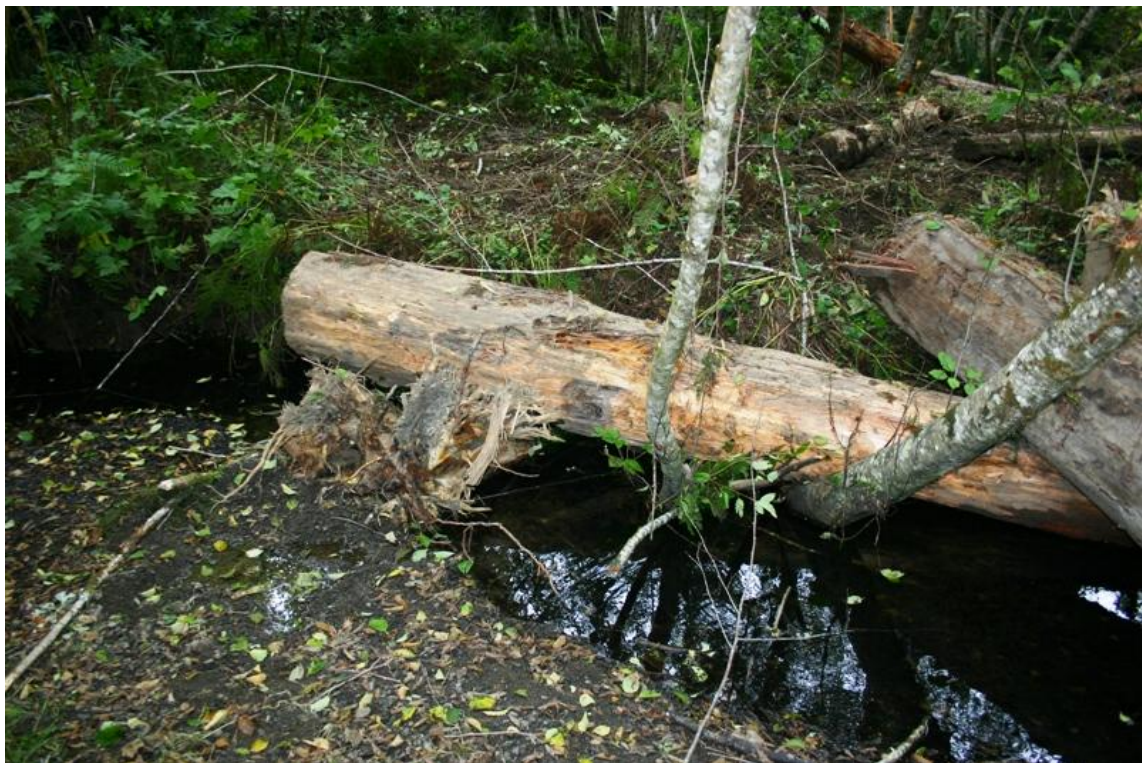
Figure 48. Shallow pool following installation of LWD pieces #18-21, West Fork McGarvey Creek, Lower Klamath River, California, 2007.

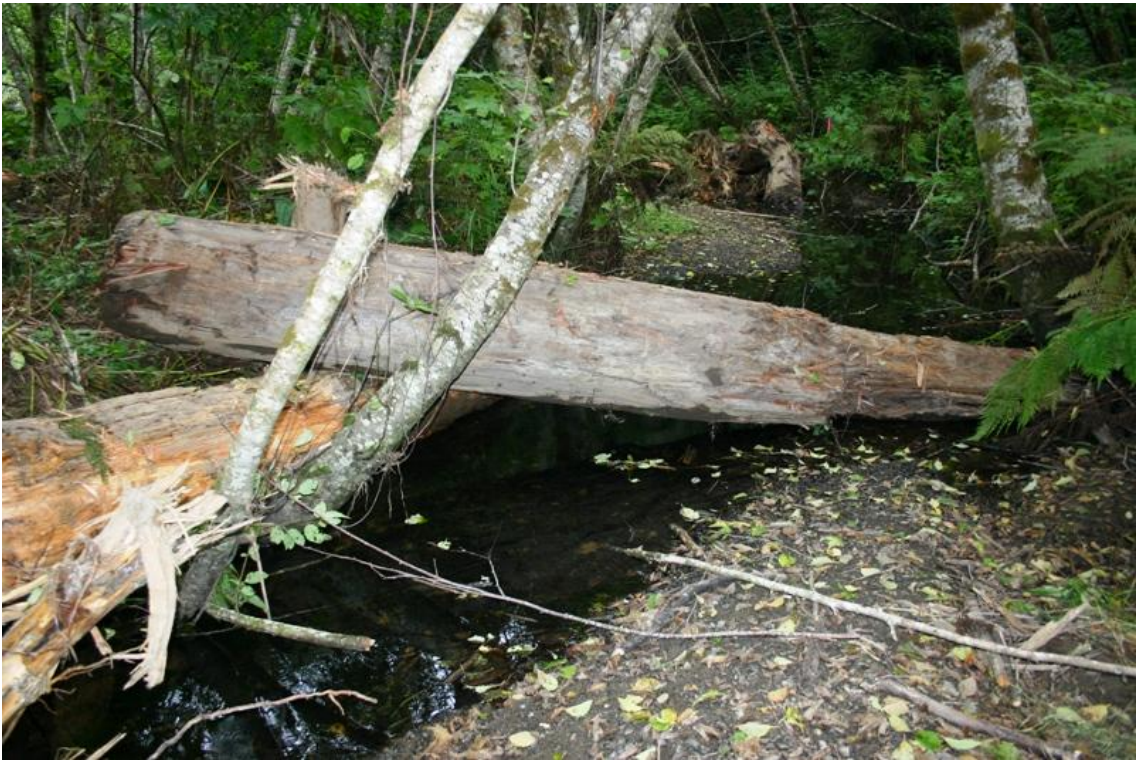
Figure 49. Shallow pool following installation of LWD pieces #18-21, West Fork McGarvey Creek, Lower Klamath River, California, 2007.

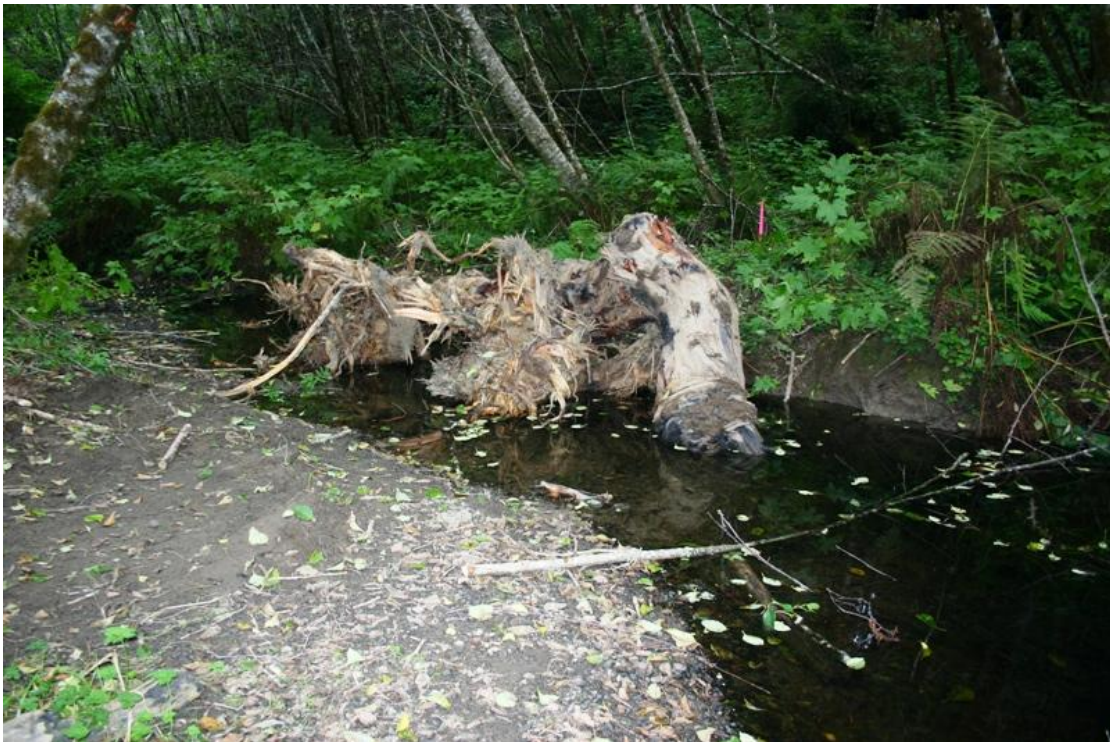
Figure 54. Shallow pool following installation of LWD pieces #22-26, West Fork McGarvey Creek, Lower Klamath River, California, 2007.

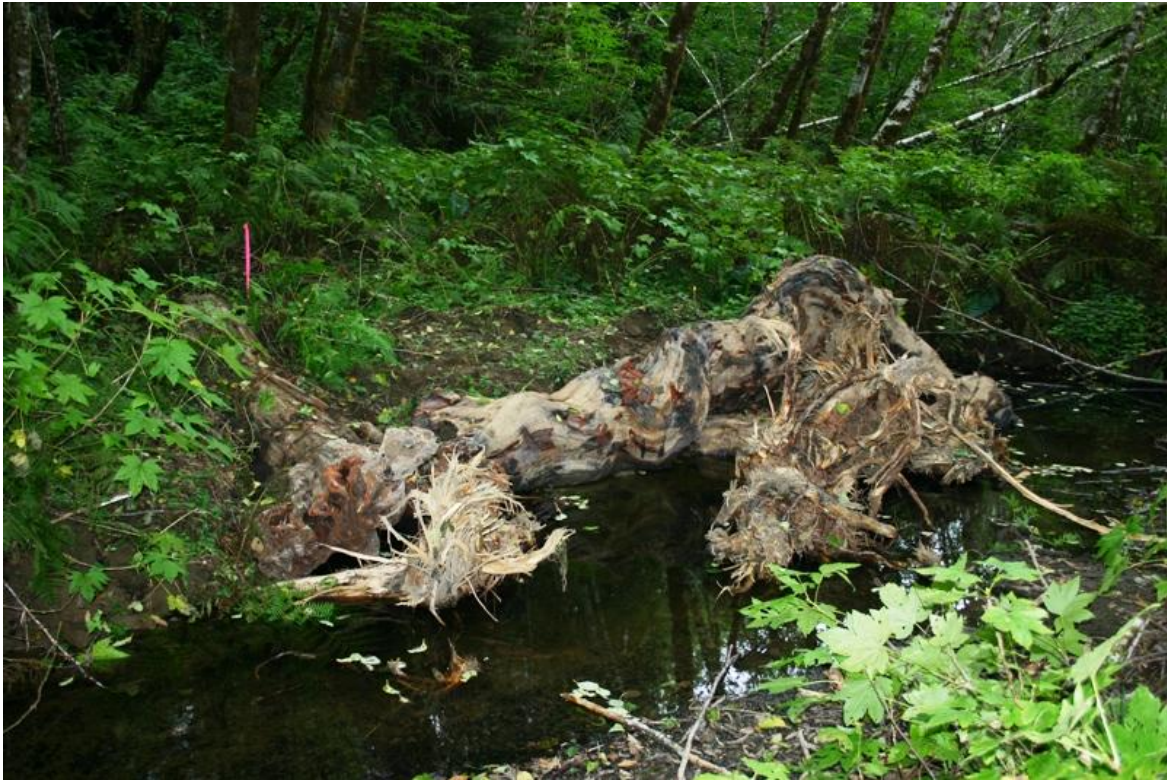
Figure 55. Shallow pool following installation of LWD pieces #22-26, West Fork McGarvey Creek, Lower Klamath River, California, 2007.

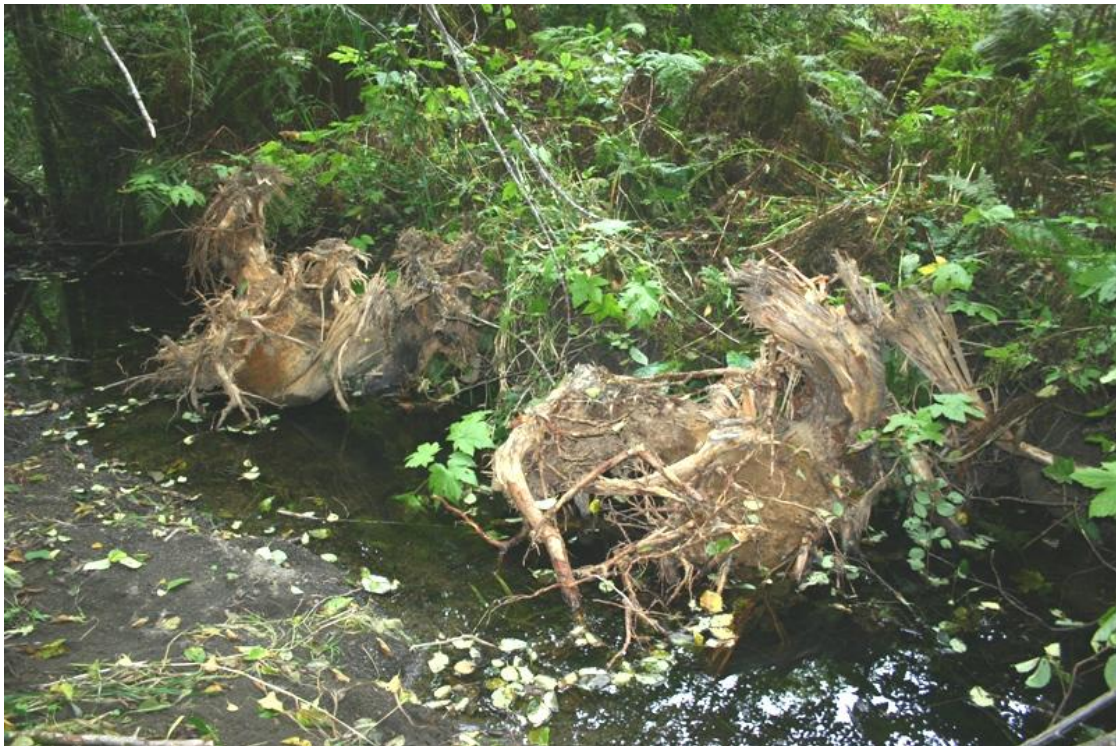
Figure 58. Shallow pool following installation of LWD pieces #27-30, West Fork McGarvey Creek, Lower Klamath River, California, 2007.

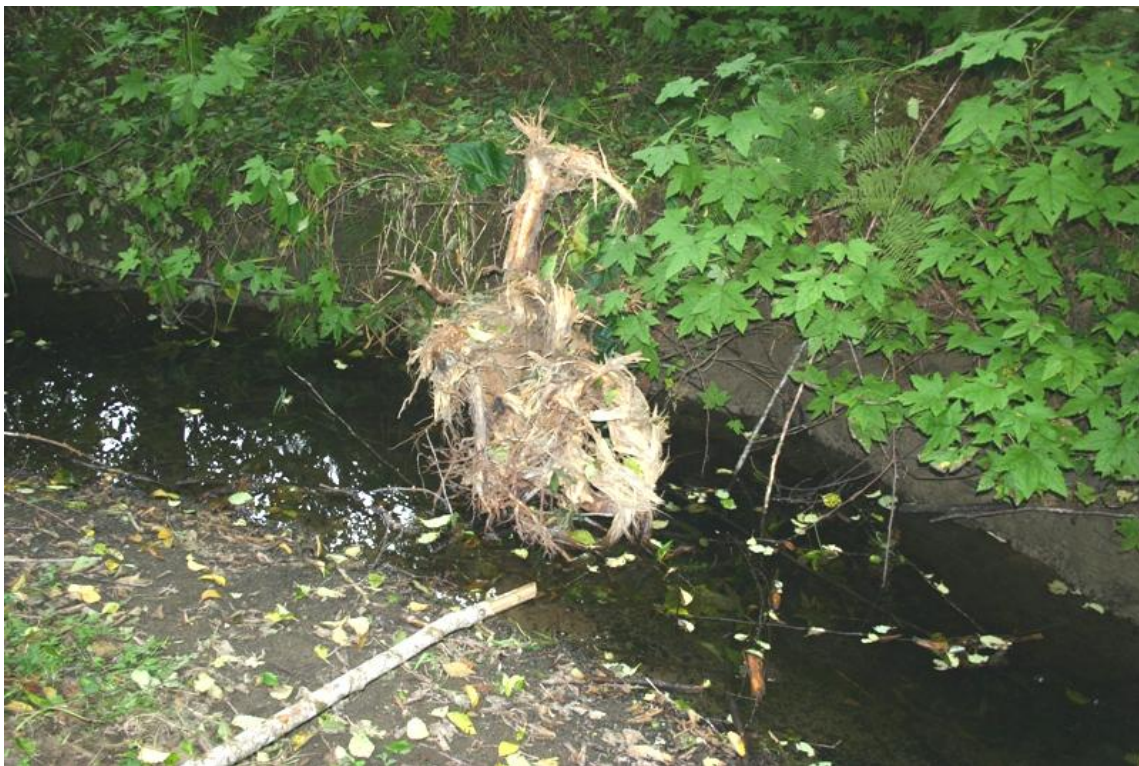
Figure 59. Shallow pool following installation of LWD pieces #27-30, West Fork McGarvey Creek, Lower Klamath River, California, 2007.

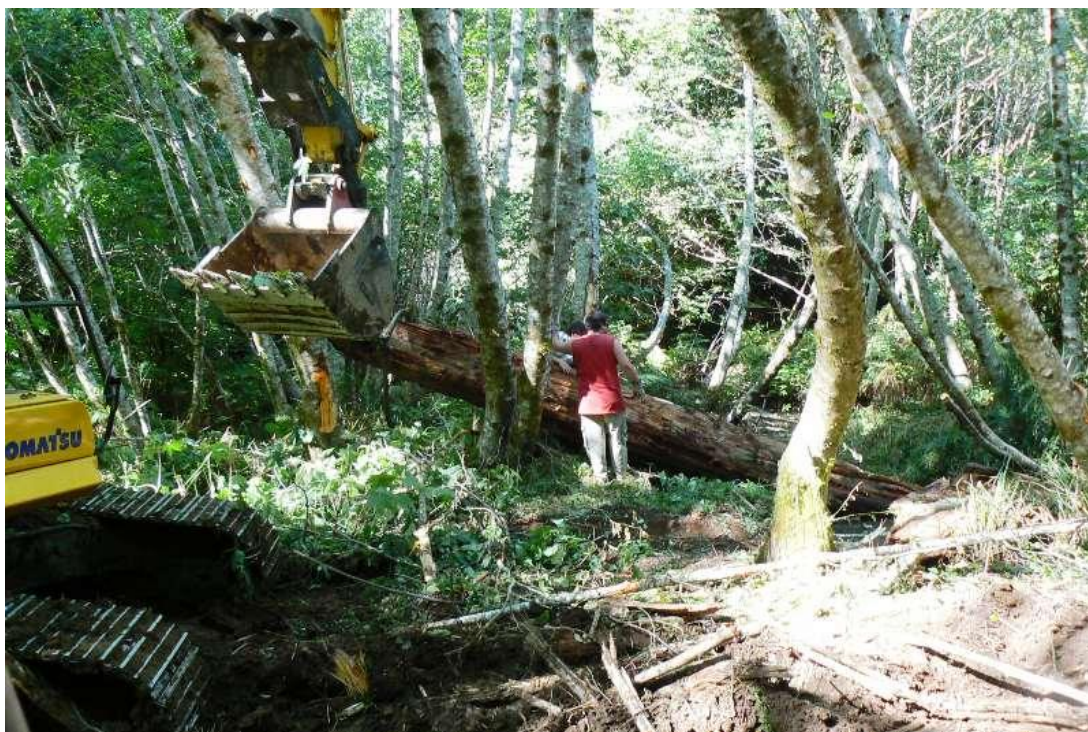
Figure 62. Shallow pool during installation of LWD pieces #31-34, West Fork McGarvey Creek, Lower Klamath River, California, 2007.

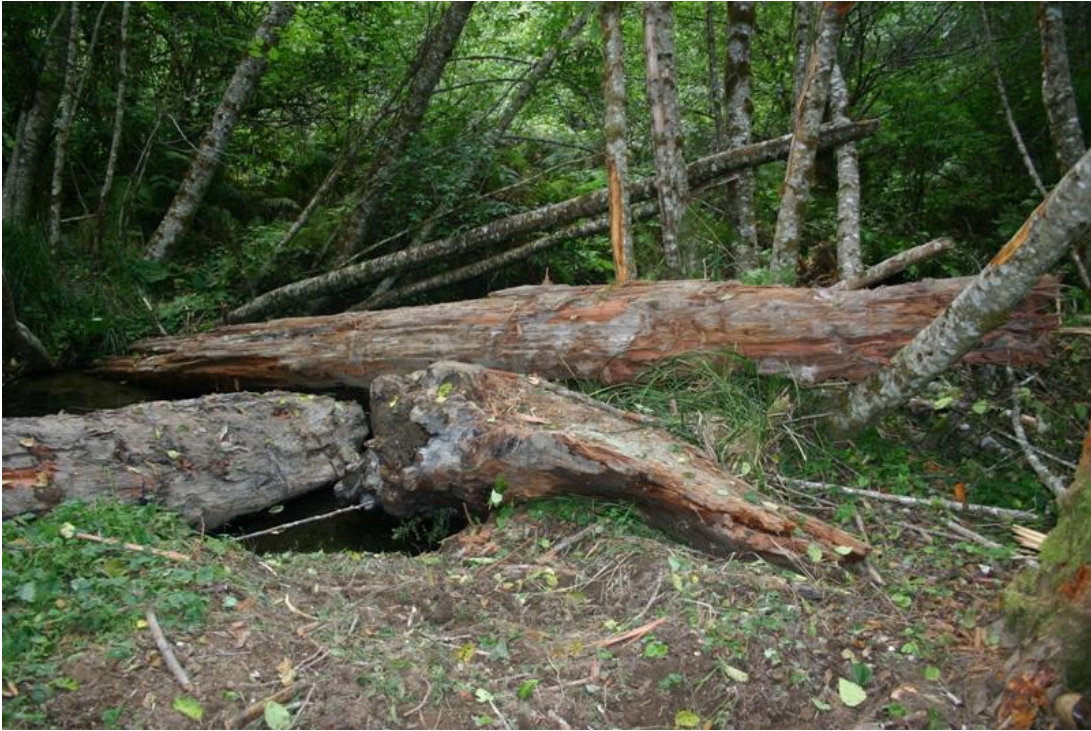
Figure 63. Shallow pool following installation of LWD pieces #31-34, West Fork McGarvey Creek, Lower Klamath River, California, 2007.

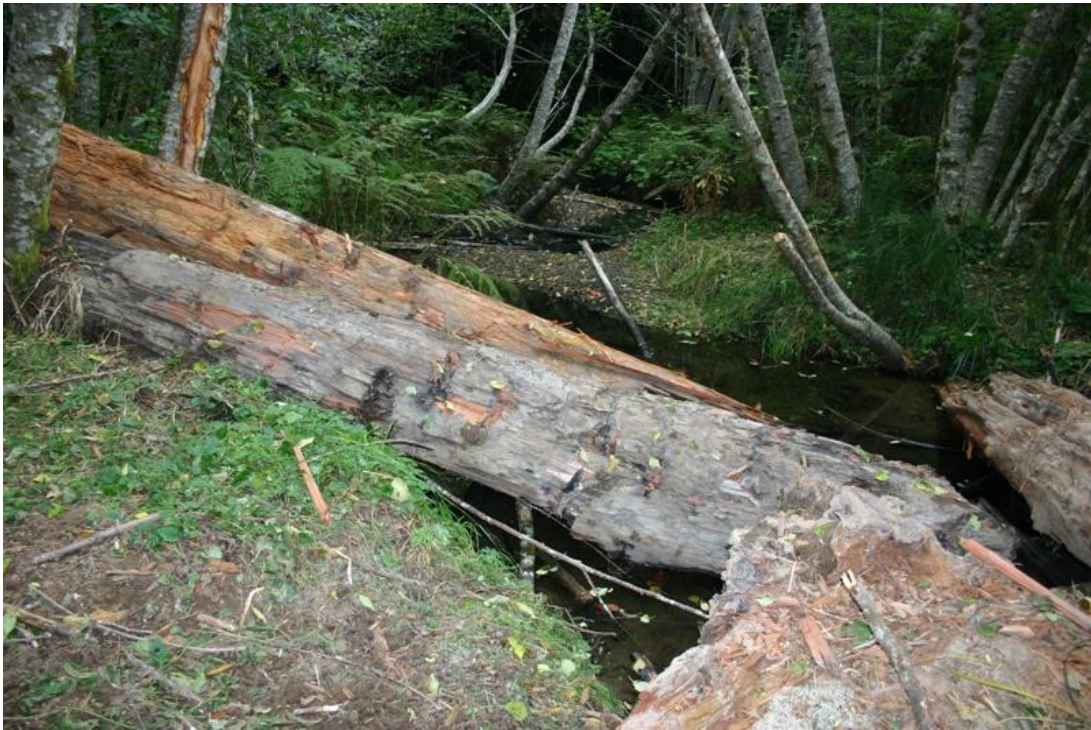
Figure 64. Shallow pool following installation of LWD pieces #31-34, West Fork McGarvey Creek, Lower Klamath River, California, 2007.
